JAMES CLAGUE  
ARCHITECTS

THE GRANARY

MOAT FARM  
HEADCORN

METHODOLOGY  
FOR REPAIR AND  
RECONSTRUCTION

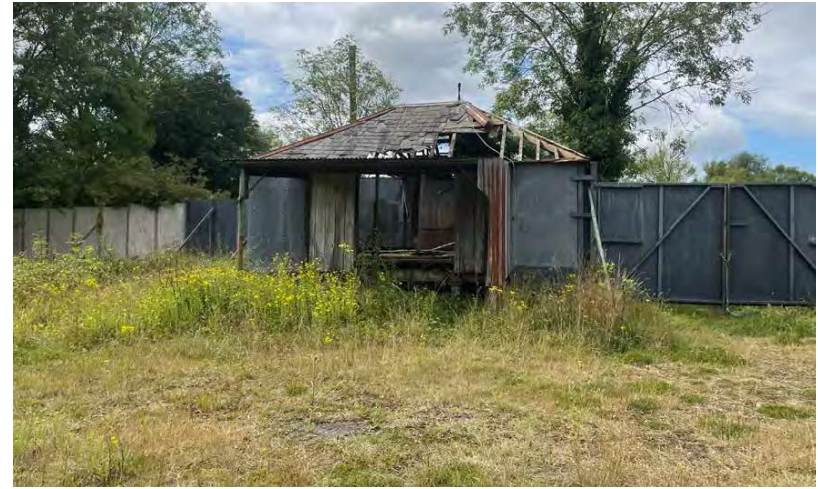
north elevation

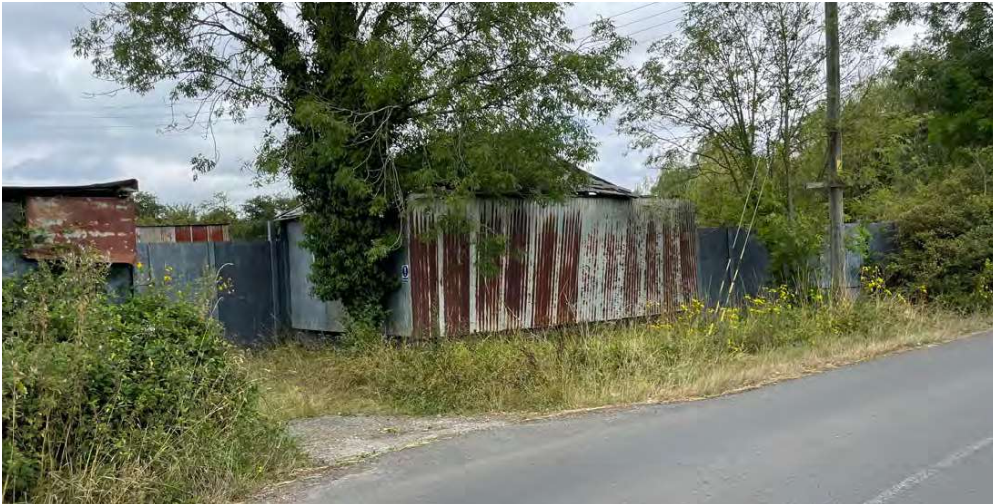
south elevation from road

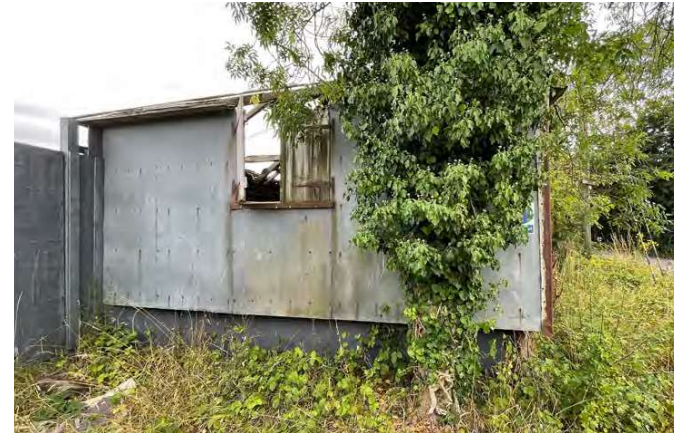
west elevation

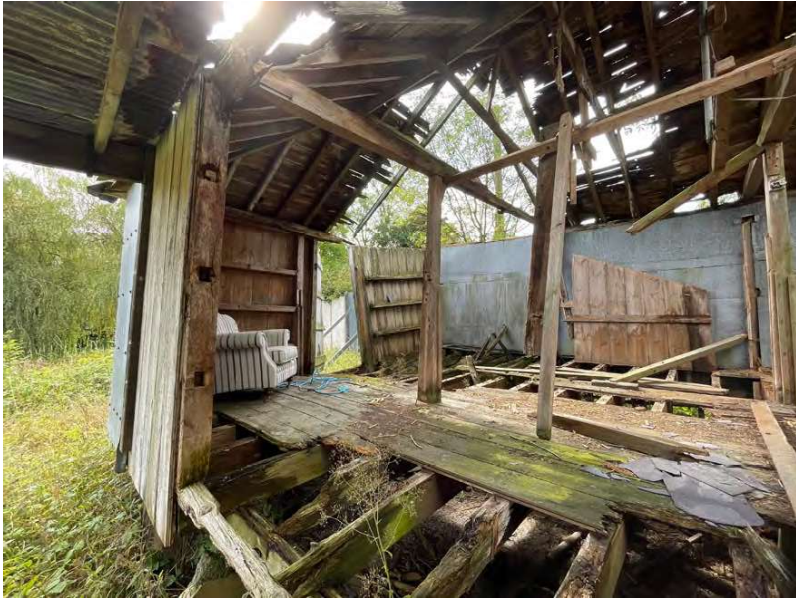
8. The roof structure appears to have been extensively supplemented and replaced, and is now in a serious state of disrepair and decay with many components missing. The assembly appears to comprise paired common rafters birds-mouthed and skew nail fixed to the wallplate and skew nail fixed to a ridgeboard ( a feature and method of fixing common in the later 19th century). Alternative pairs of rafters are connected with collars supporting a trenched purlin with hip rafters and jack rafters to the hips. The collars appear to be morticed and pegged to the rafters rather than half lapped.

internal view of roof structure

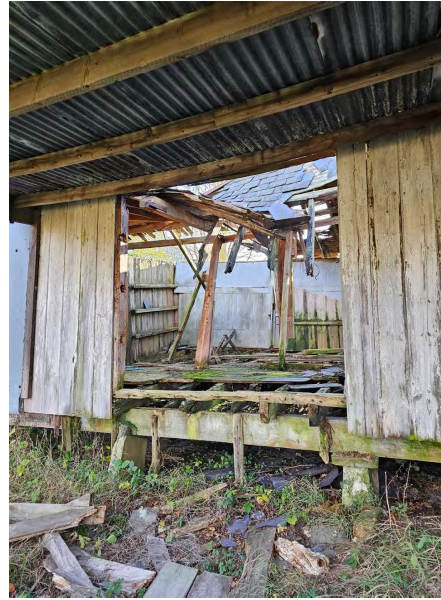
opening and original external cladding to north elevation

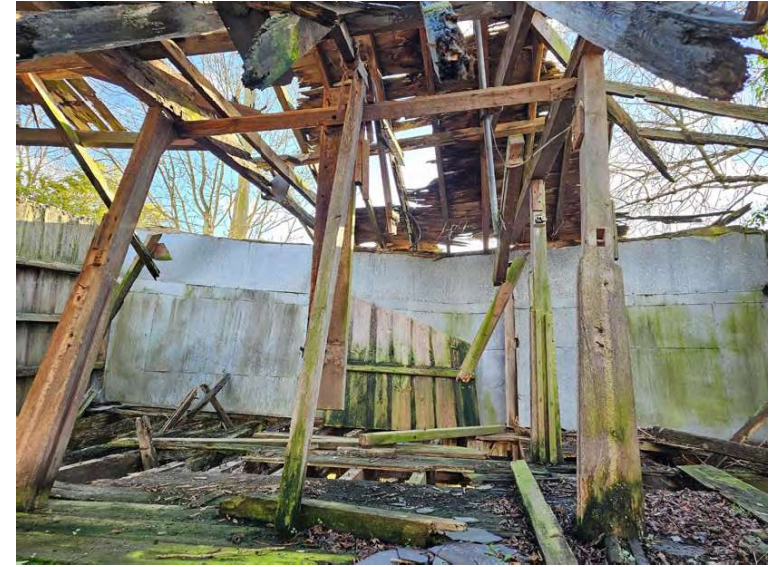
10. The central posts and corresponding wall posts are haunched and grooved to form slots to receive the grain bin 'holds'. These features appear to have been extended in height by the addition of nailed battens. The evidence suggests the subdividing partitions comprised 3 horizontal rails supporting vertical tongue and groove boards and were ramped in appearance (presumably to reflect the settlement of the piled grain) with the top rail pegged and morticed into the posts. The partitions to the central passage appear to have comprised a series of boards slotted into the grooves in the posts to allow for easy removal. Unfortunately these features have been almost extensively lost and it is not proposed to reinstate the partitions as this would be based on conjectural evidence.

haunched central posts to grain bins. Note  
pegs and mortice to receive partitions (re-  
mant of partition propped on rear wall)

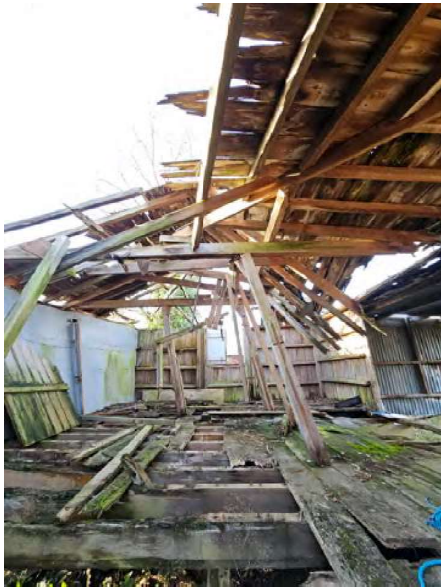
tie beam morticed and pegged to posts

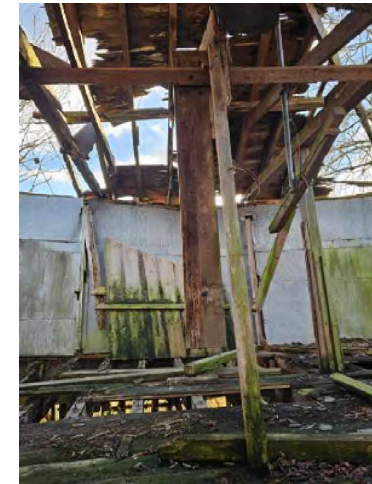
central grain bin prop supporting tie plate to be removed

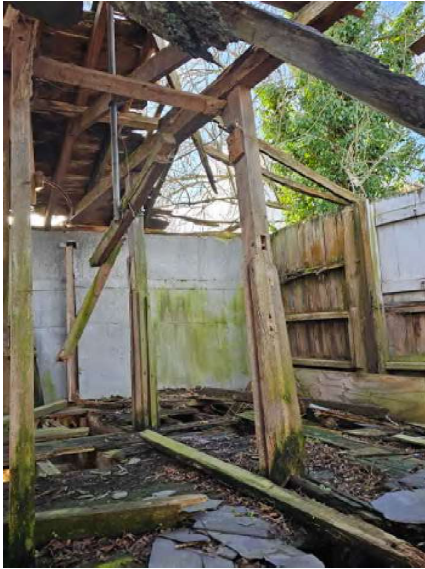
12. The central posts appear to have been altered by the addition of timber brackets nailed to the head of the posts to support a short length of plate which appears to in turn support an additional central post, possibly to reinforce the inserted partition although its exact purpose is unclear. It is not proposed to reinstate these components.

haunched and grooved central grain bin post supporting tie beam. NB brackets to be removed

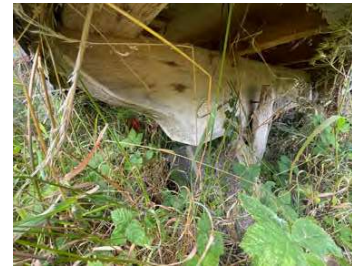
shaped end to girders (resting on inserted prop)

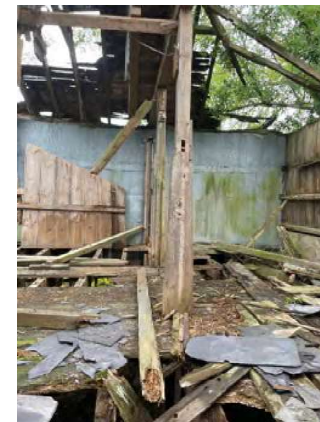
mortice and peg in grain bin post to receive partition and remnant of grain bin partition

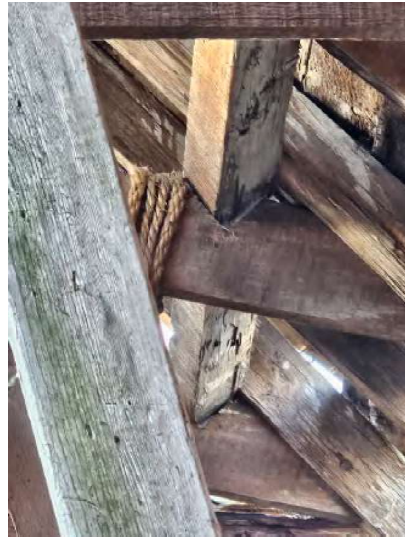
trenched purlin over collar (rafter appears lapped) Collar may be later

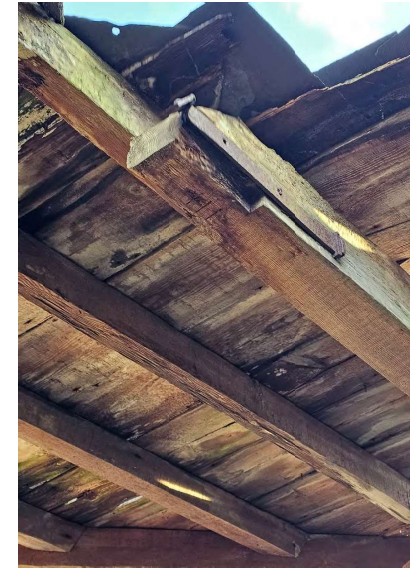
dovetail joint to tie beam to wall plate with twisted forged strap for restraint

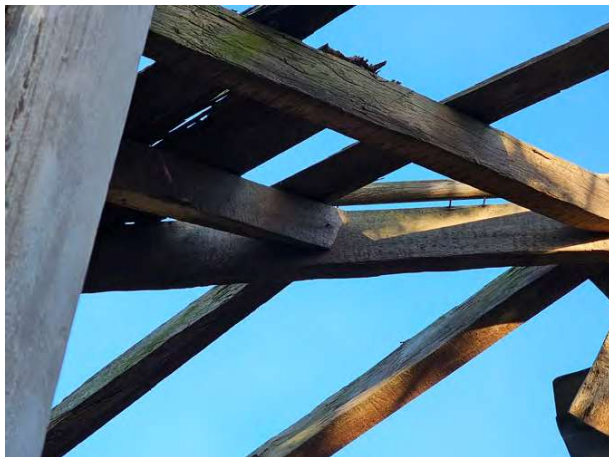
skew fixed nailed jack rafters to hip rafter

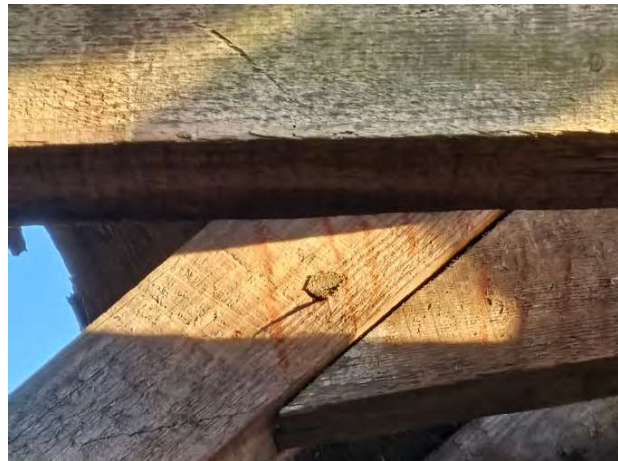
original pegged collar to rafter. Note red riddle pencil carpenter's marks rather than scribed with chisel suggestive of successive alteration to roof

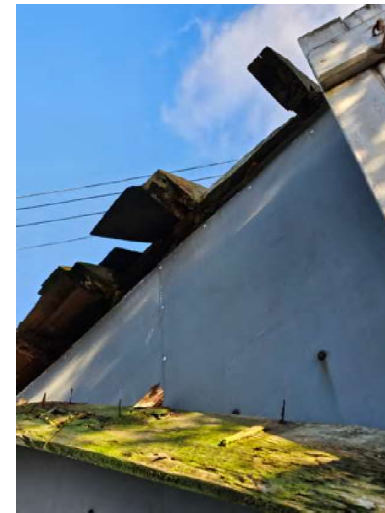
splayed rafter feet with nailed soffit board (displaced)
