Shore Associates Ltd
Chartered & Heritage Building Surveyors

Building A Condition Survey Report

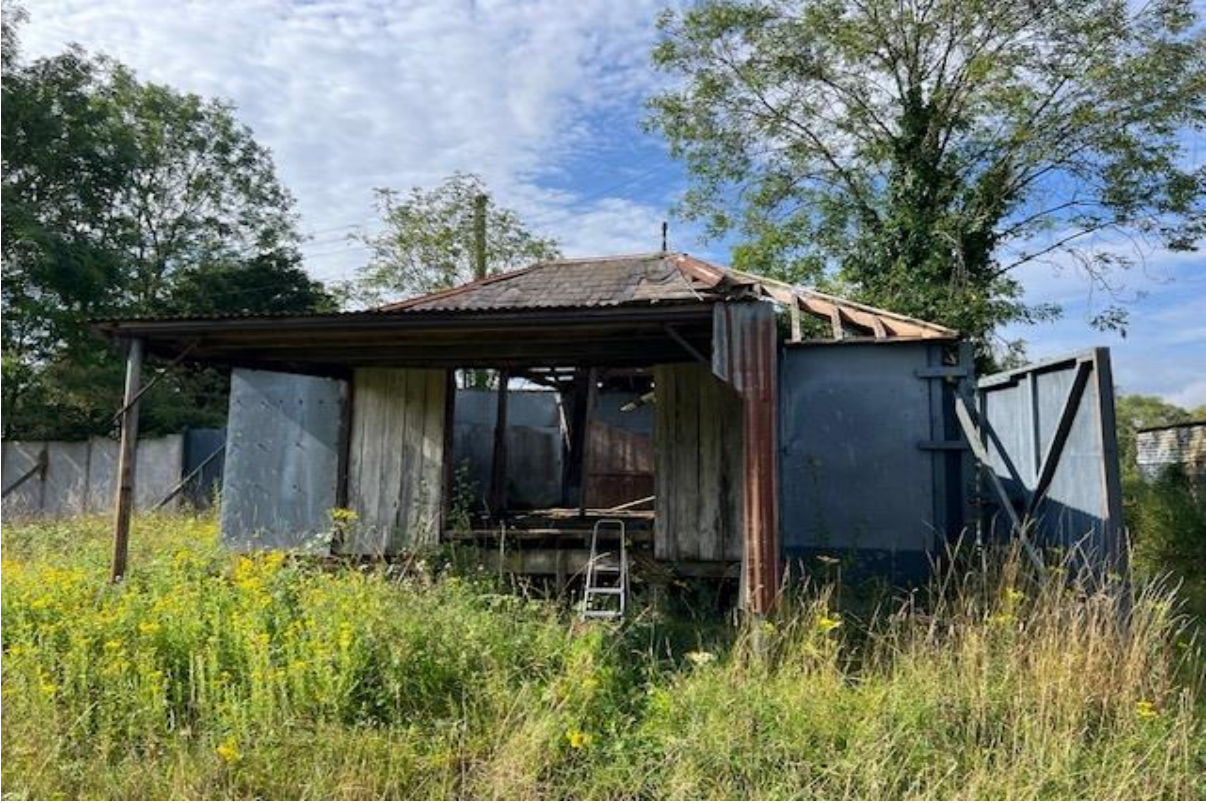
In this report, the front wall of the building — is designated “W1”. Working clockwise, W2 left hand side elevation, W3 the rear of the property and W4 the right-hand side of the property: Where appropriate, a wall junction/corner would be described as “W1/W2”, for example.

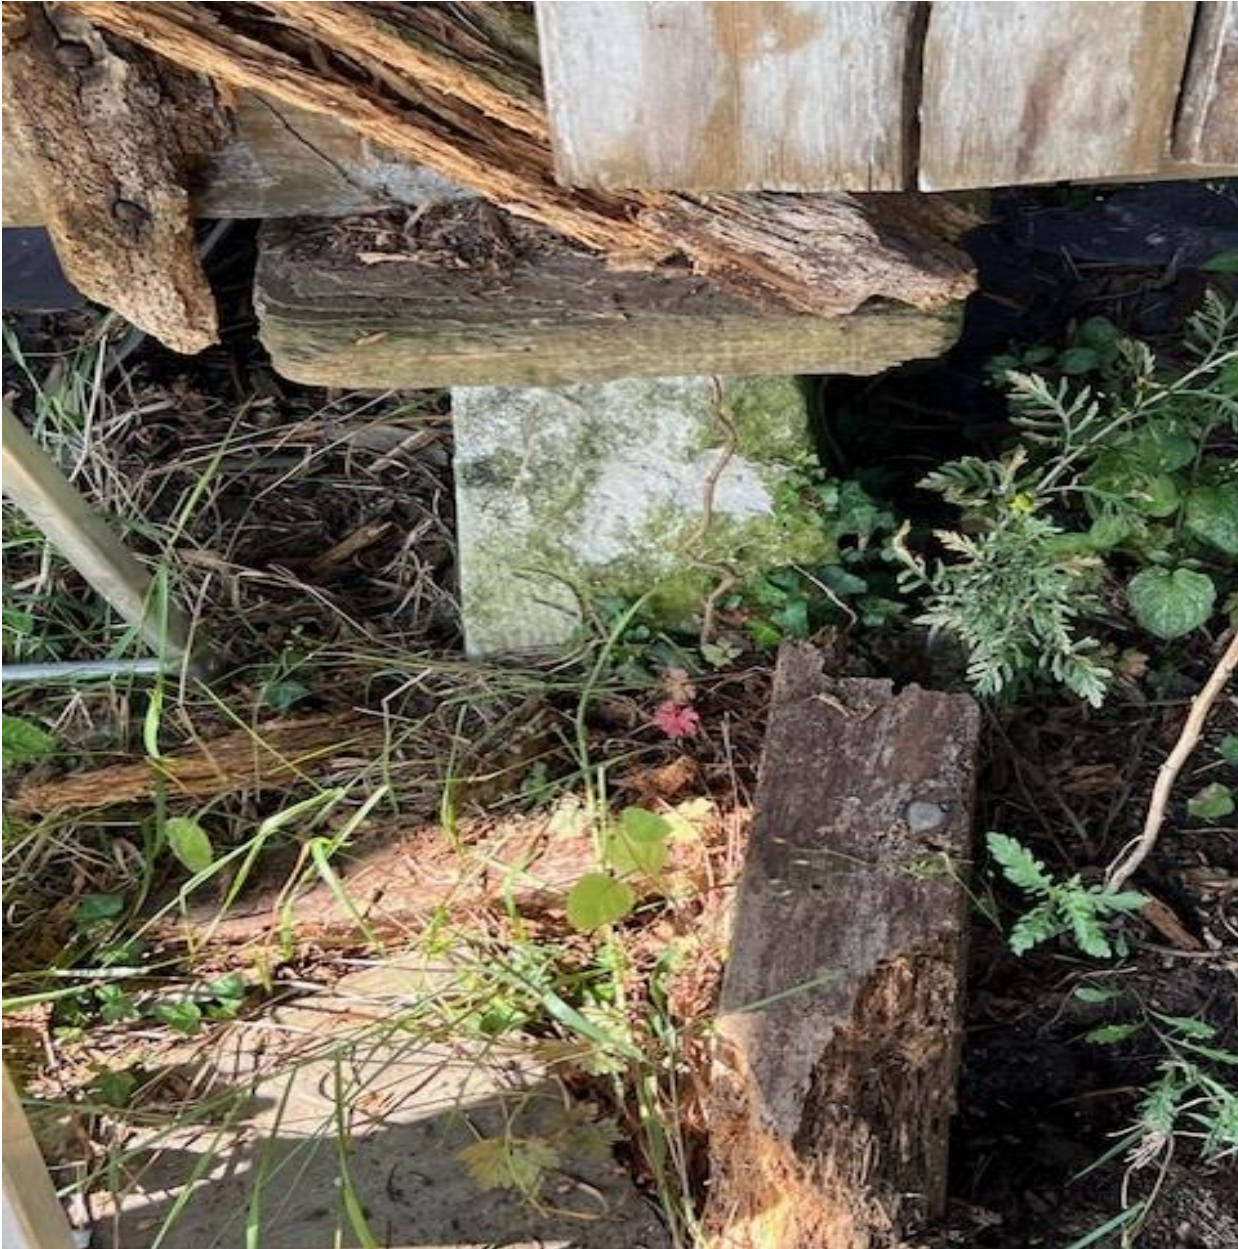
Staddle Stones are sat at the base of the bearing timbers, these all detail in fair condition.

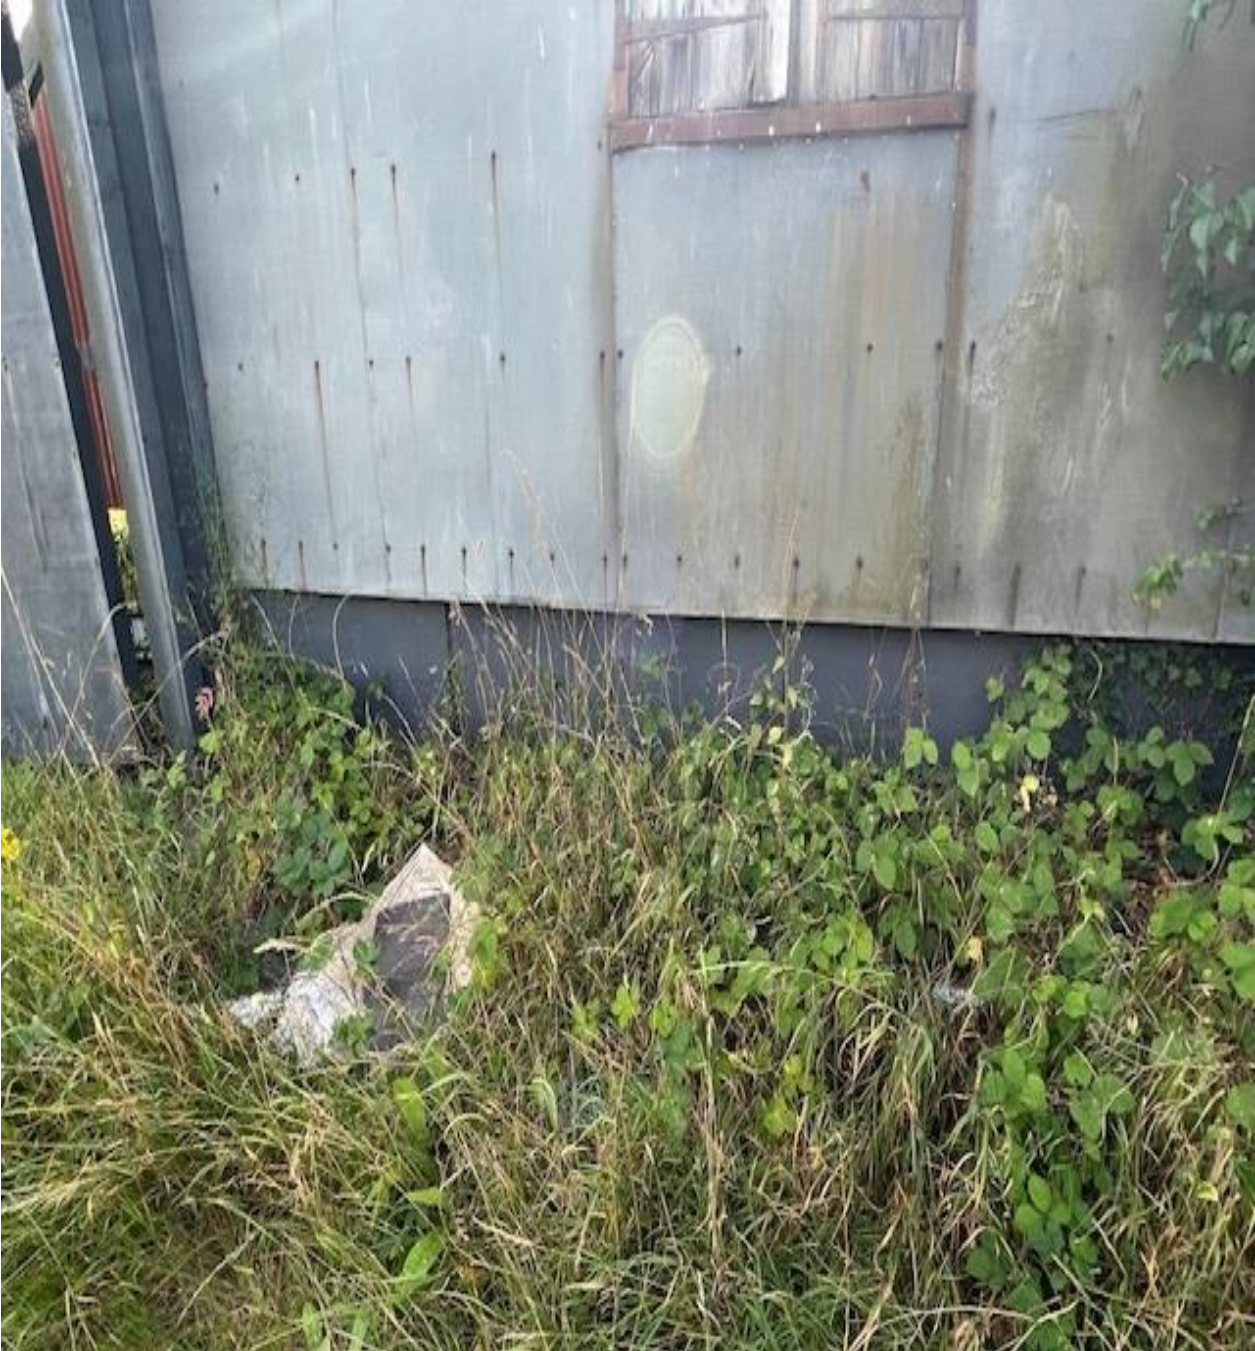
At W3 there is a ply timber base, the main covering at the elevation is cladded in a metal sheeting.

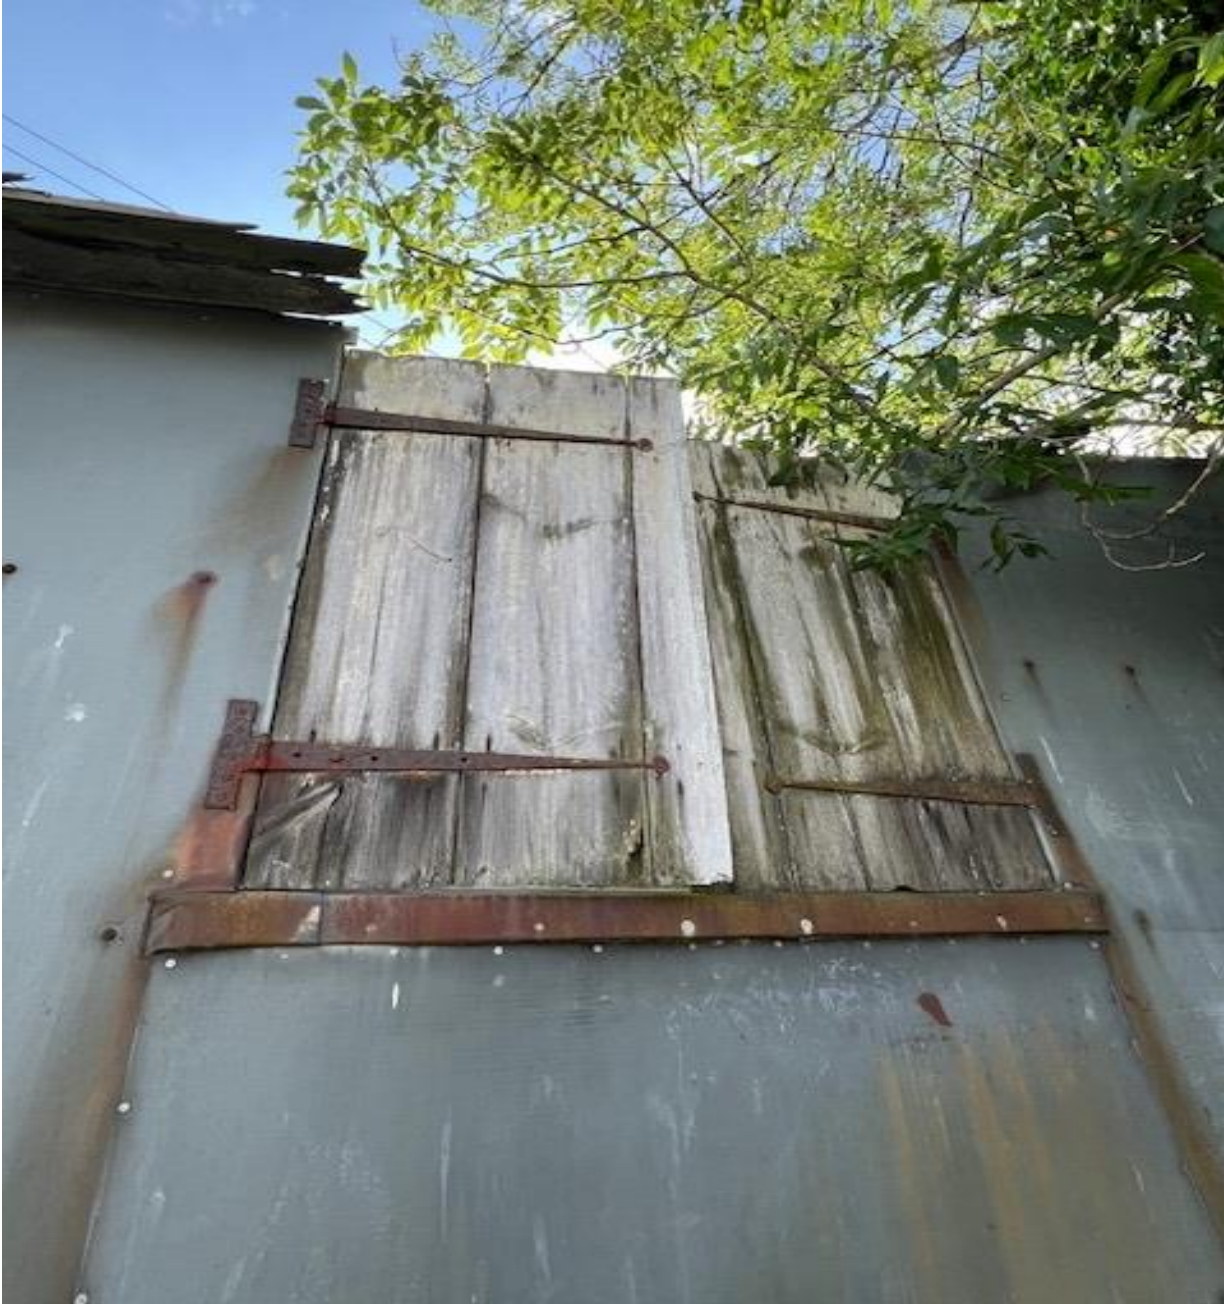
W3 Elevation details two timber shutter doors at the opening – these are hung on metal hinges – which are detailing corrosion.

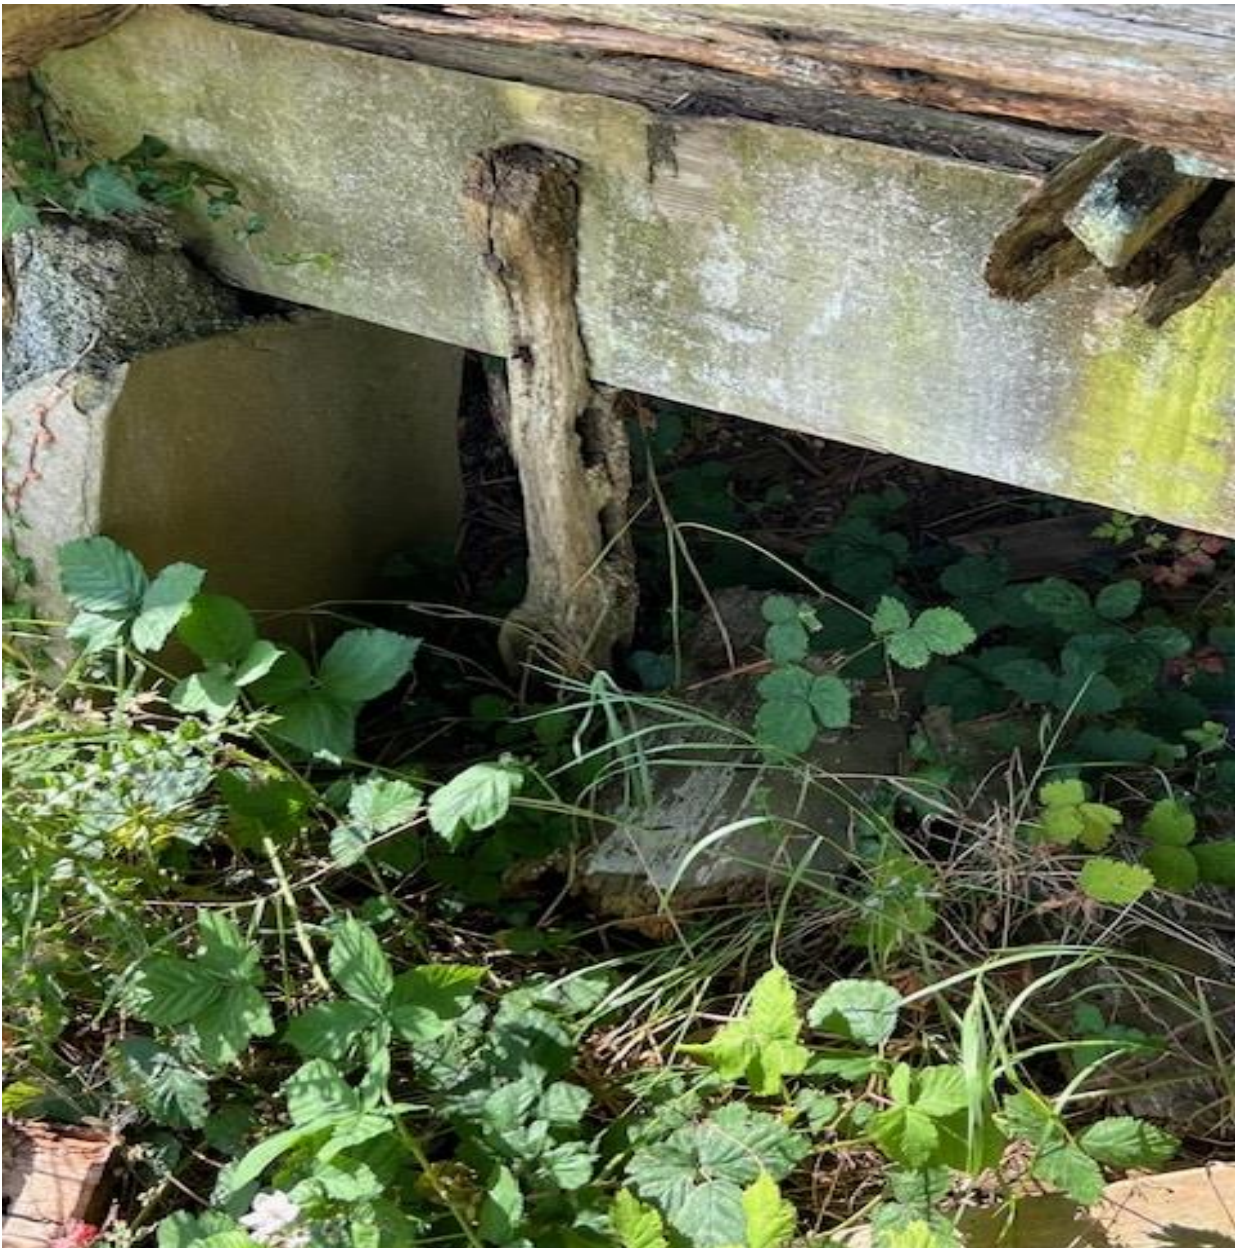
In addition to the Staddle stones, there are vertical struts around the perimeter, these are in some places notched around the main bearing timbers and sit directly at the ground below, its condition is considered poor.

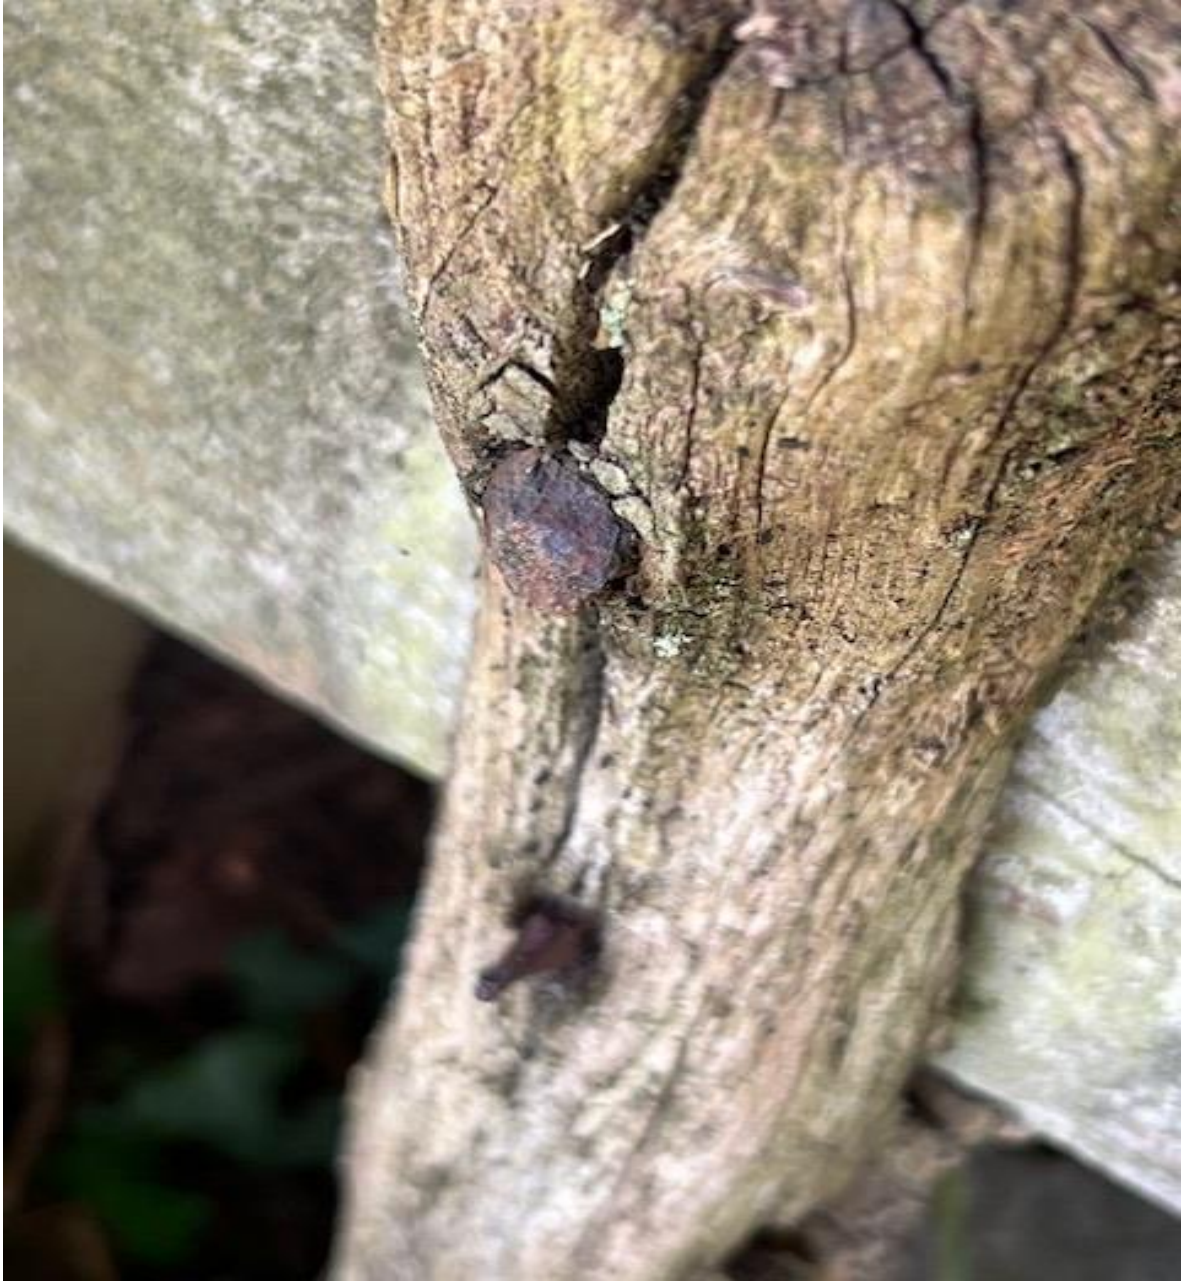
As above, the timber strutting here is nailed to the main 10" x 5" timber.

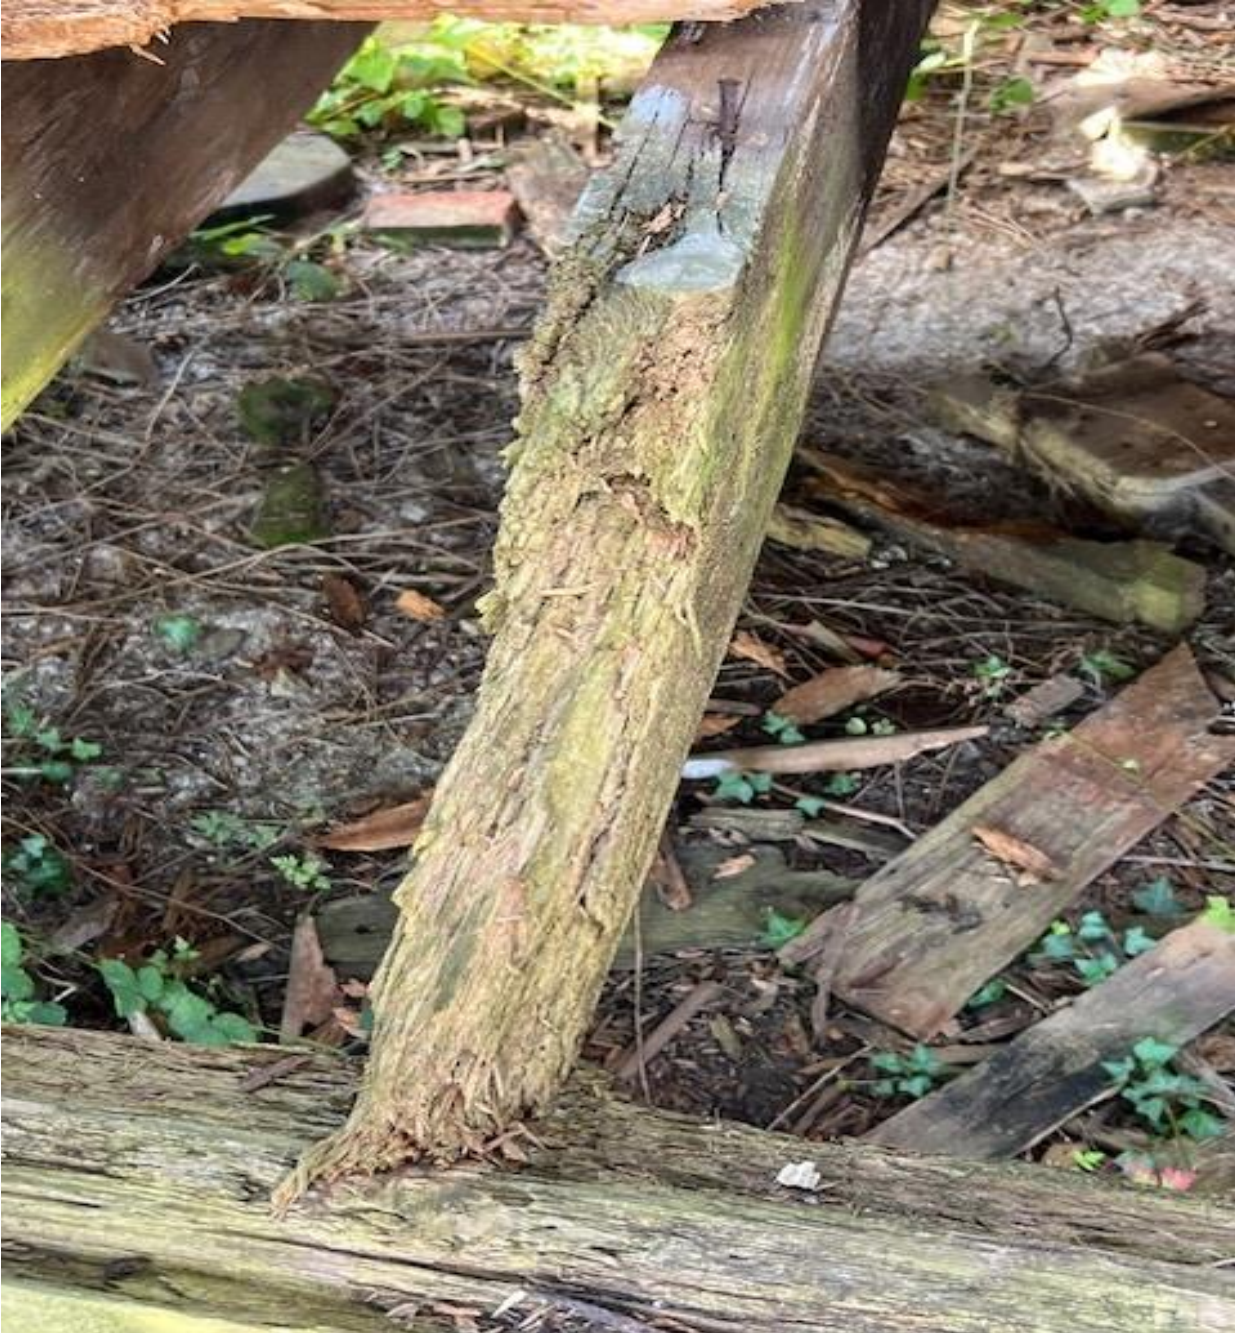
The joists that run from W1 back to W3 are in poor condition, decay / wet rot has caused significant decay to the vast majority of the timbers.

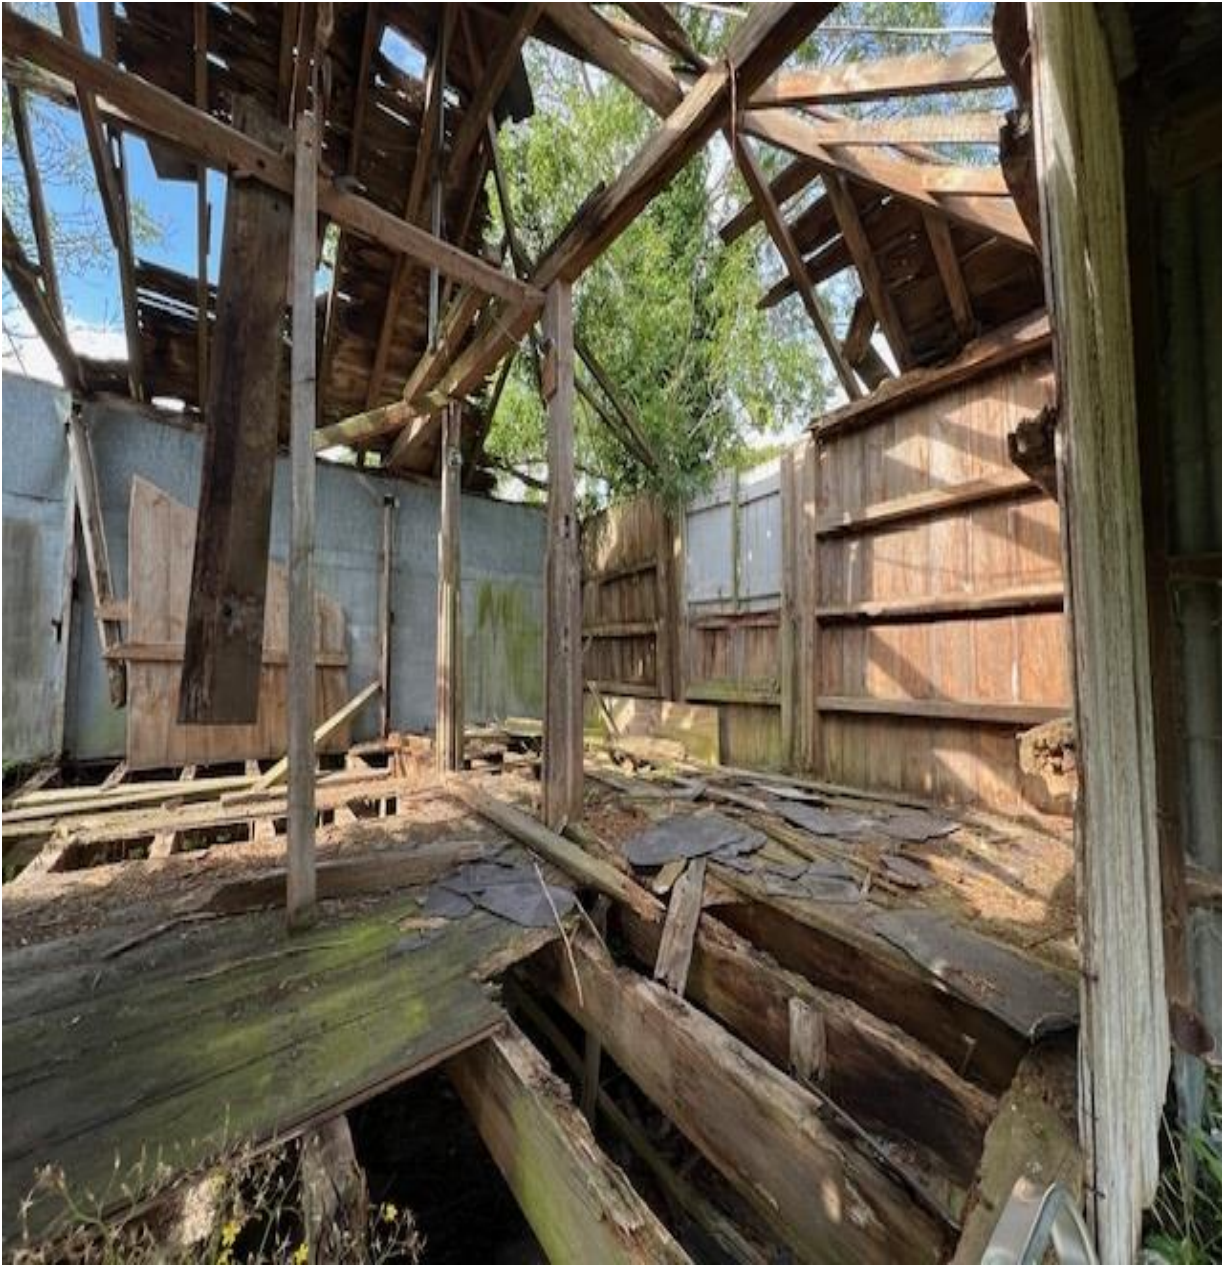
The timber flooring, those at the main bearing joists and the floor boarding laid over all detail significant rot, underfoot they give way.

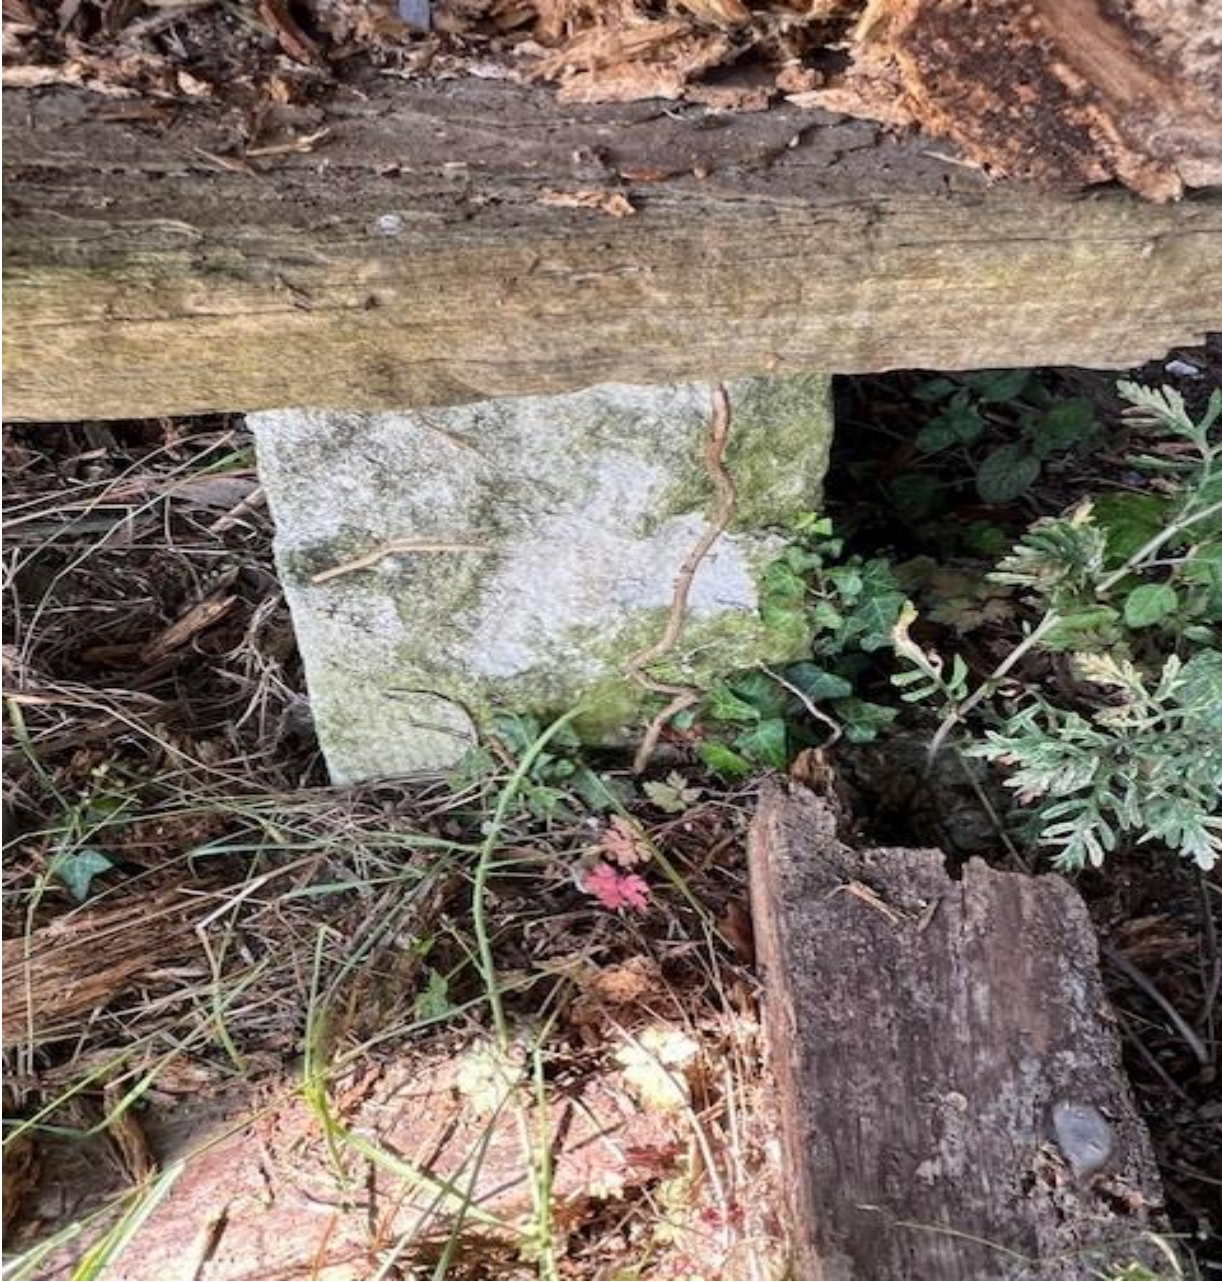
Further example of the staddle stone acting as the support for the main timbers, the stones are in limestone, and although show some sign of decay, the main stone is still structurally supportive.

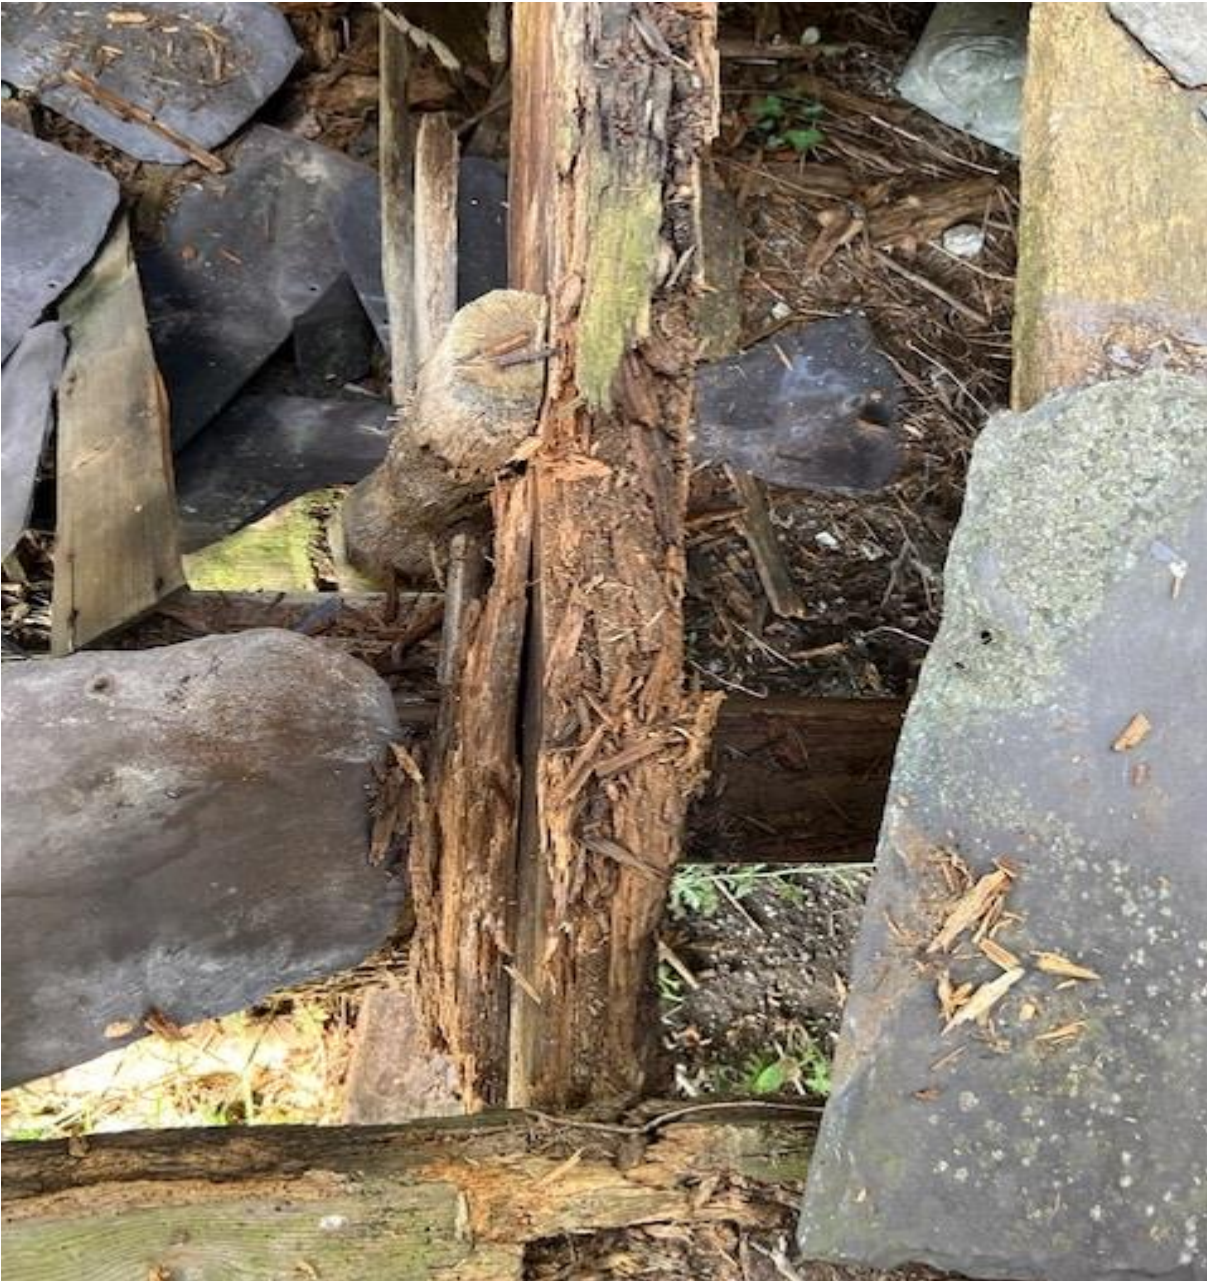
Example here of one of the main joists spanning from the sole plate through to the rear W3 elevation, the timbers are rotten and decayed, no longer sit at the bearing timber, and easily break away at touch.

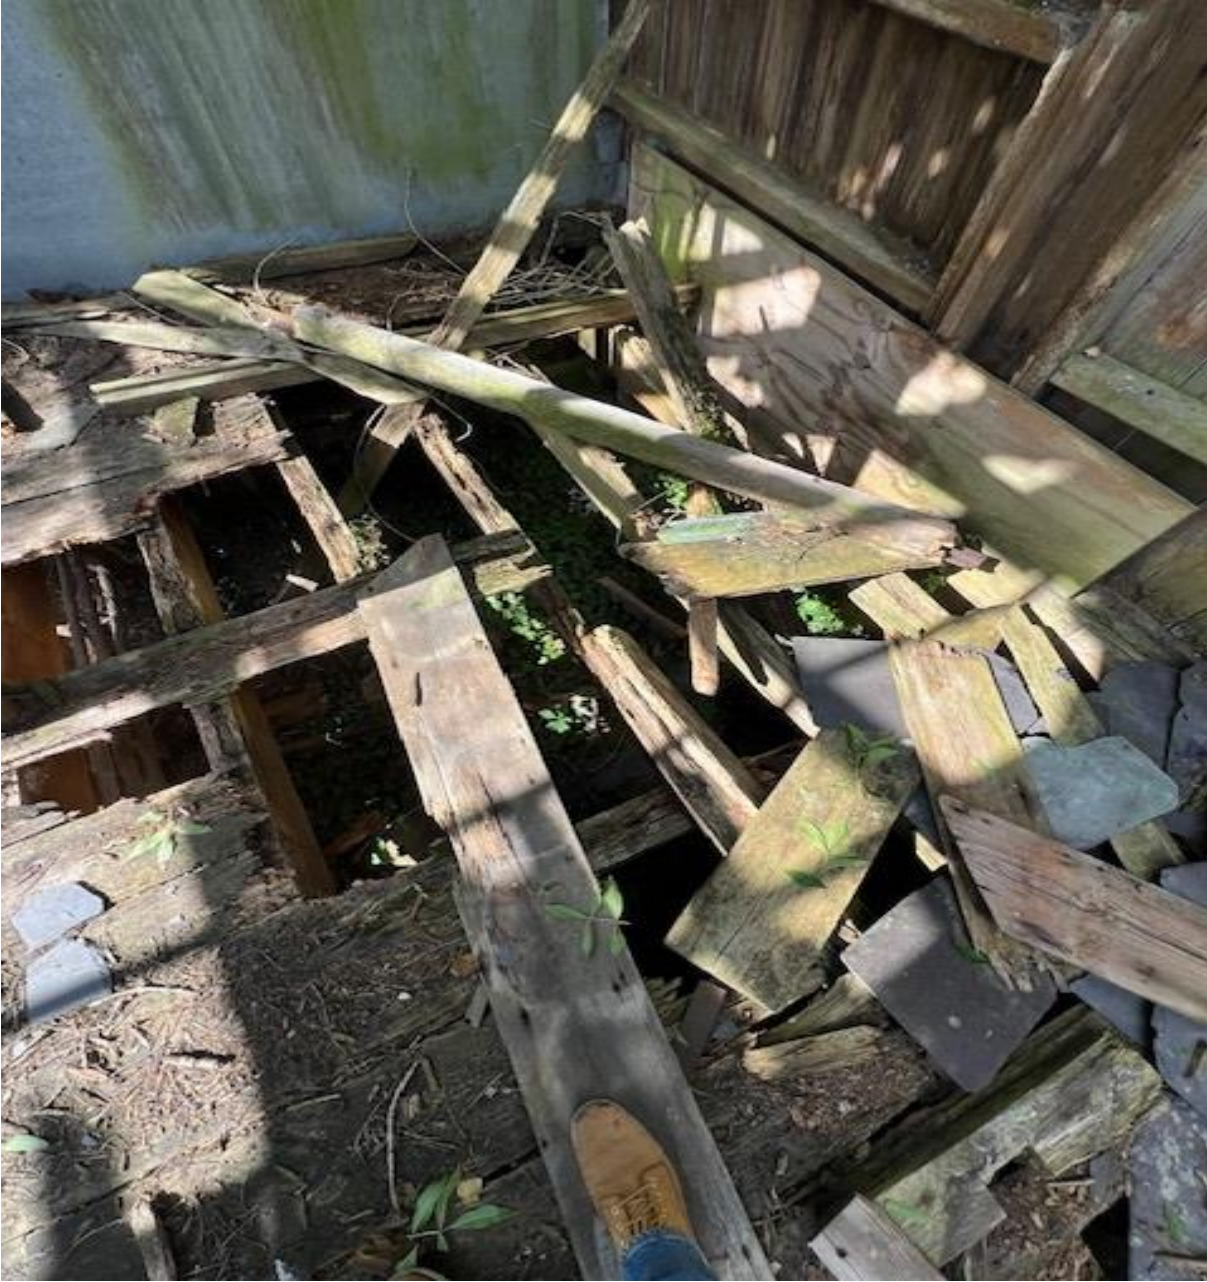
At the corner of the W4/W3 there is little in the way of floor boarding left, the main joists below are decayed to the point that access was restricted.

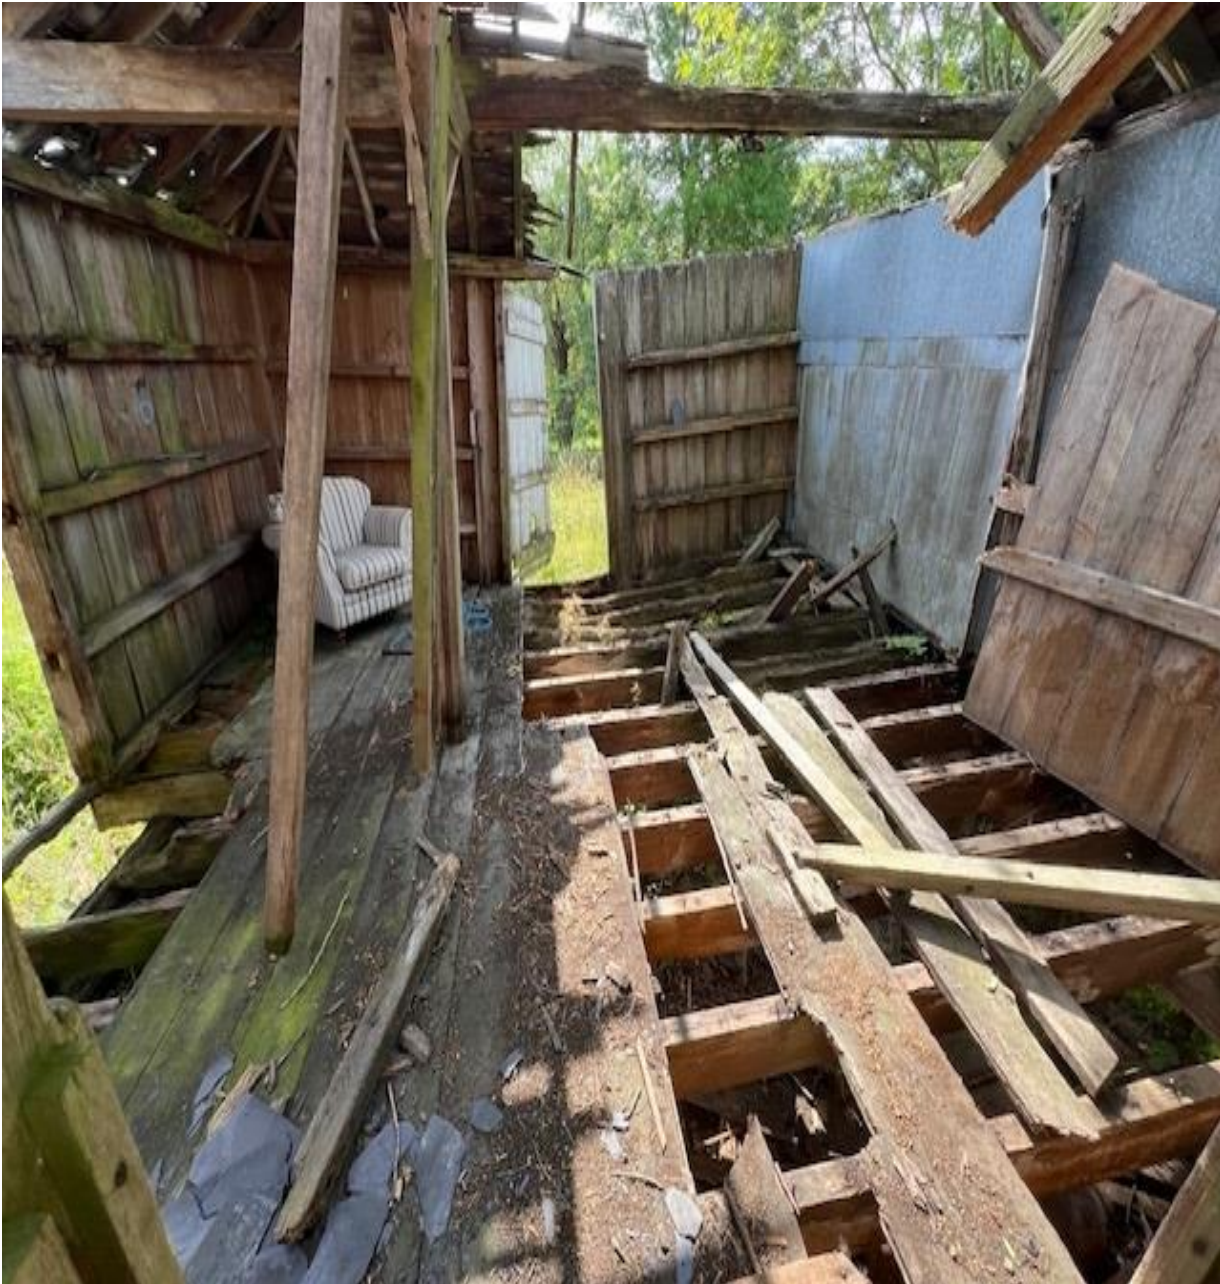
As can be seen here the flooring throughout details significant rot through all of the flooring, there is significant rot where the joists are exposed, less so where floor boarding sits over.

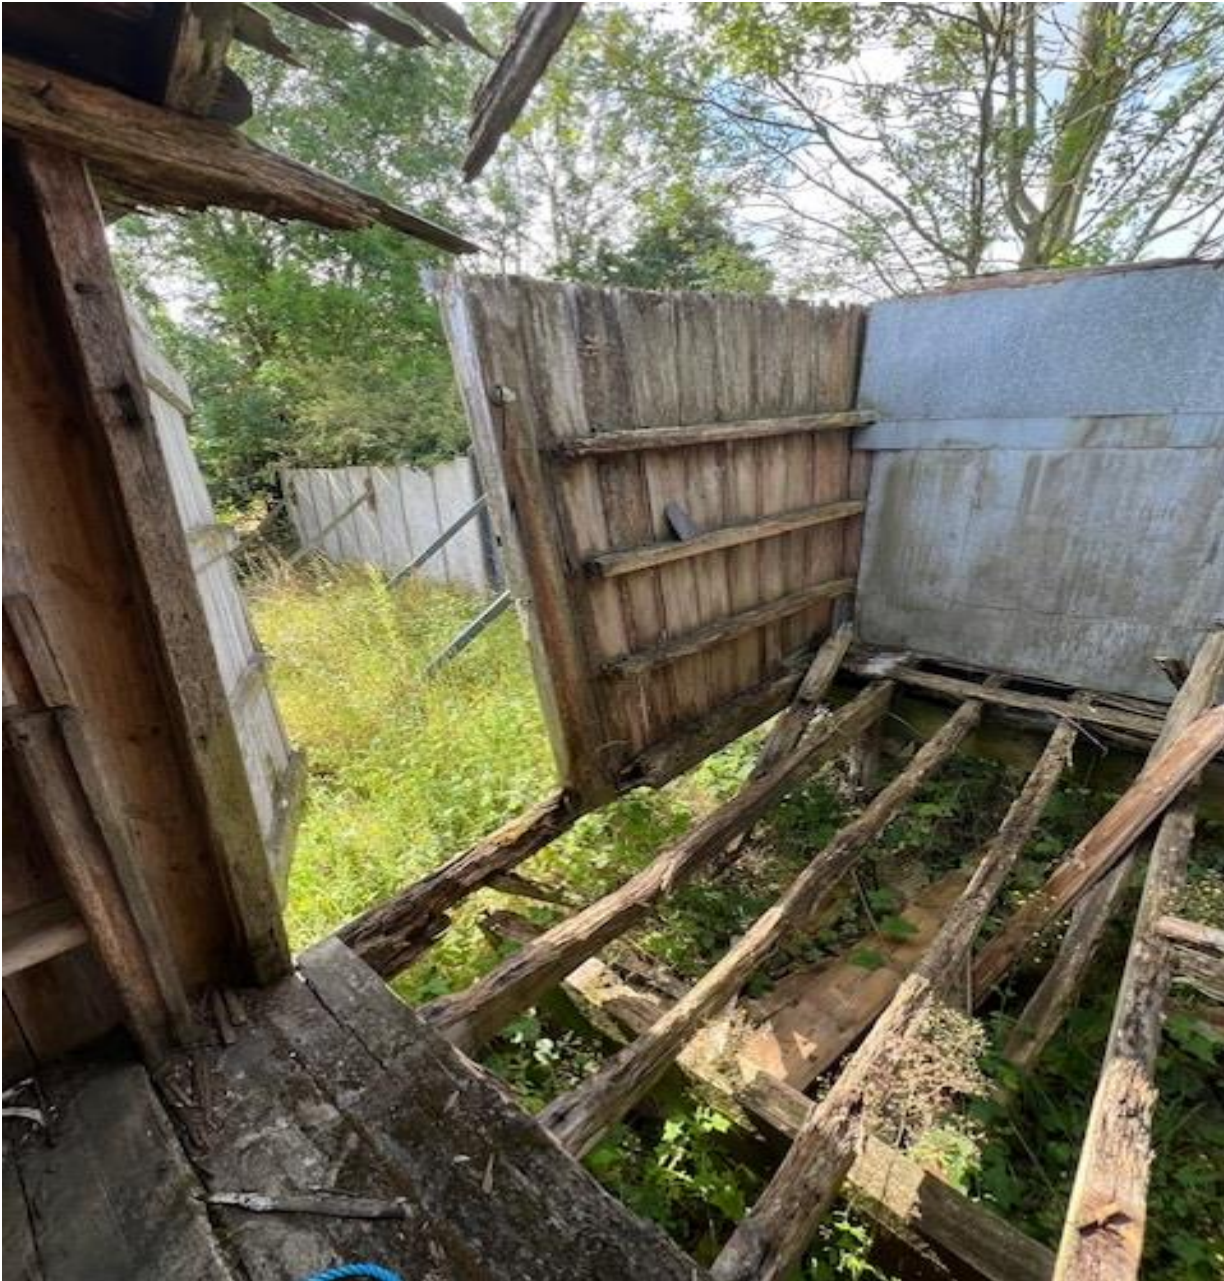
The main joists at W2 are in very poor condition, the rot is extensive throughout the full length of the timbers.

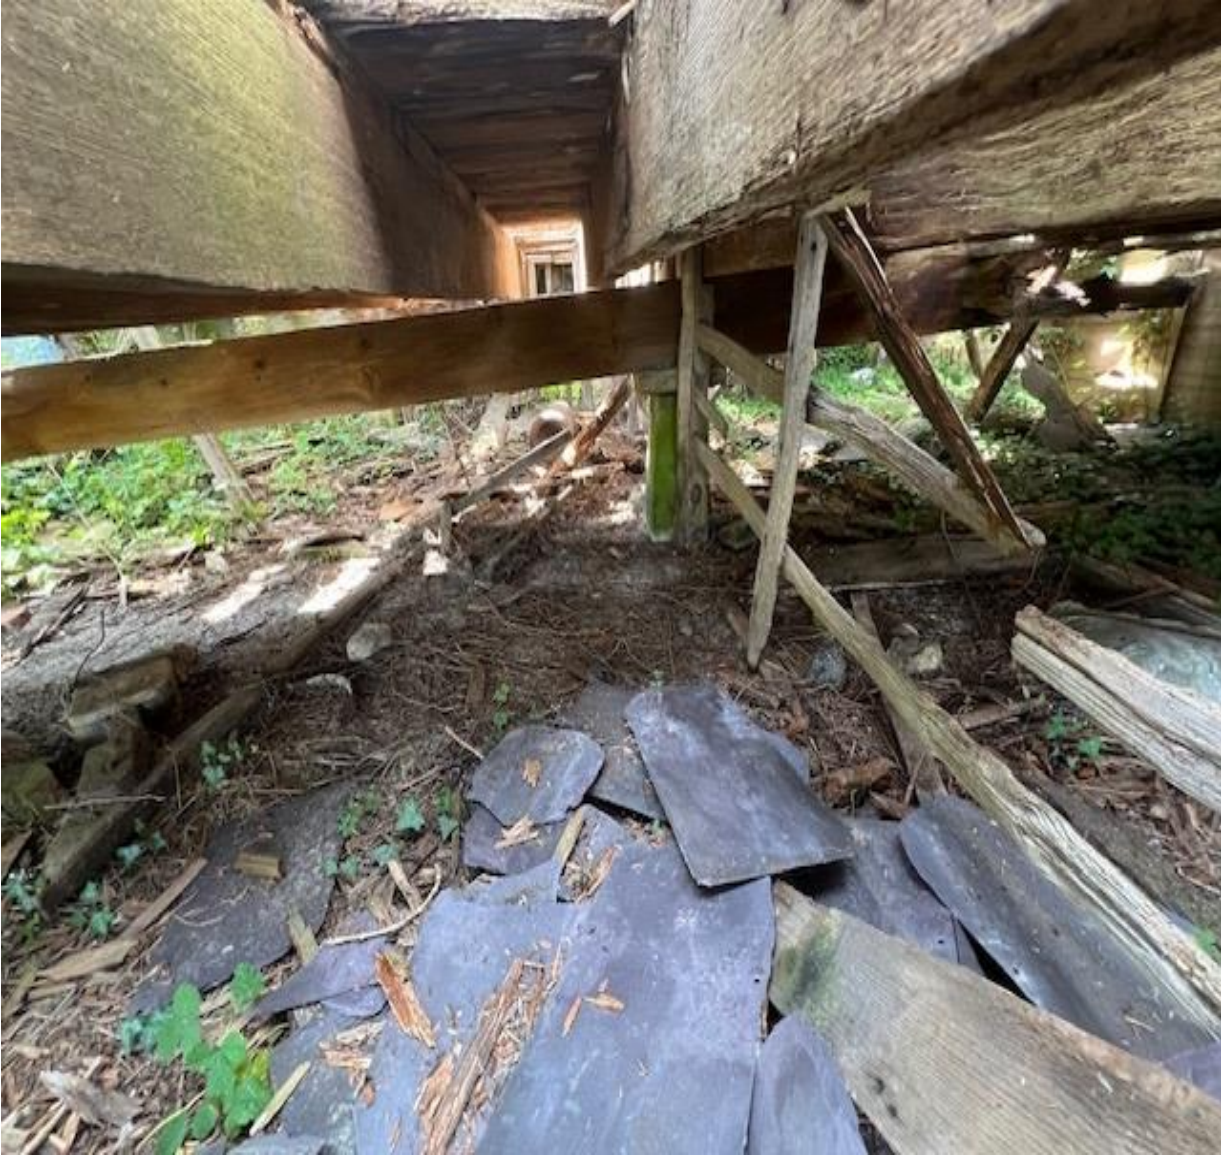
The photo here shows the underside of the timber joists.

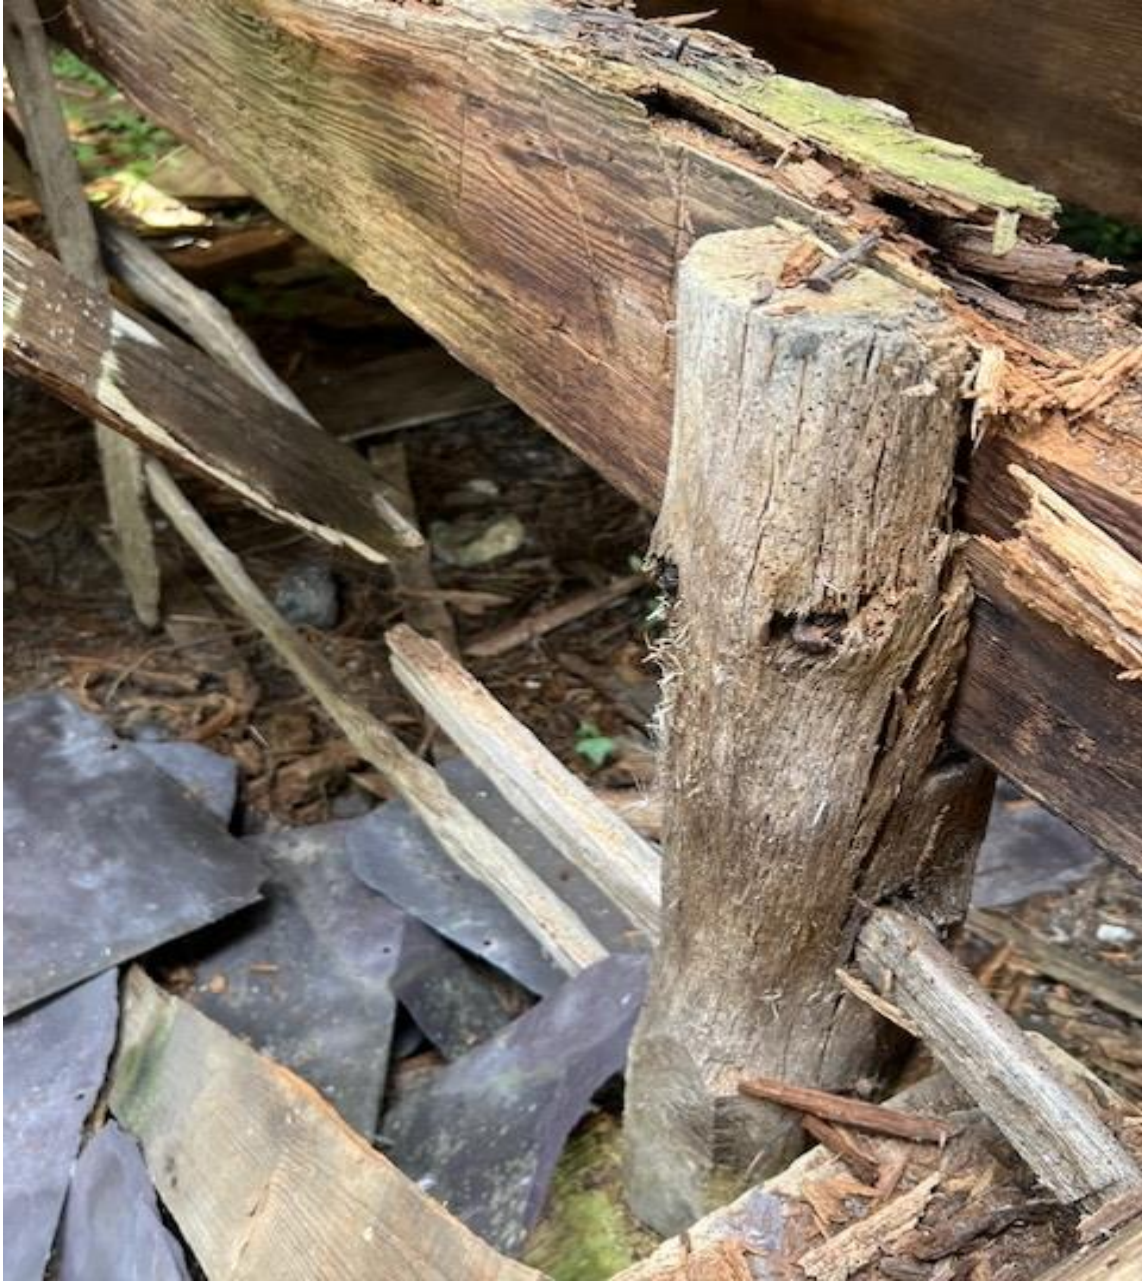
Where the older timber joists sit, and as above there is extensive rot through the full sections of the timber, here the post notched around the timber acting as additional strut support is also decayed, the flight holes detail extensive wood boring insects, the timbers generally detail as wet.
