Shore Associates Ltd
Chartered & Heritage Building Surveyors

Building A Condition Survey Report

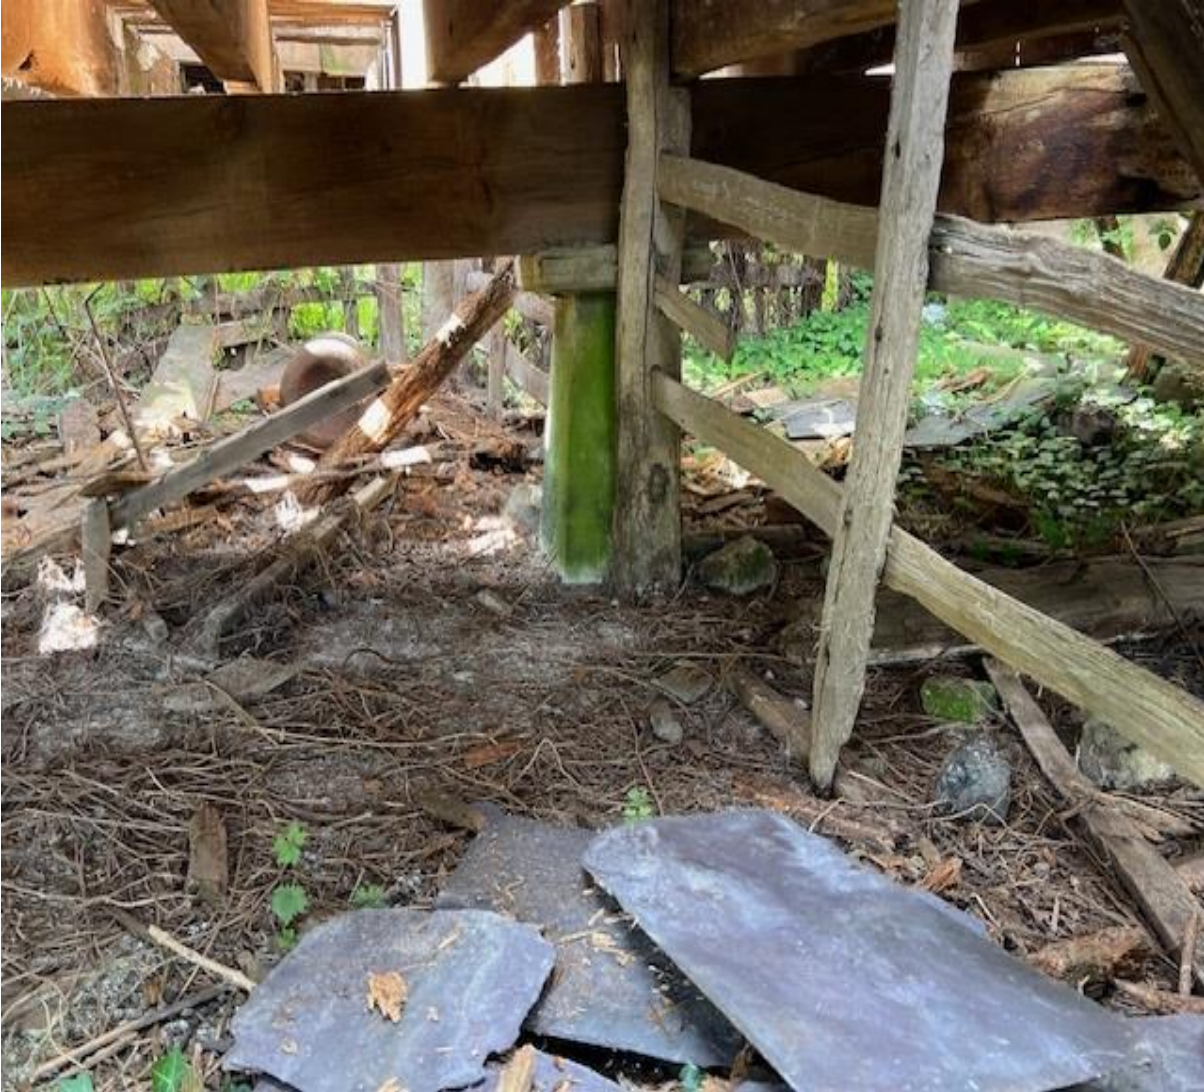
The photo here shows further the staddle stone in a mushroom shape sitting under the main perimeter acting as the support foundation, the post and rail separating fence. The main timbers that are extensive in size acting as the timber ring beam are probably in the better condition of all the timbers, in the main due to their size.

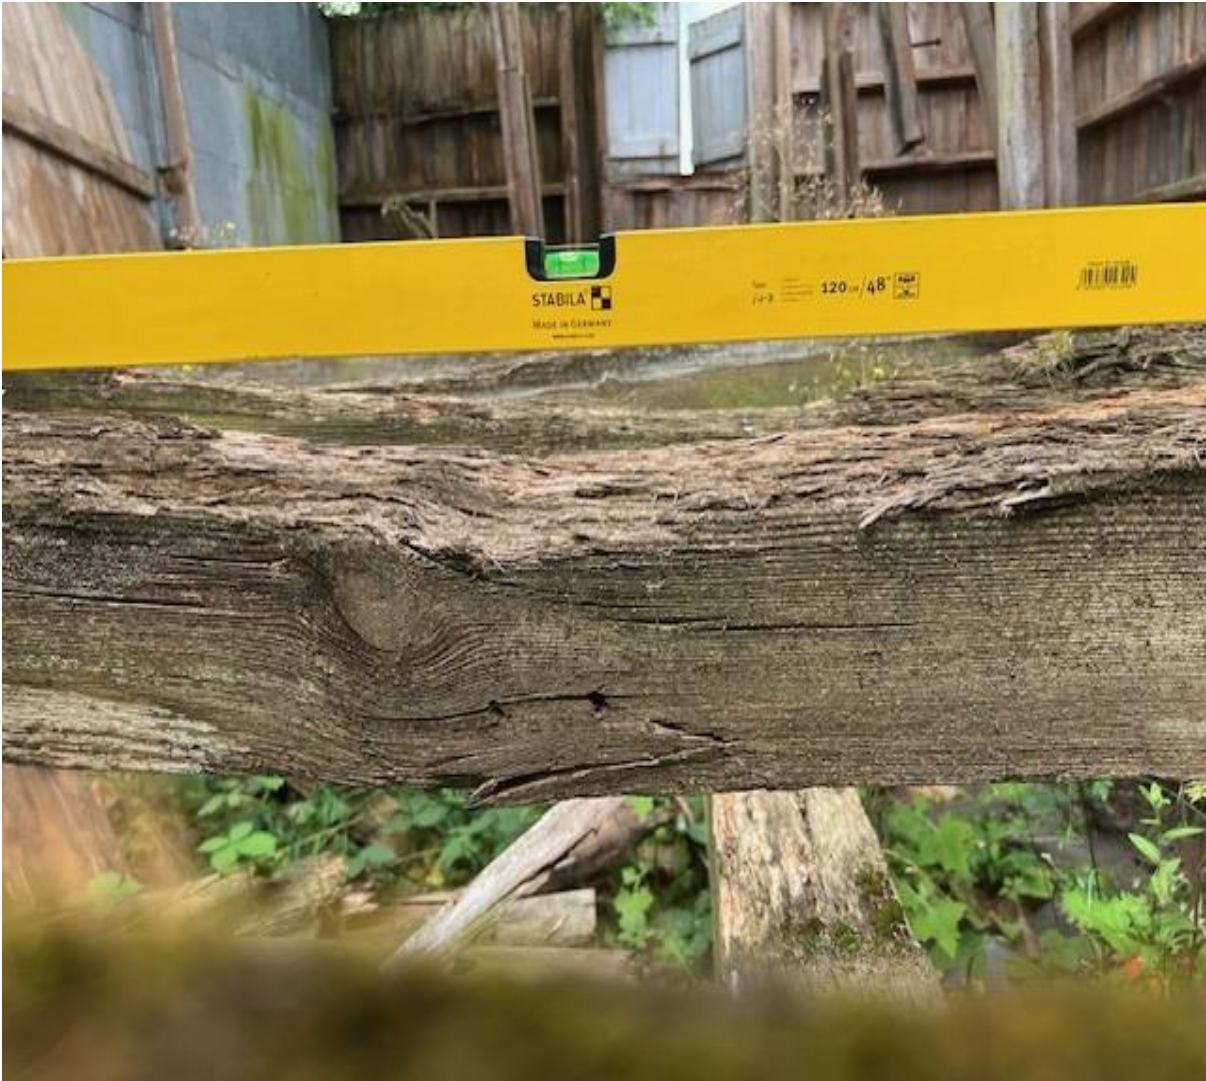
The level here shows that the timbers running W1 – W3 are fairly level, the decay through the timber where it has decayed and come away, details the misshape of the timbers.

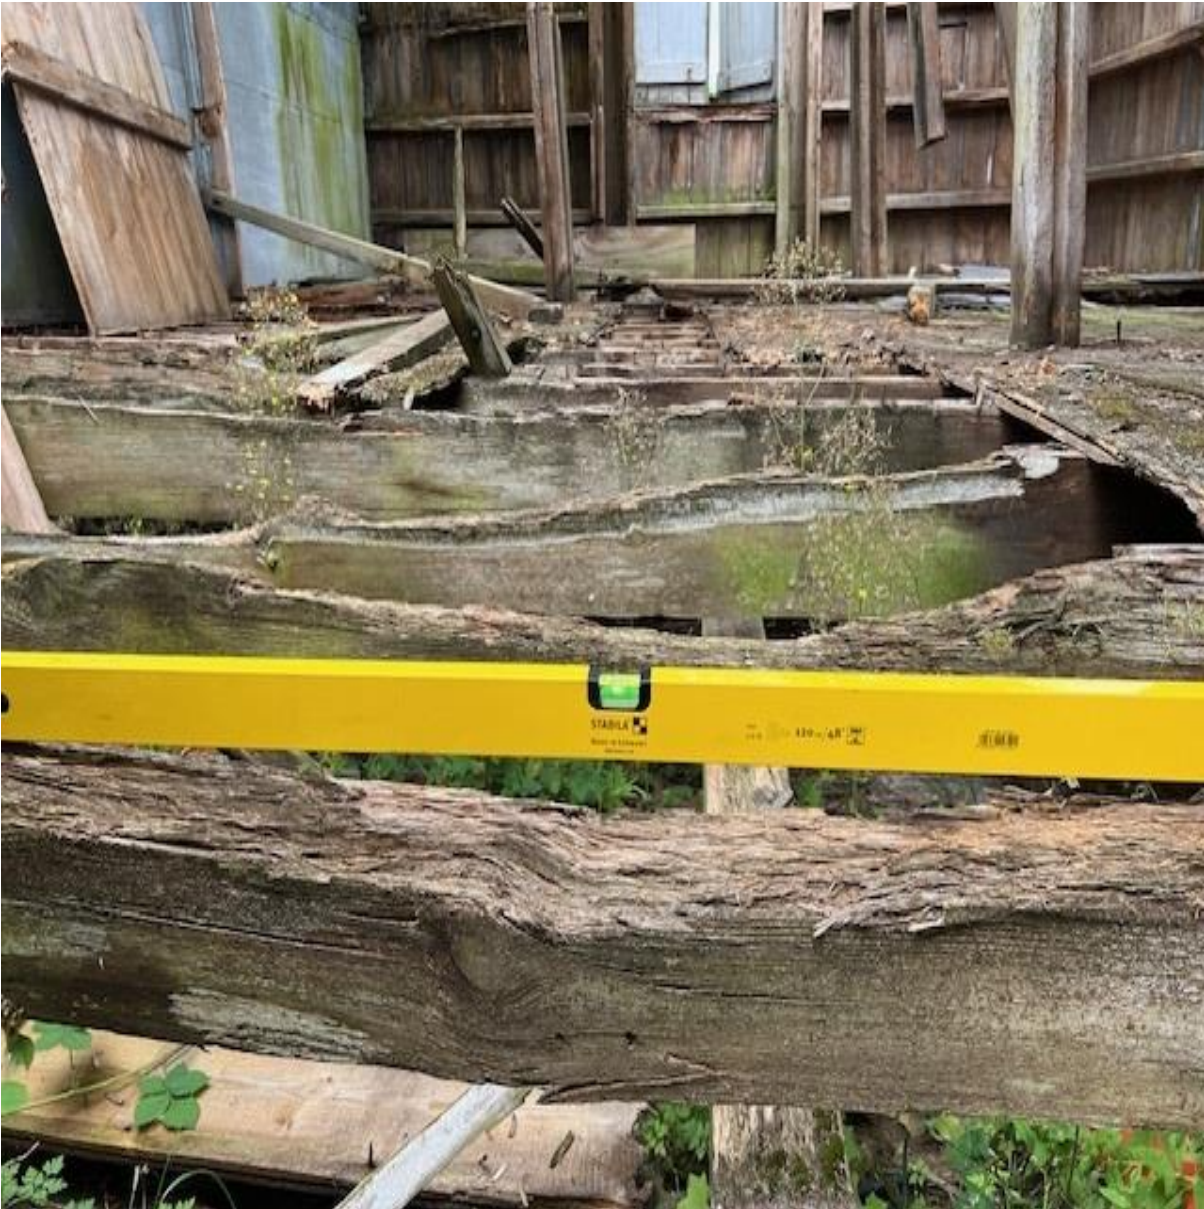
As above photo, it can be seen through the photo here the first 5 joists in particular extensively decayed.

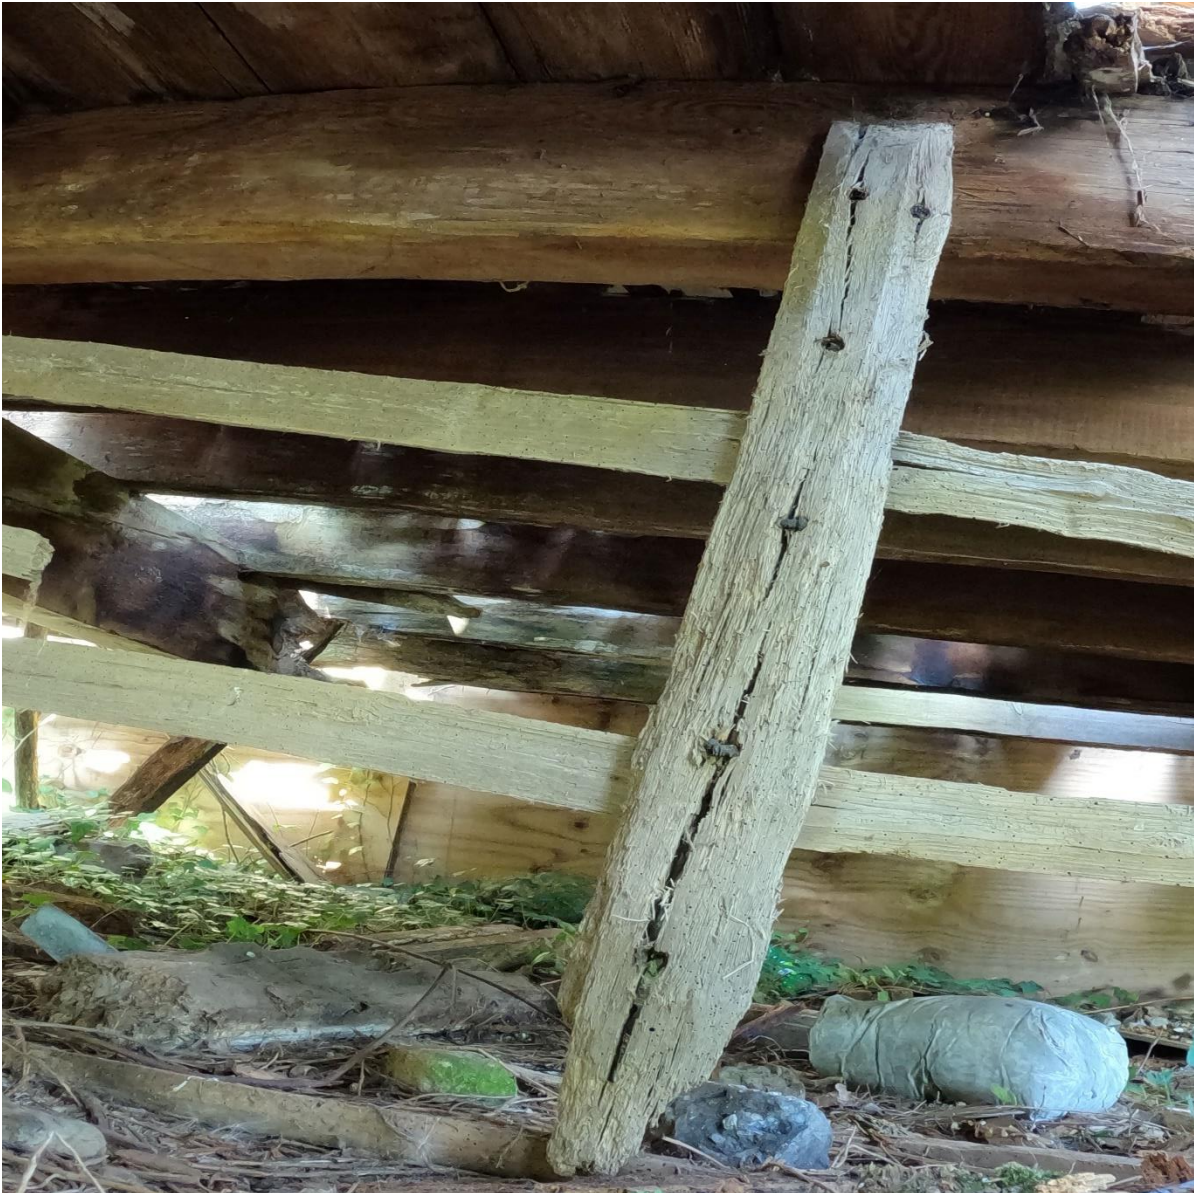
The photo here taken with a pole camera under the main floor shows the underside of the joists to be saturated, and details wet rot and some decay.

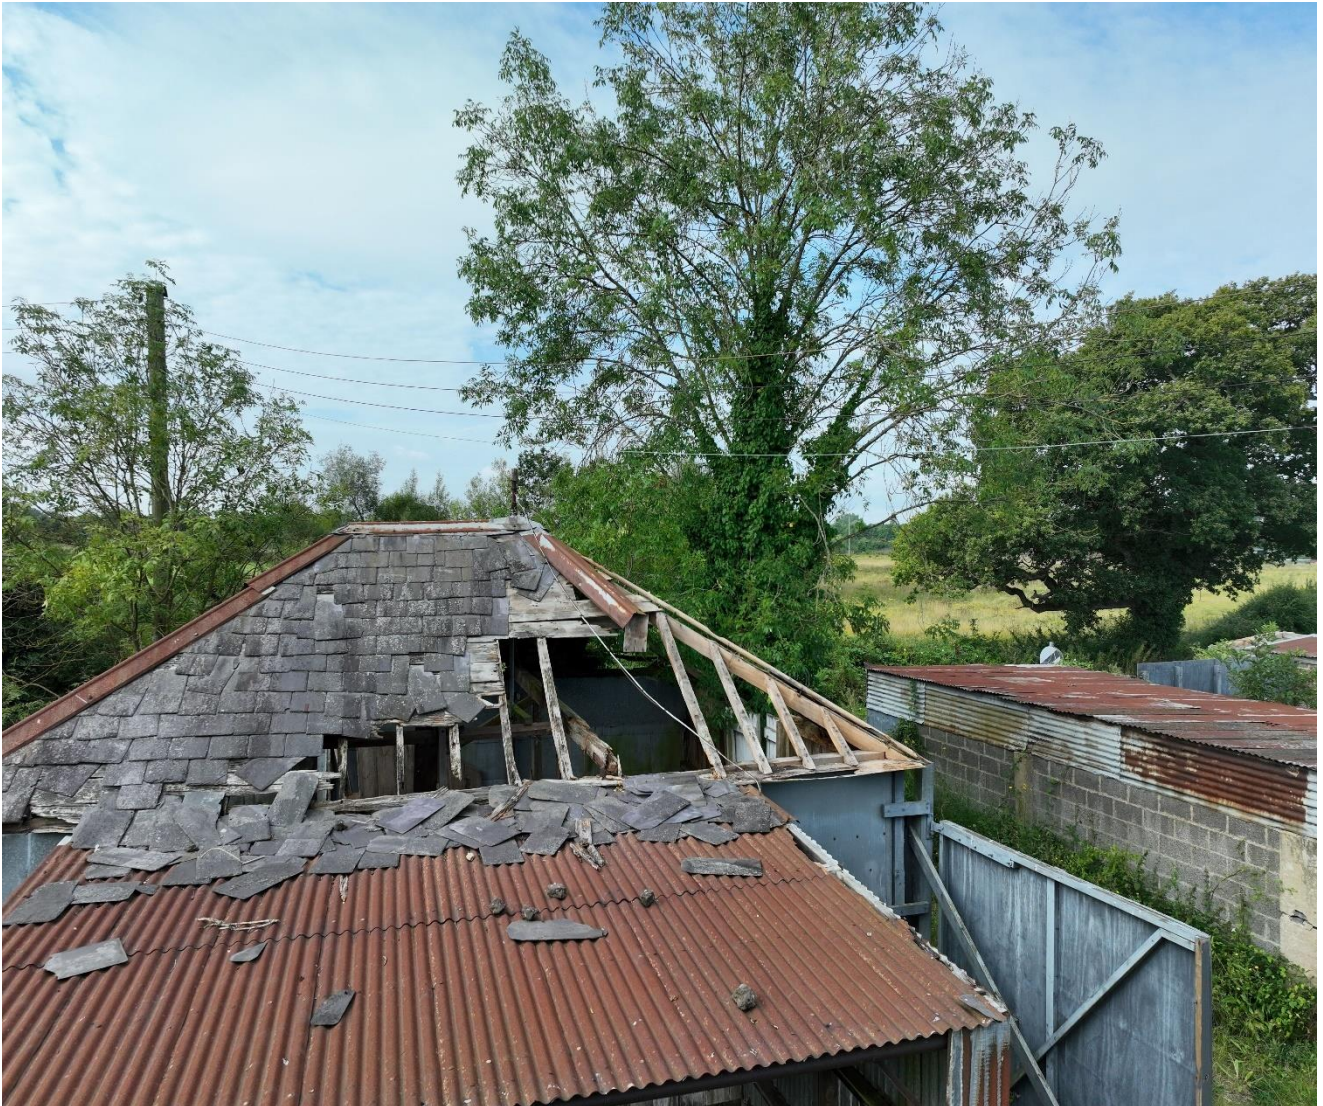
The main roof covering as earlier described is a cut & pitched roof, with close boarding laid over the main timbers, with a slate roof covering, metal profiled sections at the hips and ridge.

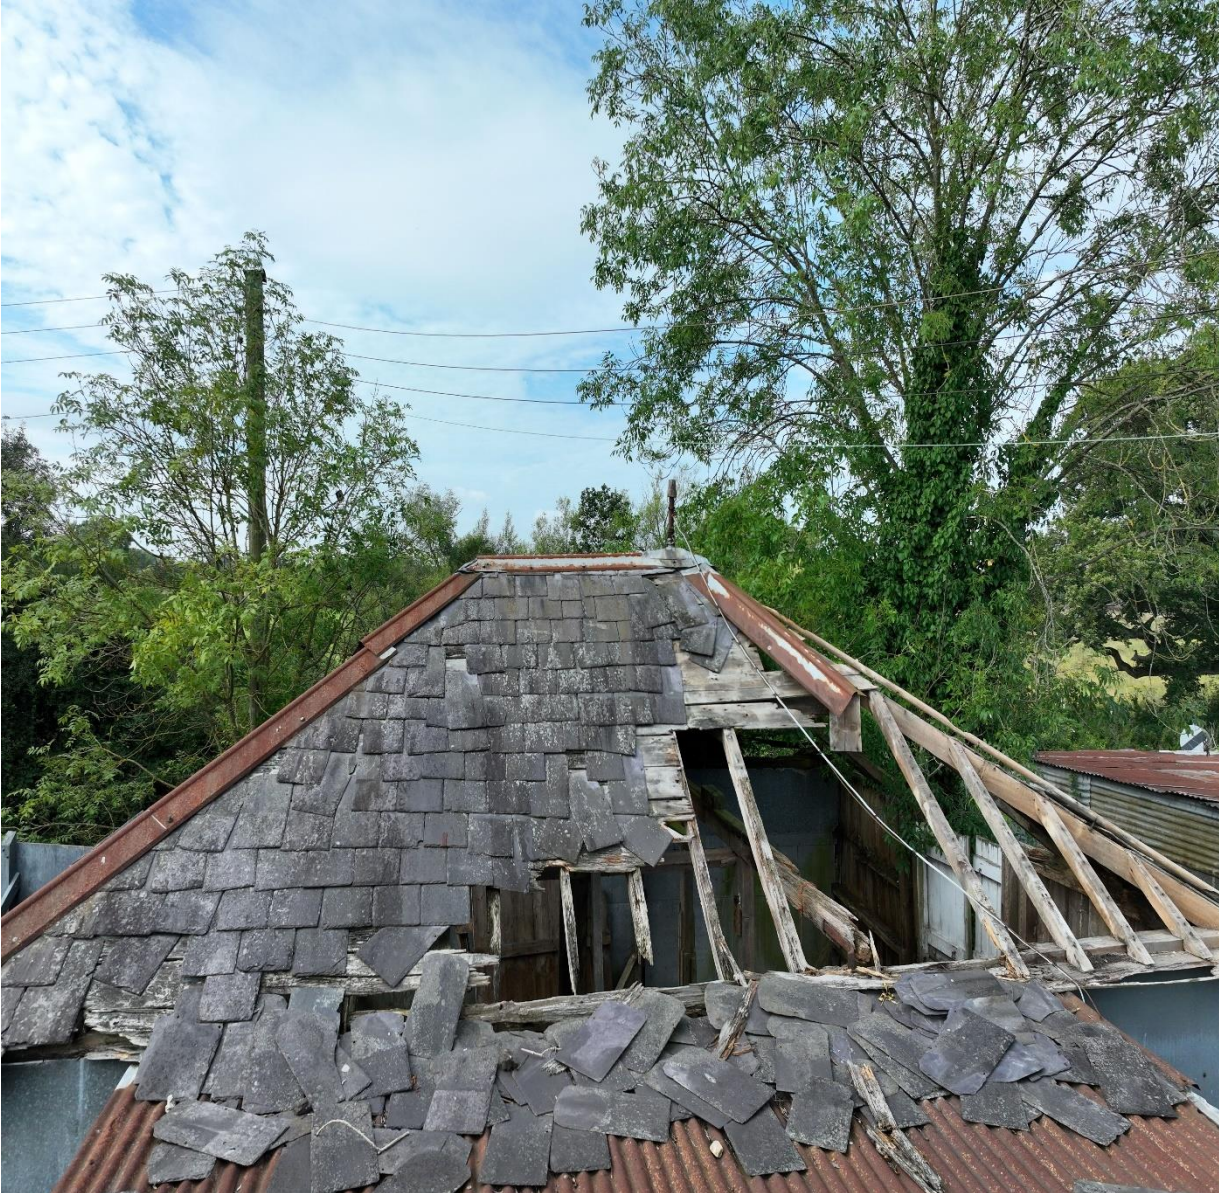
The drone photo here shows the extent of the decay of the roof.

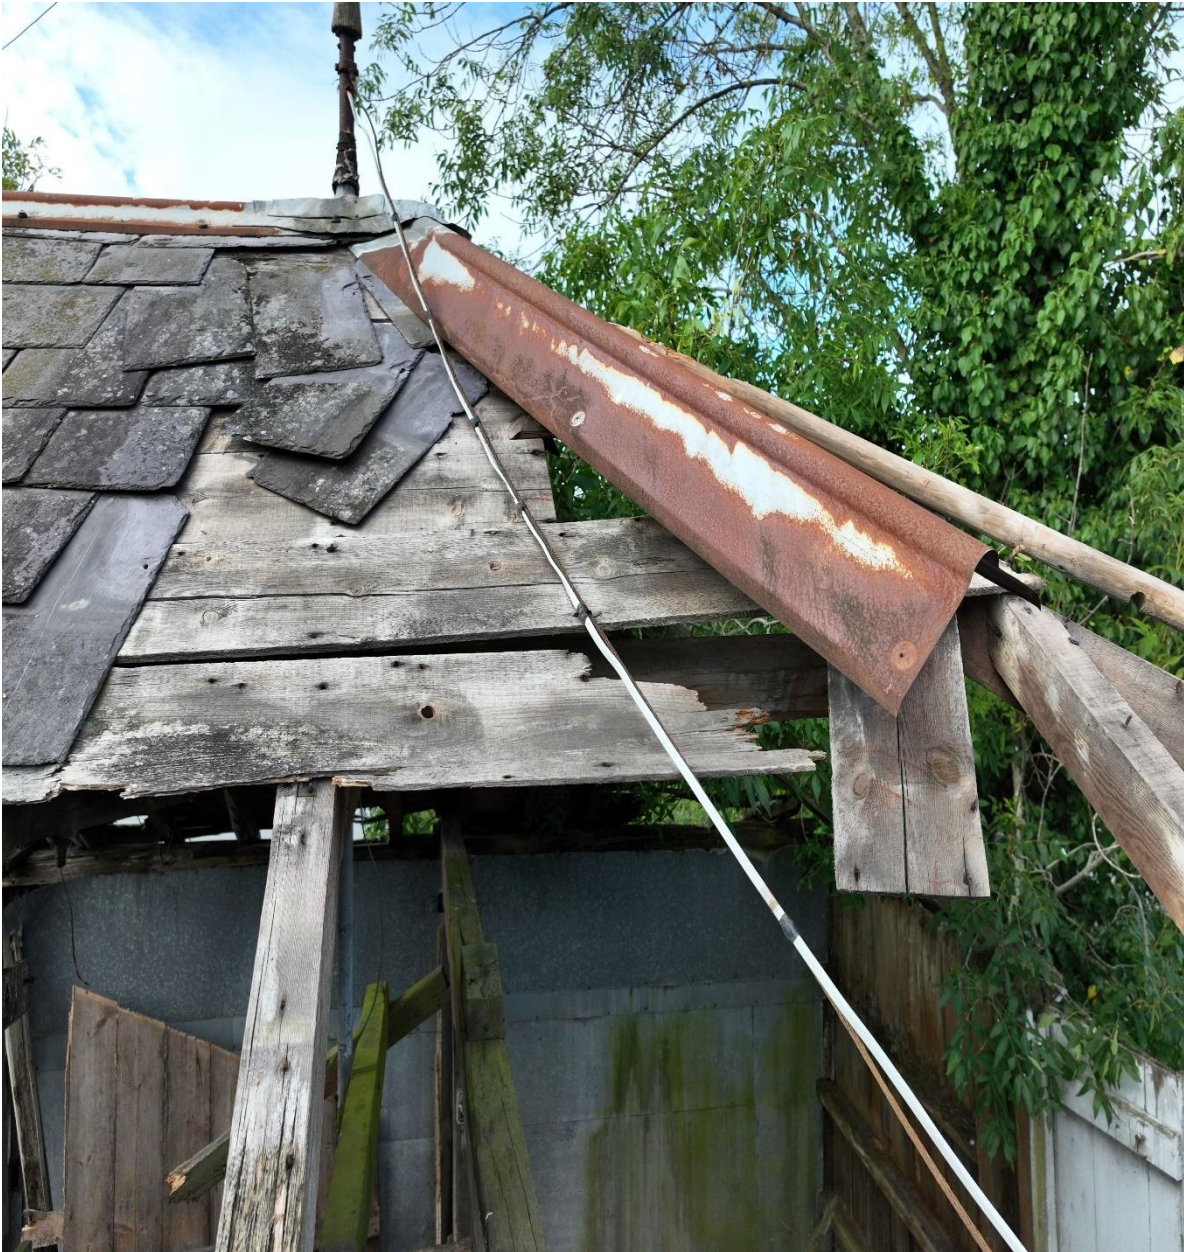
The boarding at the roof timbers has decayed and collapsed, the slate coverings with it, in the main throughout the roof, some sections remain, but are precarious.

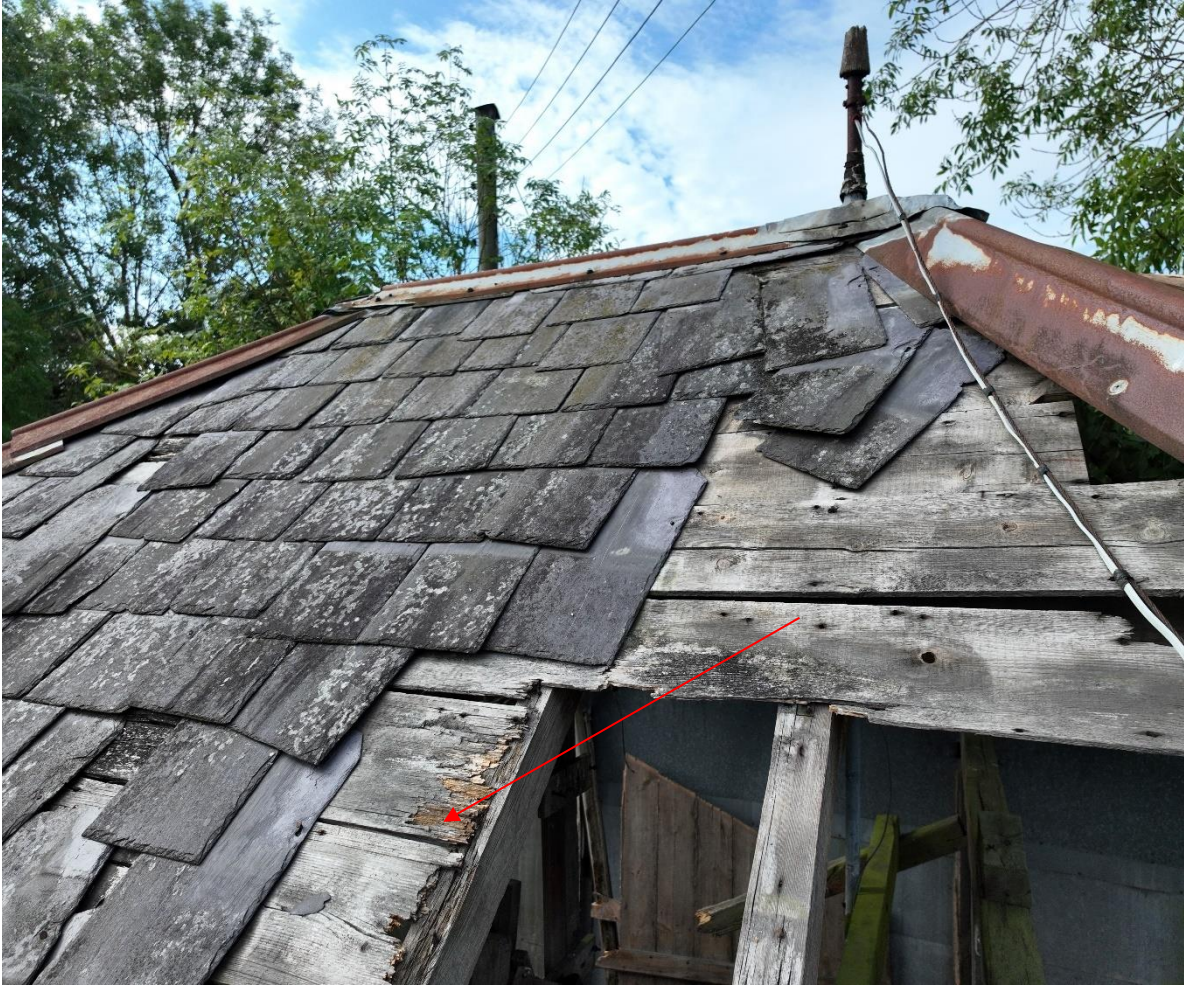
As above, the close boarding is small in profile and as highlighted details significant decay, slates are slipping due to assumed nail sickness and the decay of the boarding below.

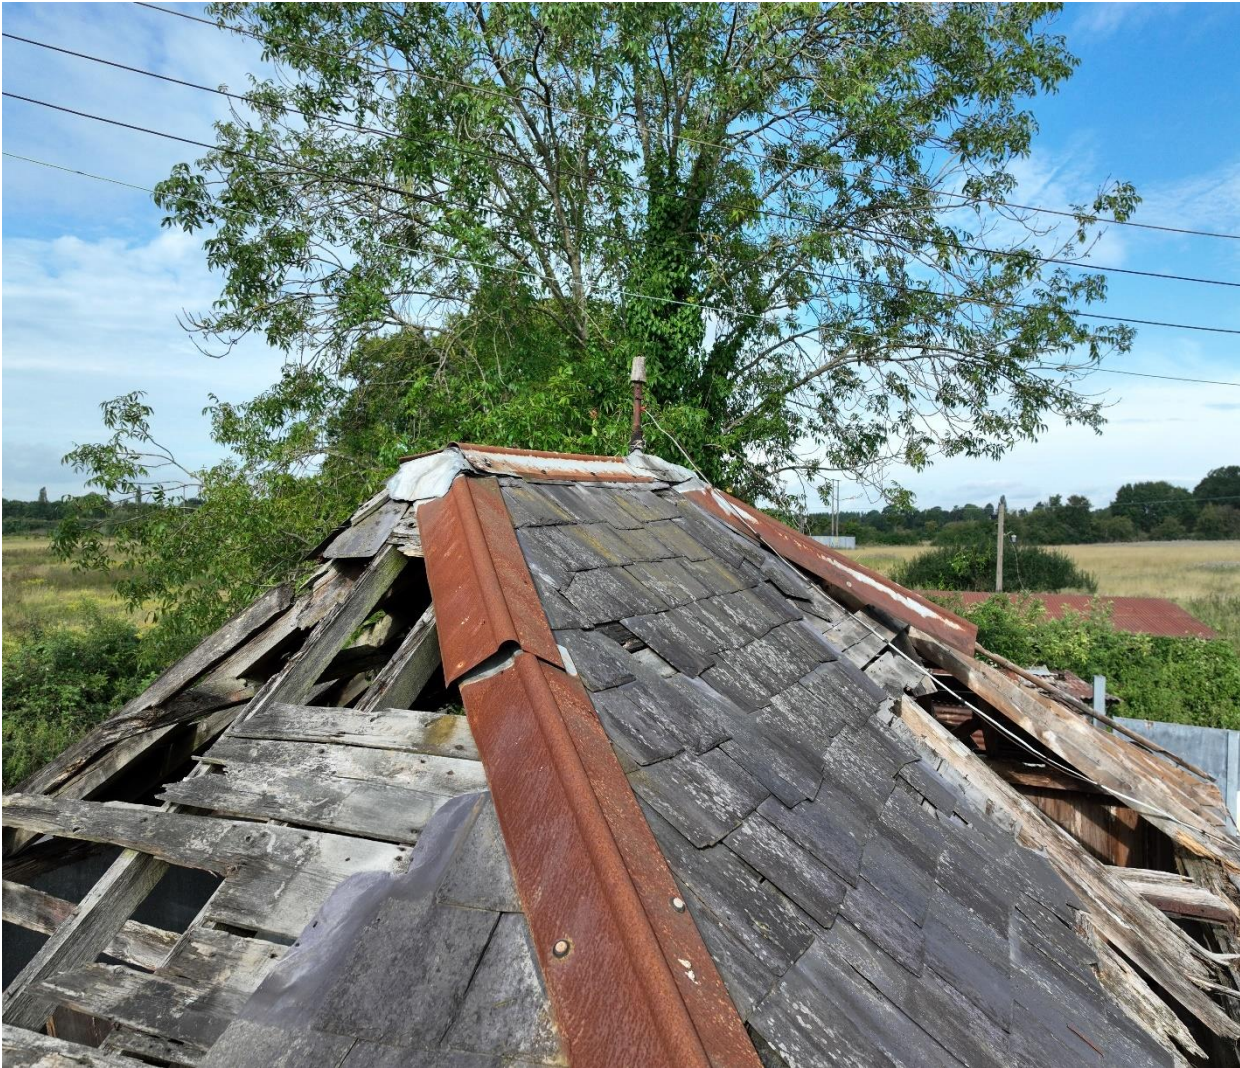
The drone photo here shows the W1/W2 hip section of the roof, again the boarding is decayed, the trusses detail decay due to water ingress over a long period of time.

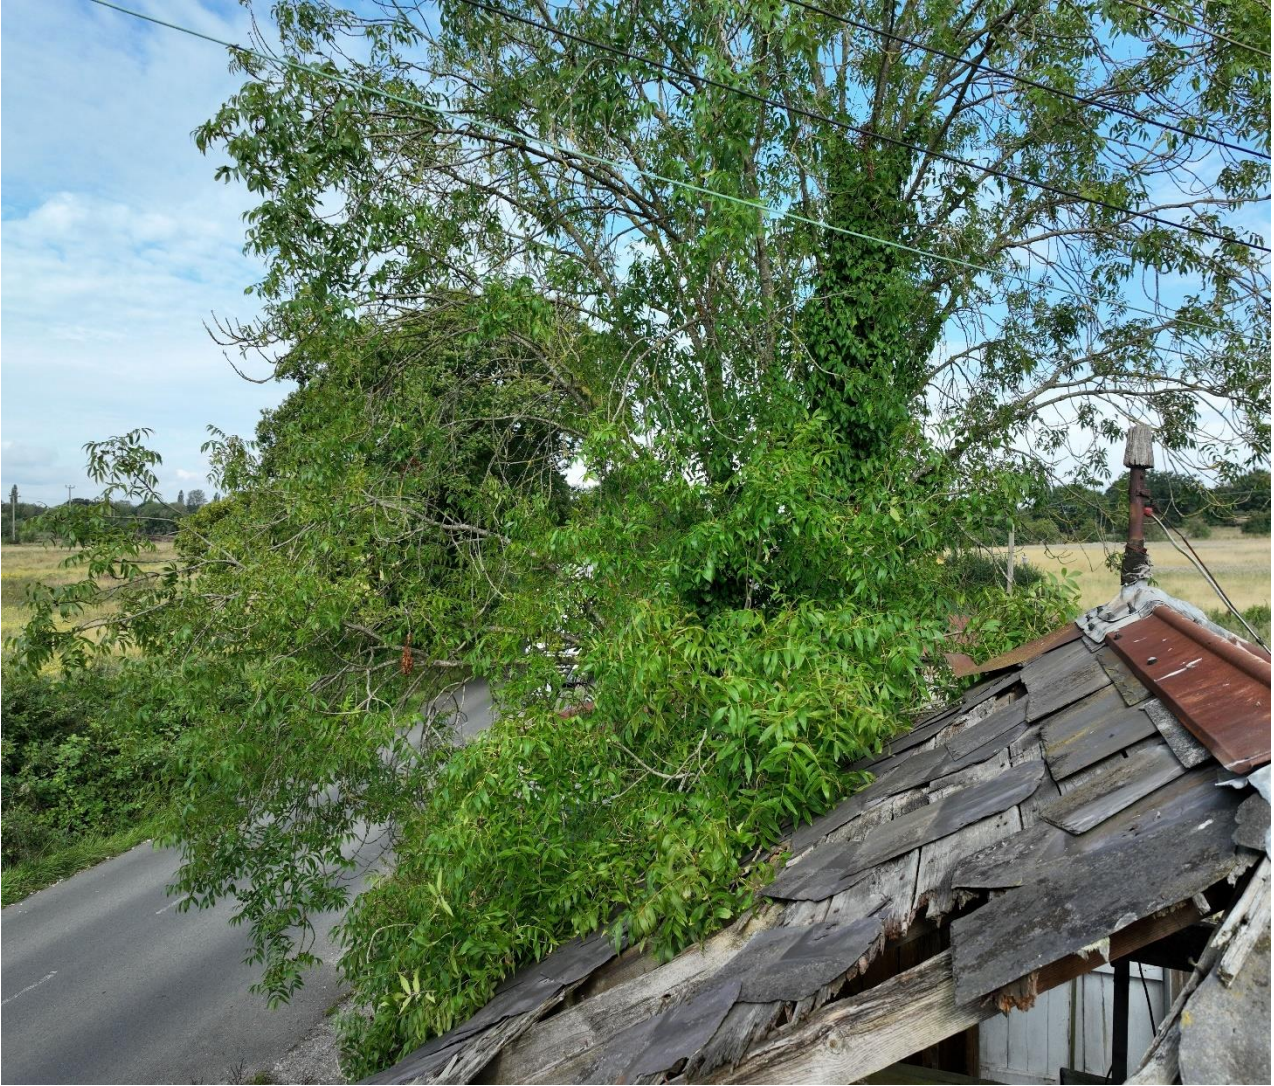
The roof section at W3 is in similar condition to those at the other elevations.

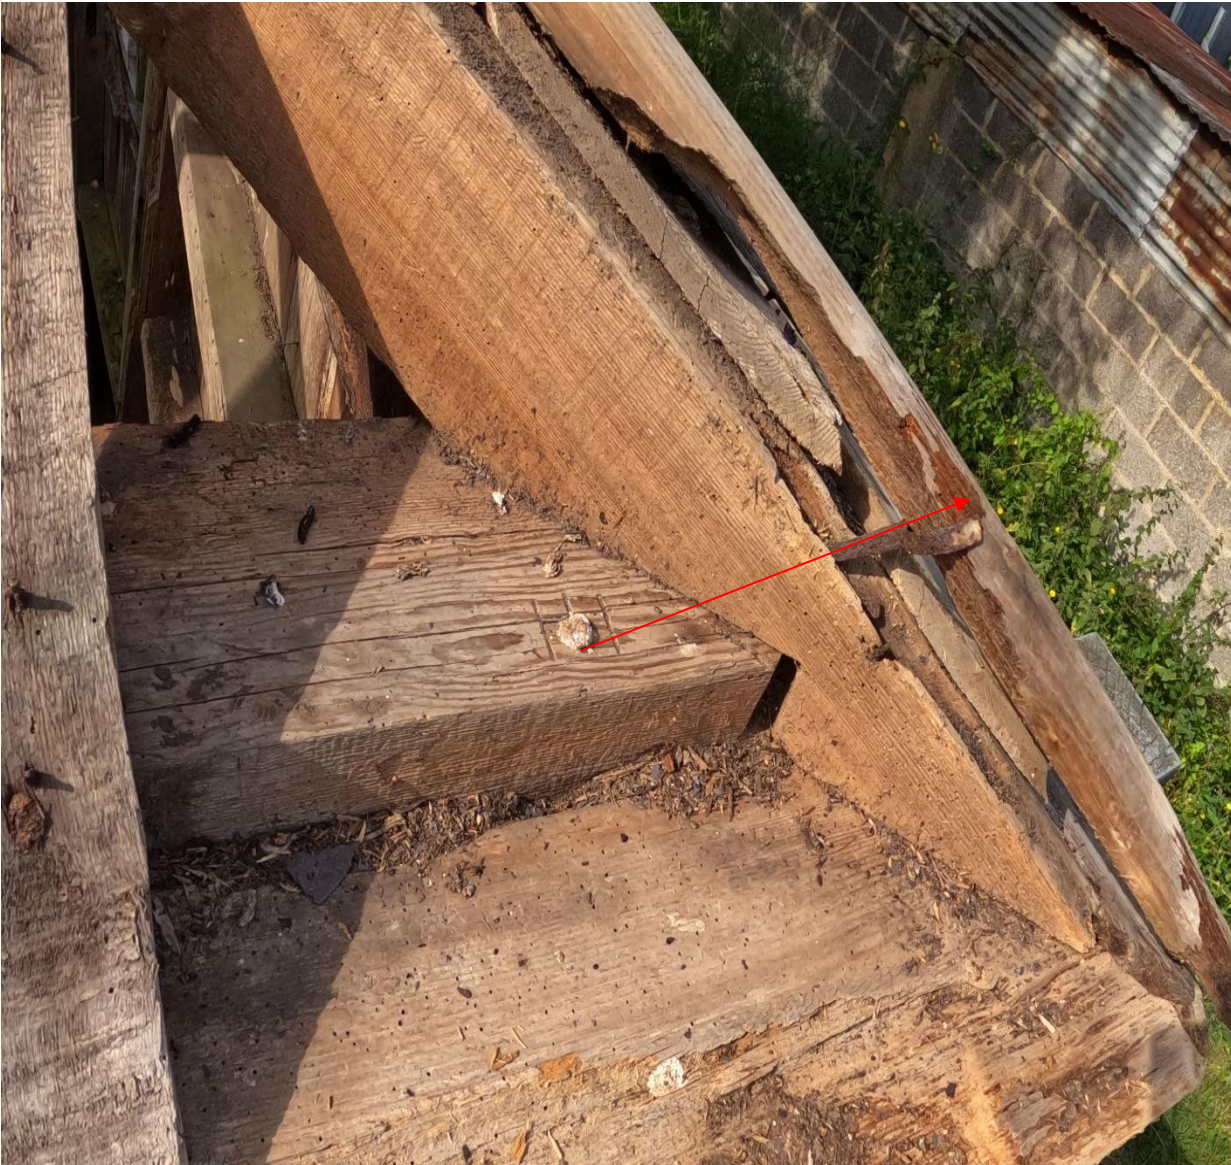
At the hip, as indicated, the timber is circular in profile, with metal support rings rising above the main hip timber, the circular section now details rot through the timber. The truss is birds mouthed over the plate; the timbers here given the condition of the other trusses is fairly good in comparison.

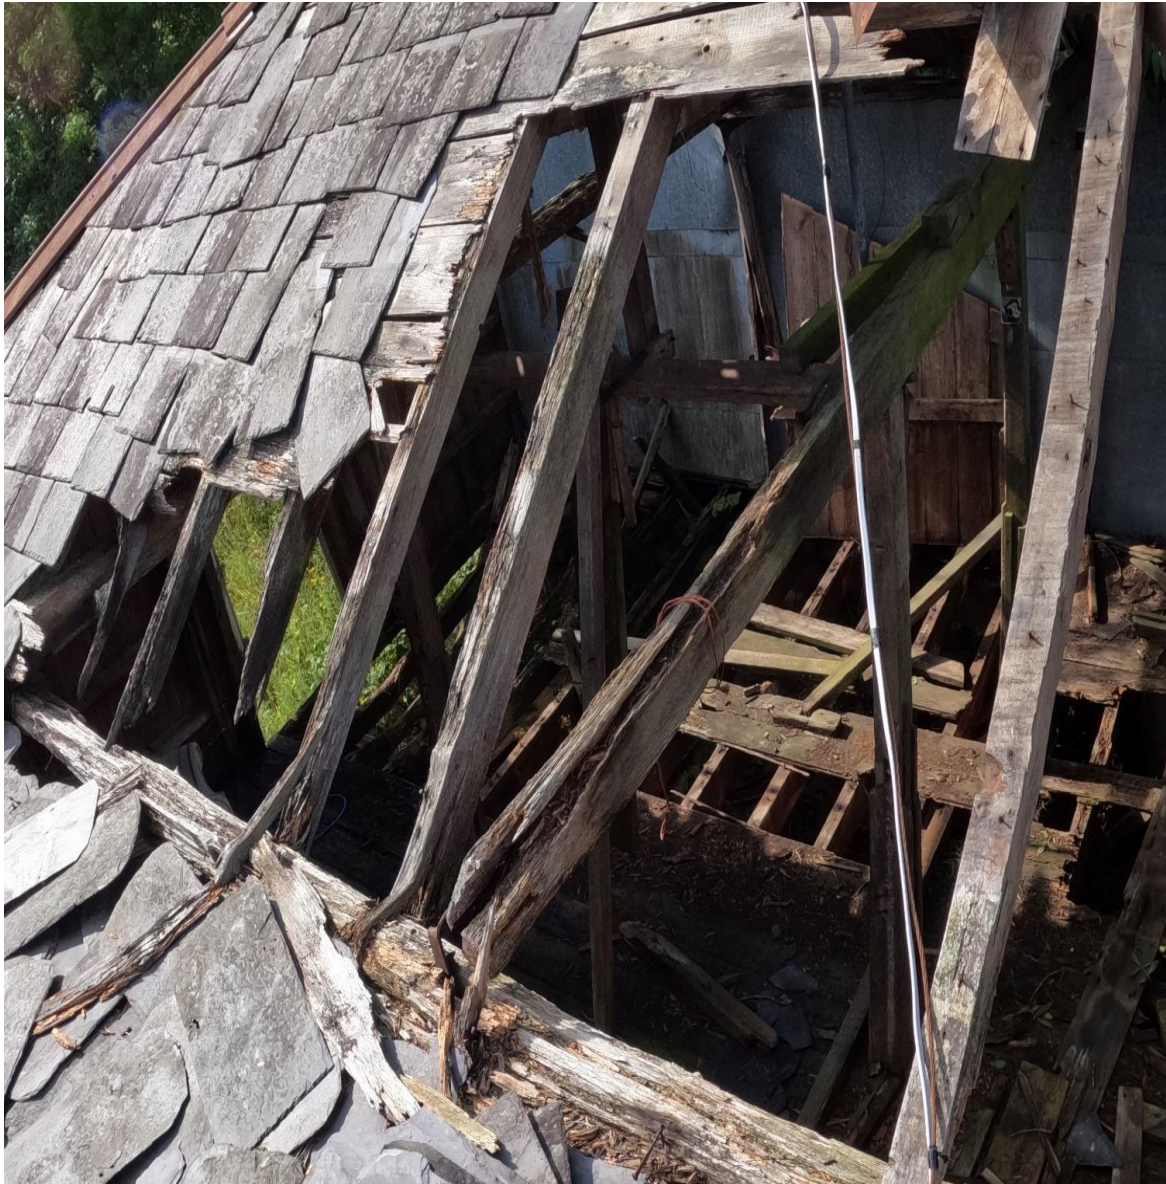
As can be seen here at W1, there are a number of trusses missing, many of those that remain are rotten at the ends, are no longer in contact with the plate, and would suggest that this section of the roof is hanging on by a thread and would be considered dangerous and ready to collapse.

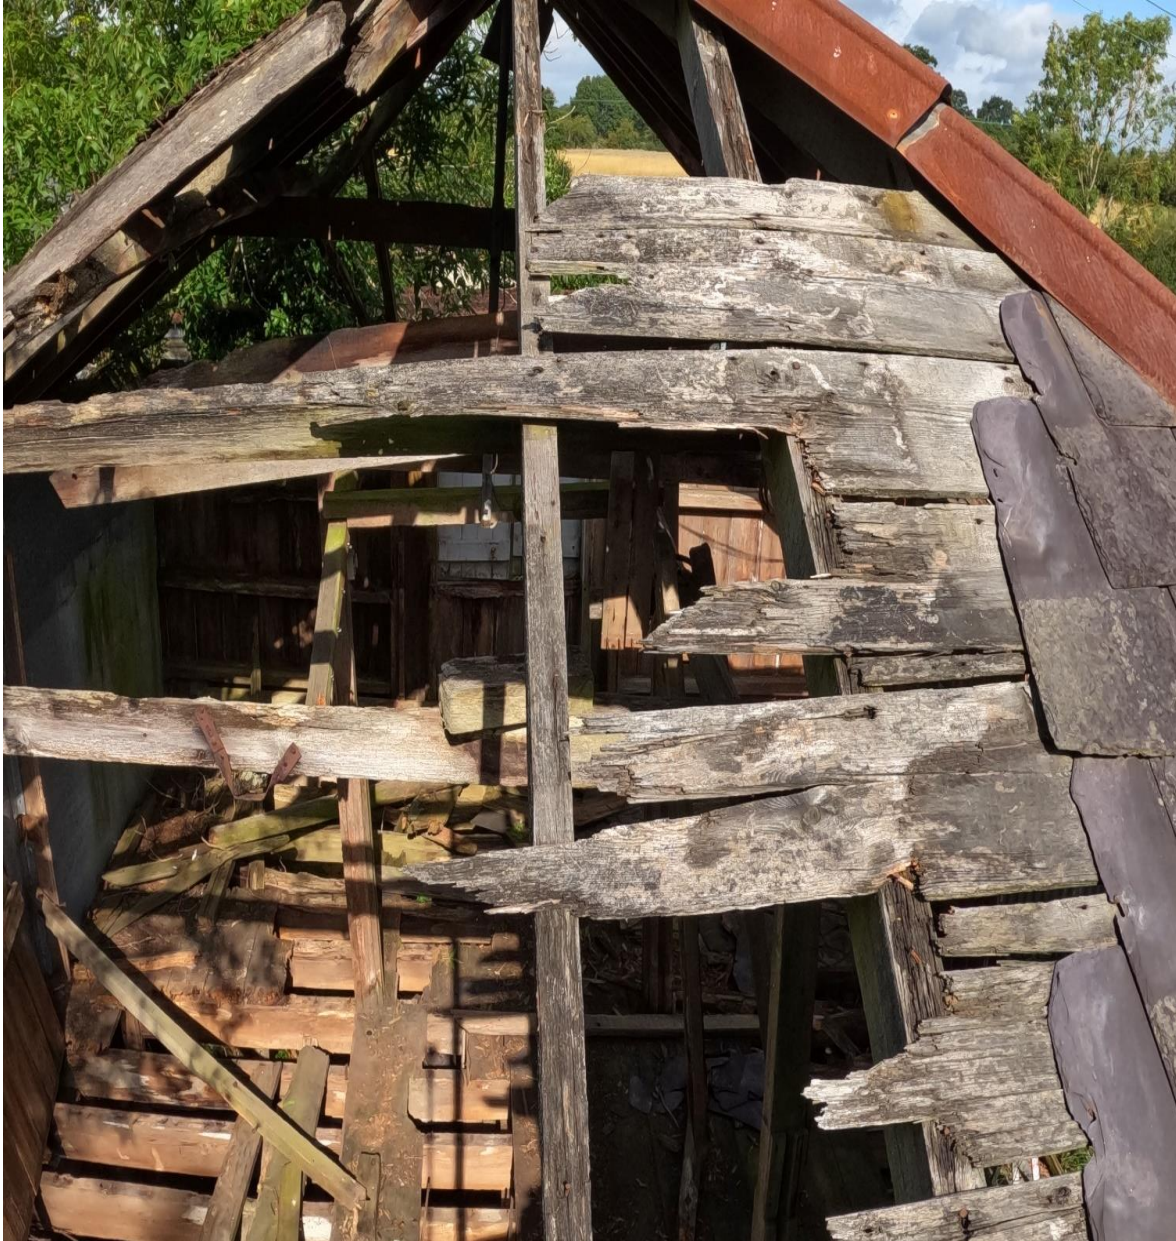
Similarly, at W2 many of the trusses are missing, and can be seen laying at the sub floor, the close boarding is decayed, and again the structure here would be considered dangerous and, in a condition ready to collapse.

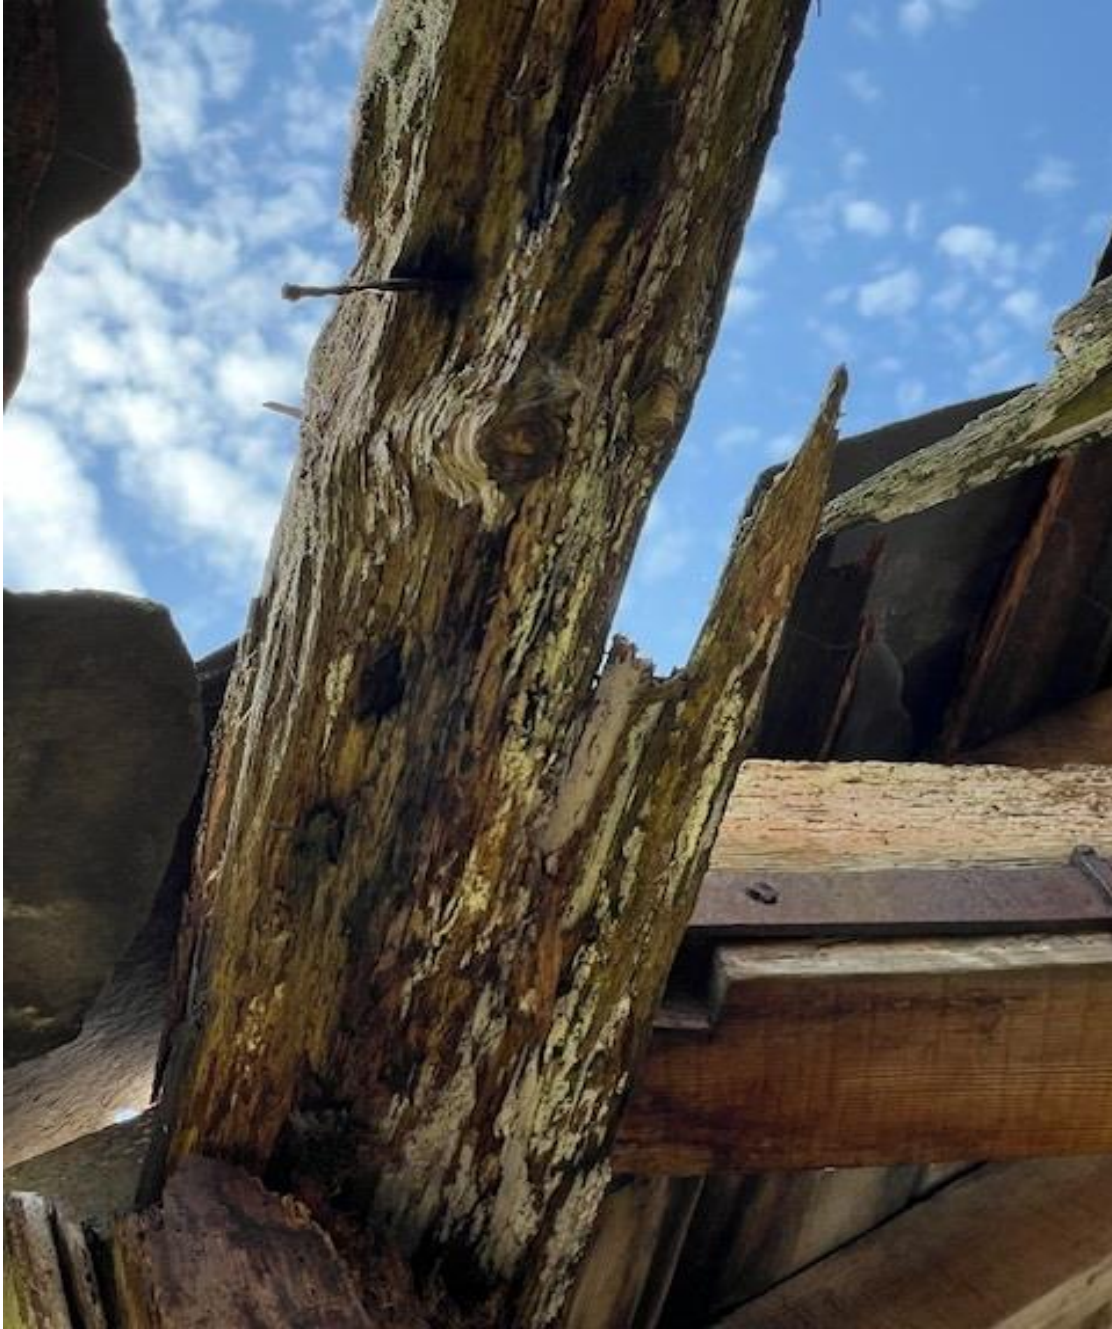
Condition of some of the rafters' still in situ are considered decayed and are suffering from extensive wet rot.

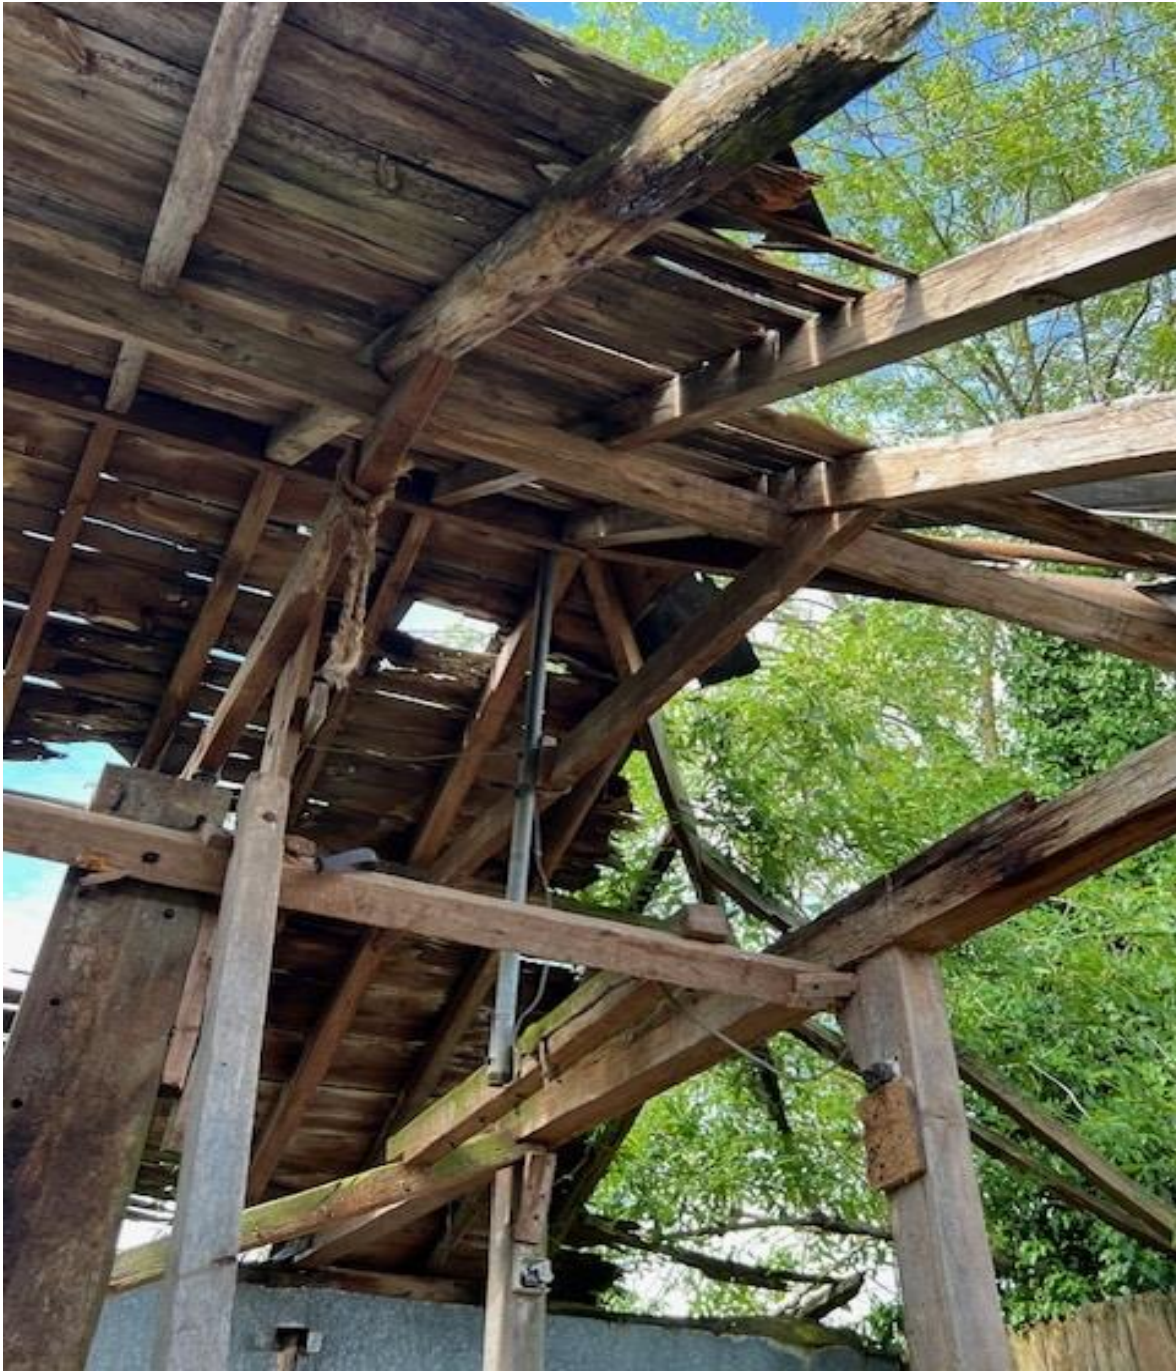
Photos taken from within the building show the extensive decay throughout the roof.
