Shore Associates Ltd
Chartered & Heritage Building Surveyors

Building A Condition Survey Report

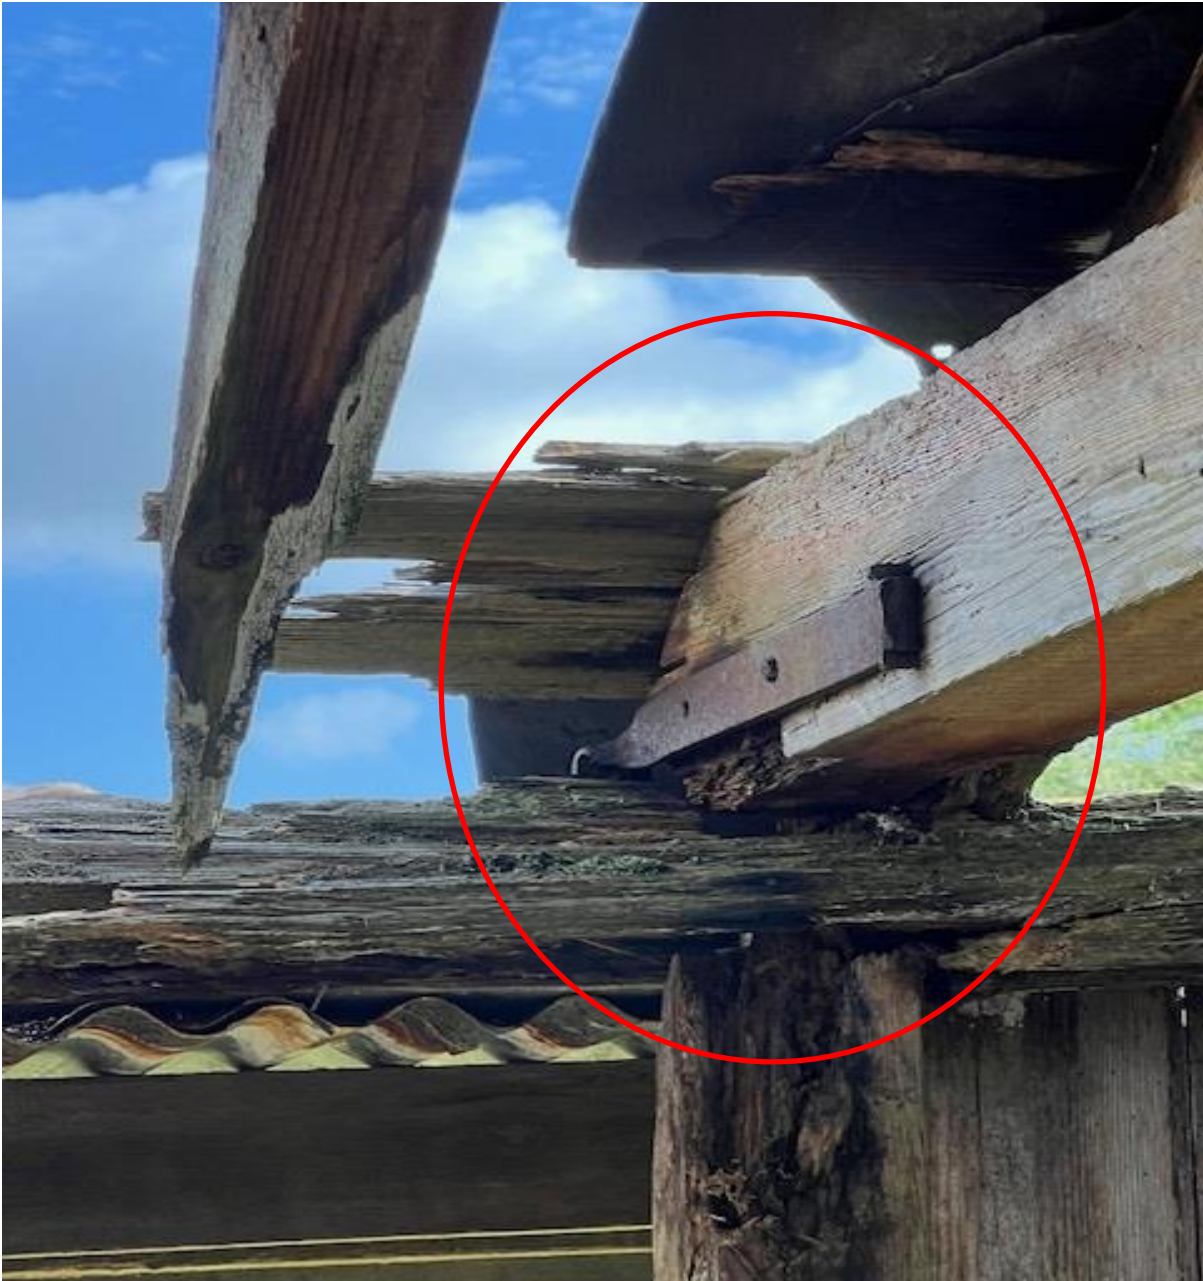
The photo here details the main bearing cross sectional timber sitting on a decayed wall plate, the post below also details extensive decay, the joists ends are no longer in contact with the wall plate in many locations.

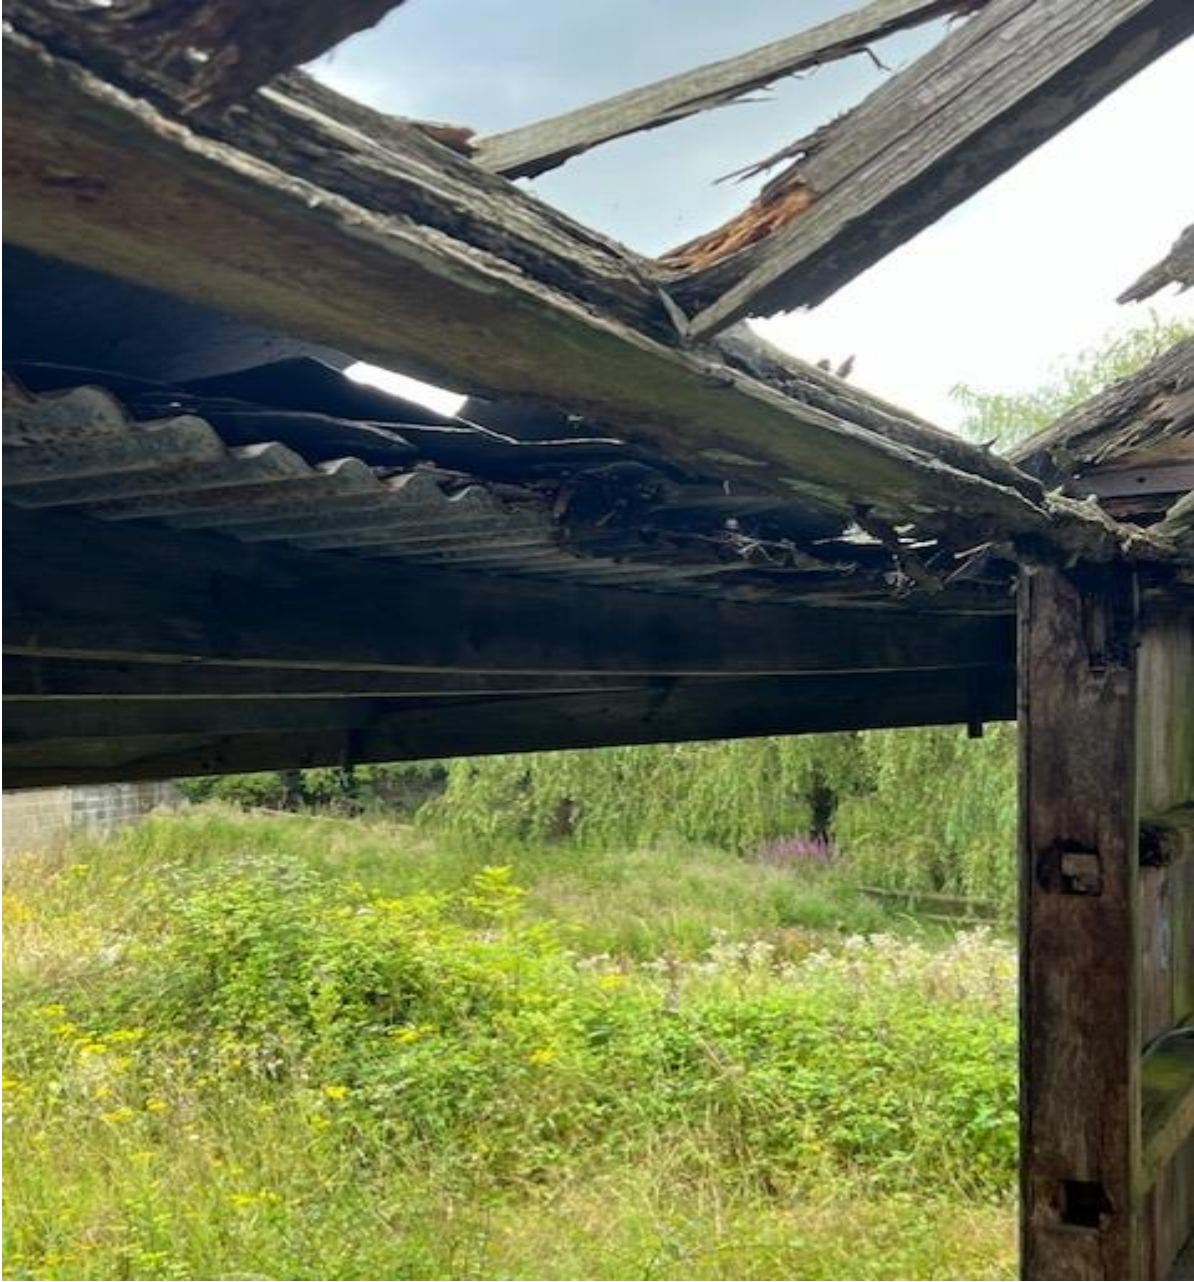
The wall plate which would also be the lintel at the W1 elevation, is decayed to the point of complete rot through the timber.

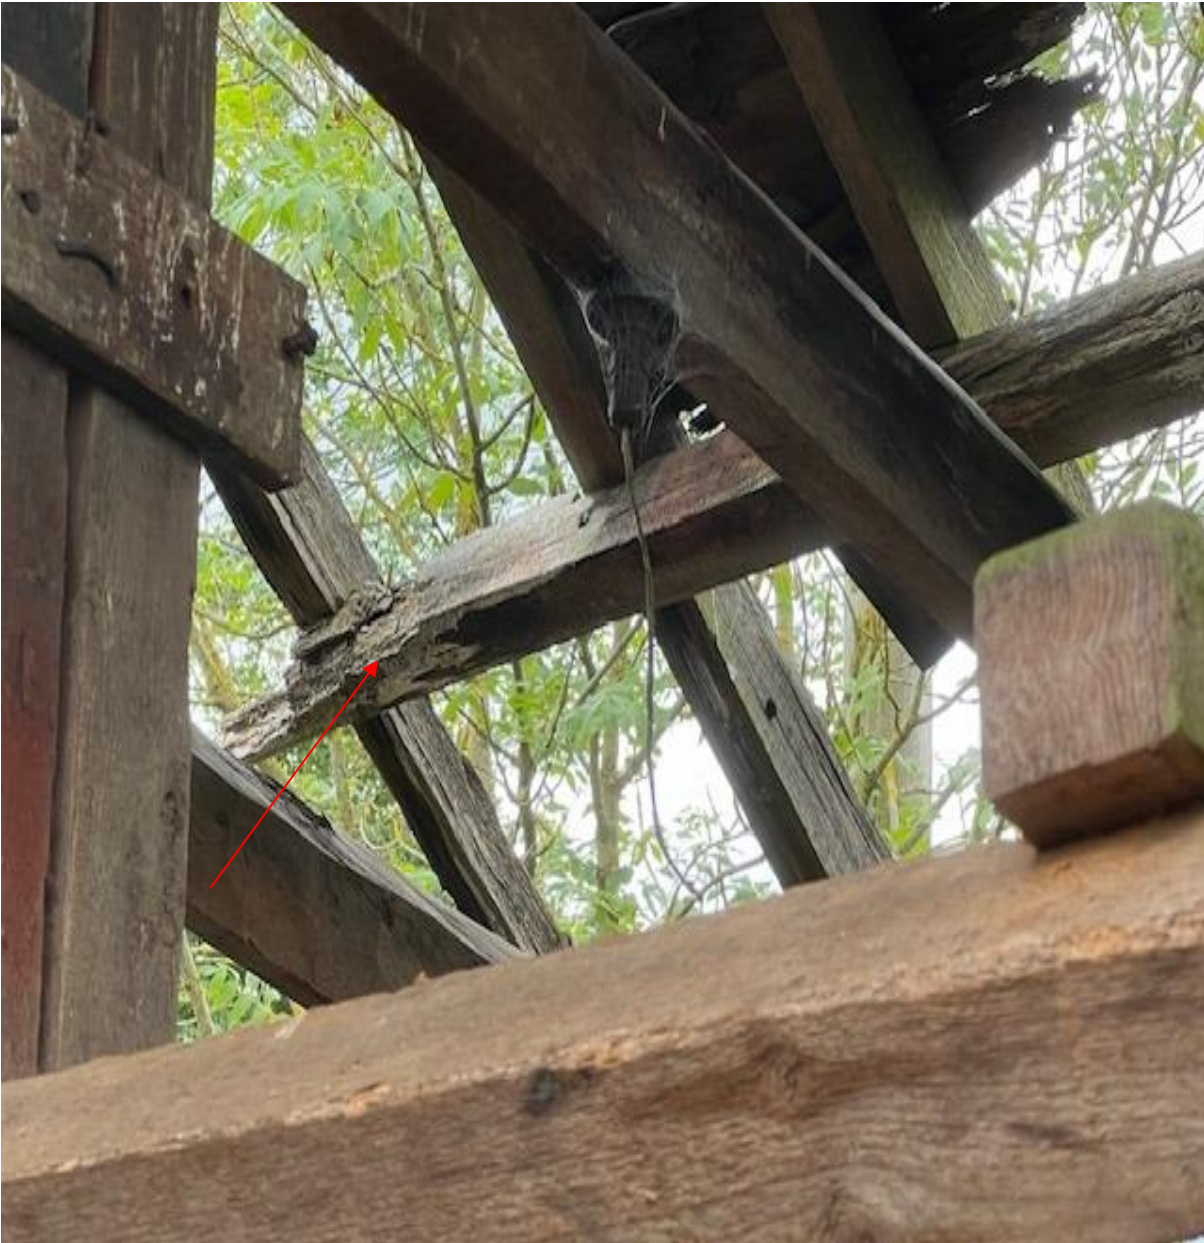
Detailed here is the main purlin, substantial in size given today's standards, but decayed at the ends and being held up by rotten strutting and cross braced timbers.

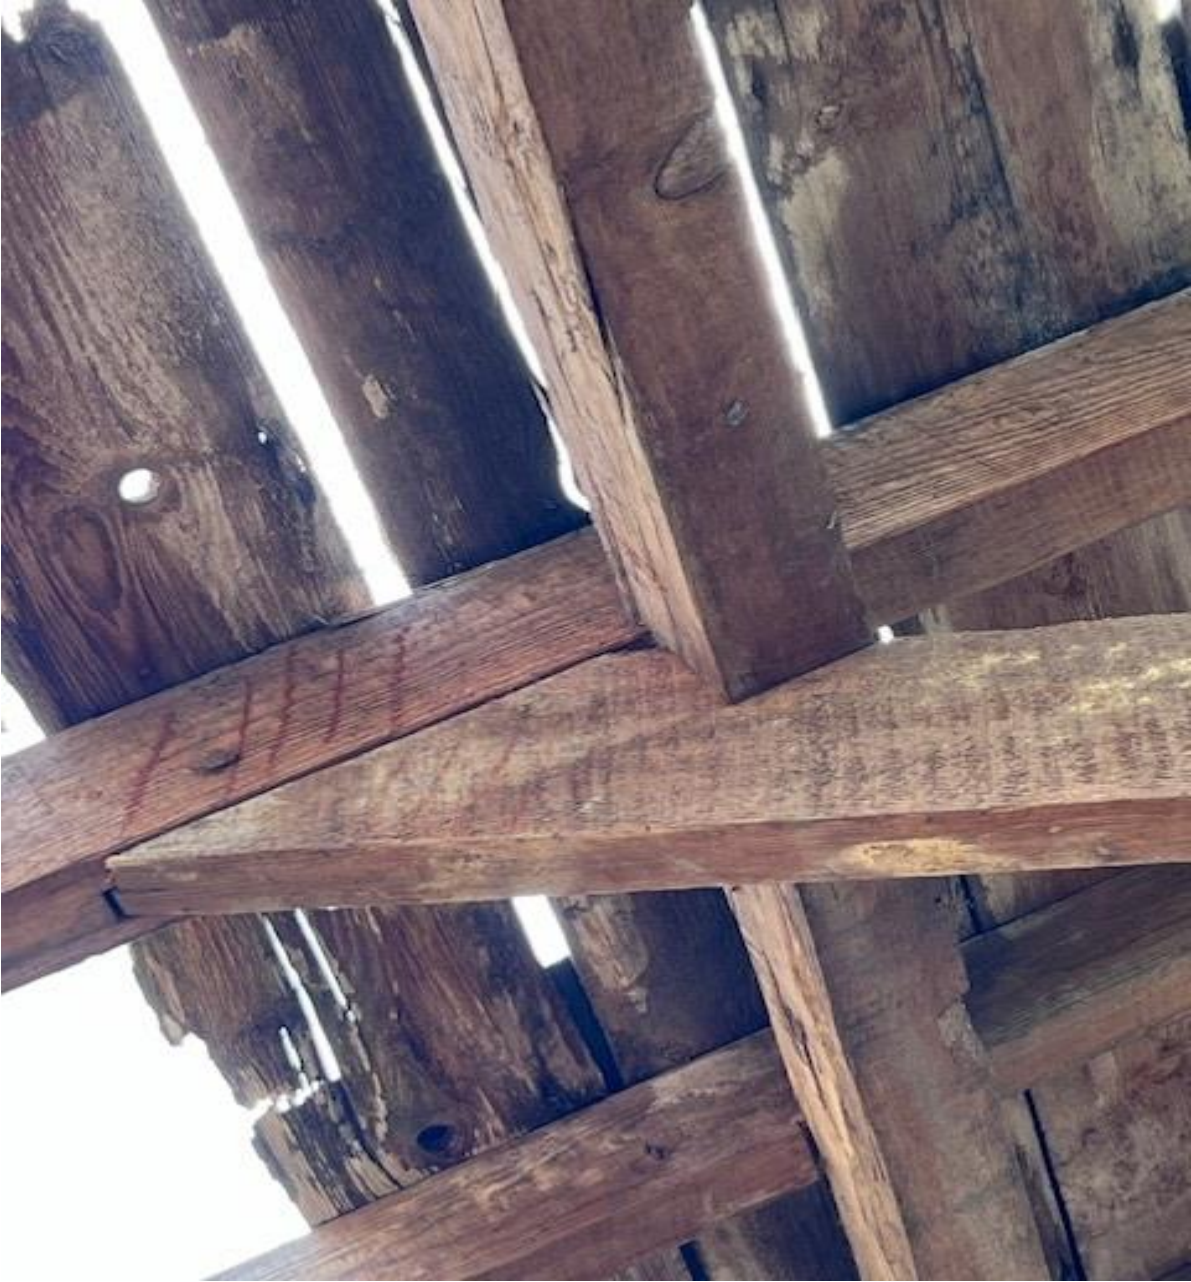
In the main the vast majority of the timbers, at the roofs, walls and the floors are Machine sawn timbers. The timbers that detail as older are in generally in a poorer condition.

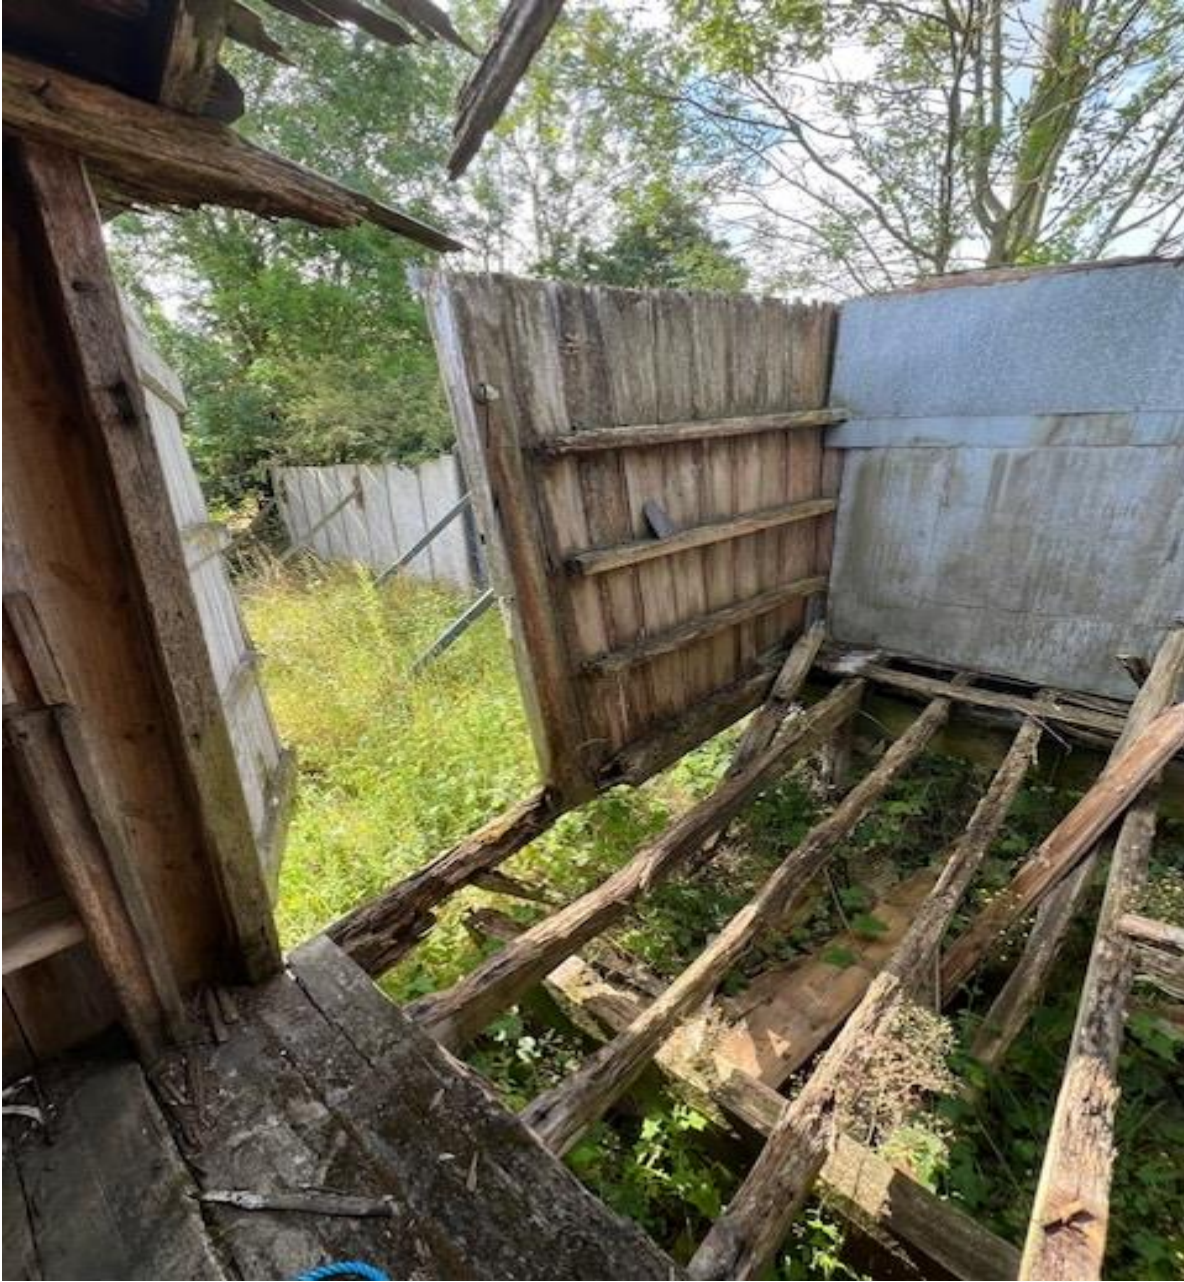
As can be seen here at the W2/W3 the roof section is completely missing, the hip rafters are no longer in situ, similarly with the wall plate and rafters.

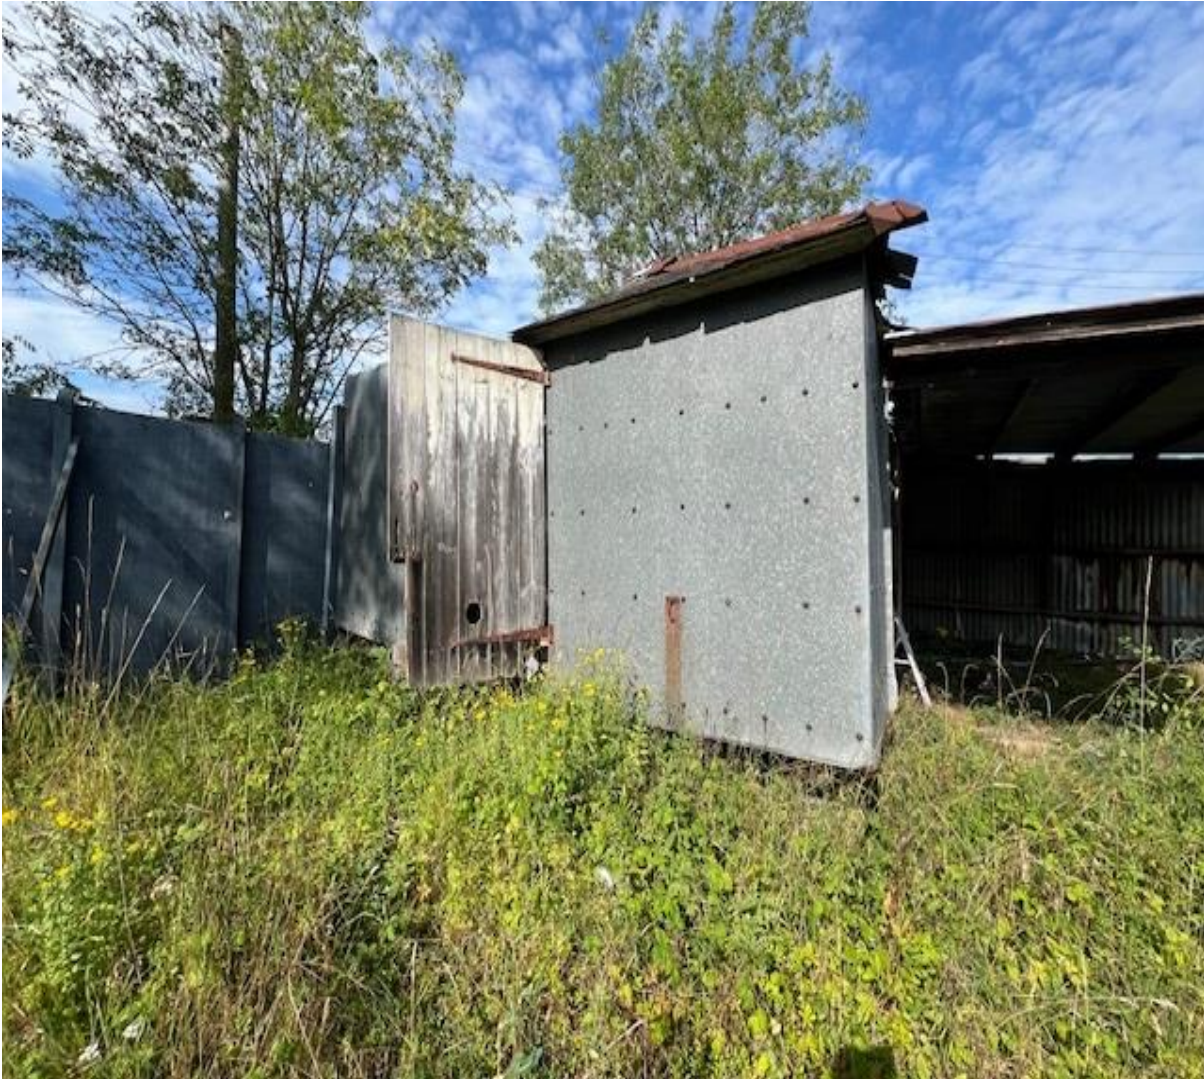
Metal cladding that sits at the external of the building

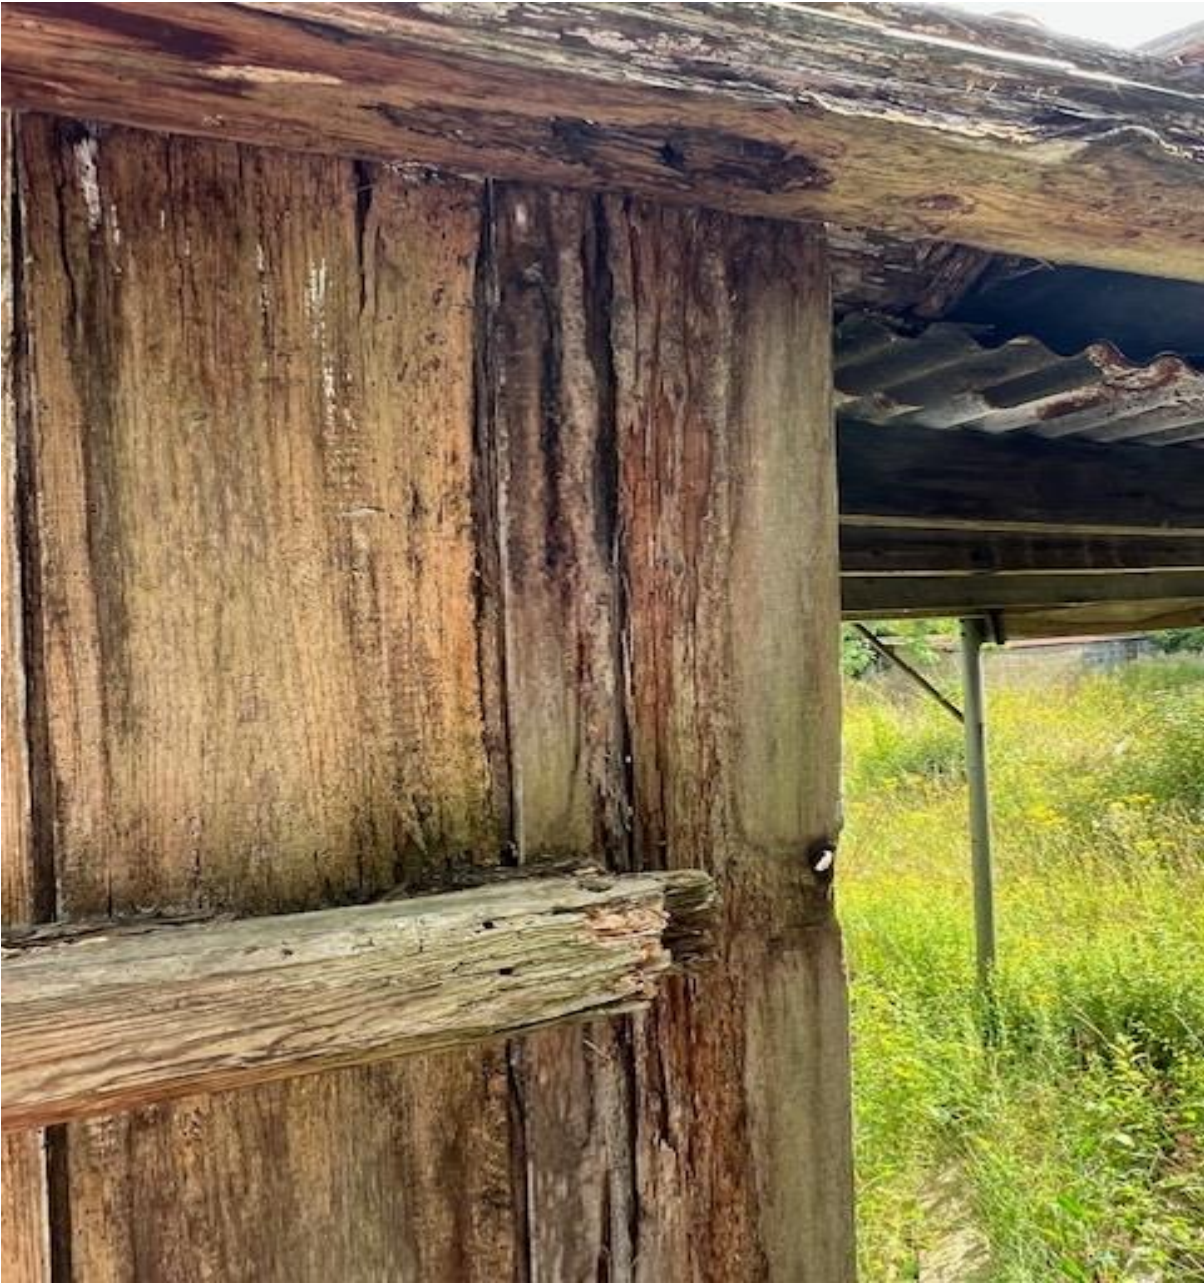
The vertical timbers at W1 show the timbers to be significantly decayed, as are the support horizontal timbers.

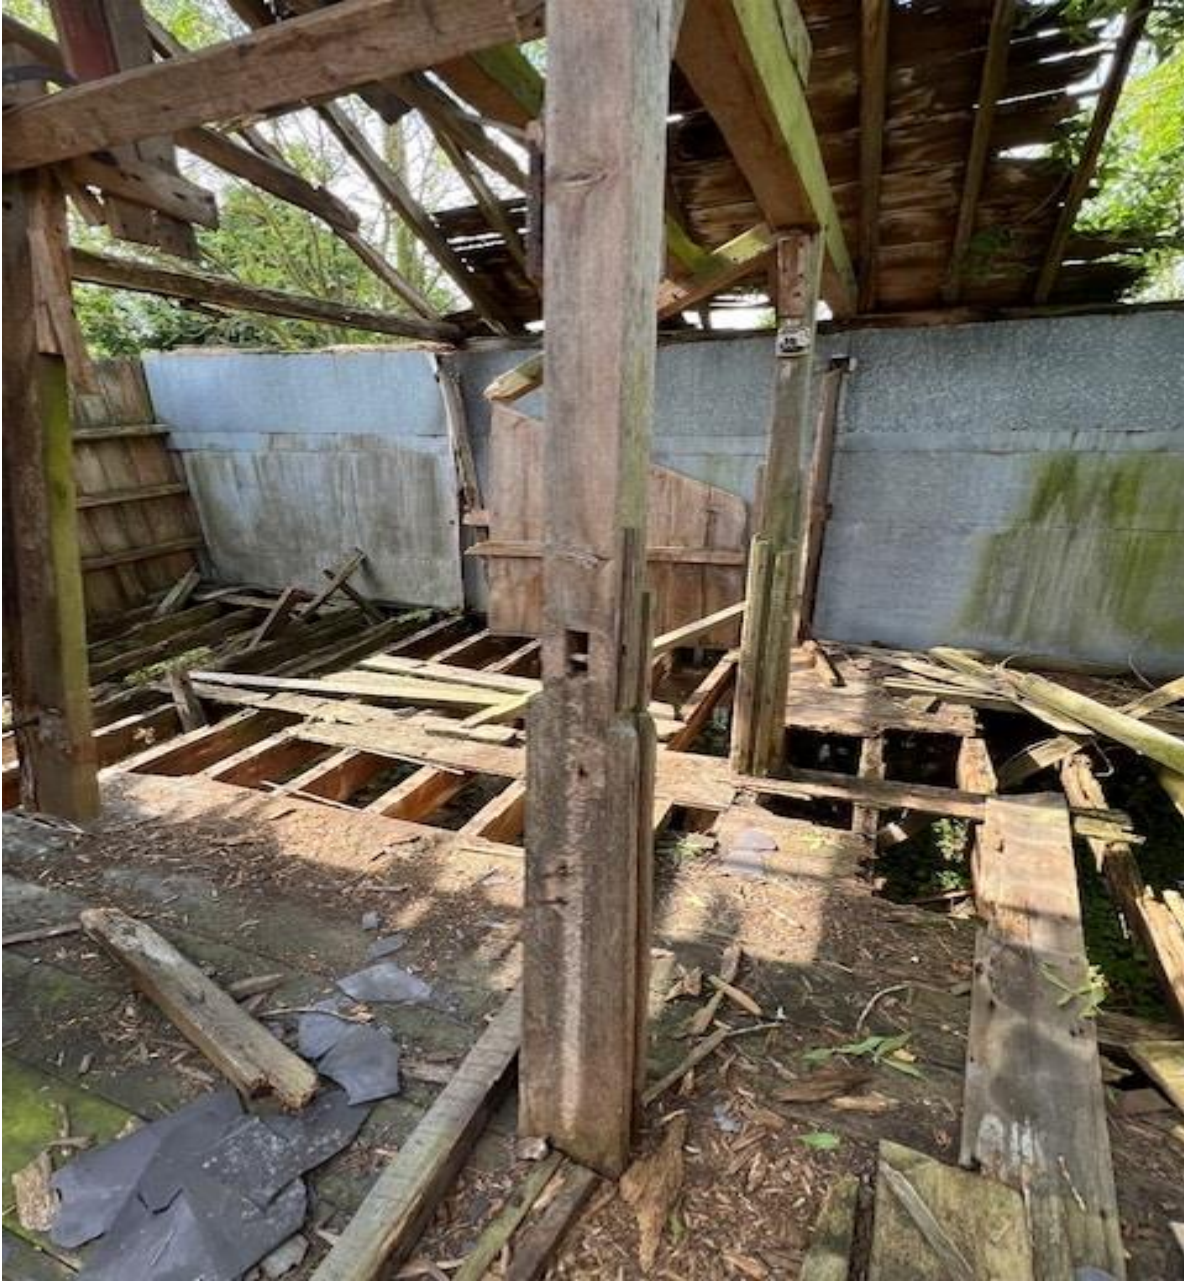
As earlier described, there are vertical posts within the building, it is assumed there were 4, only 3 are now still on show, the posts are chamfered in style.

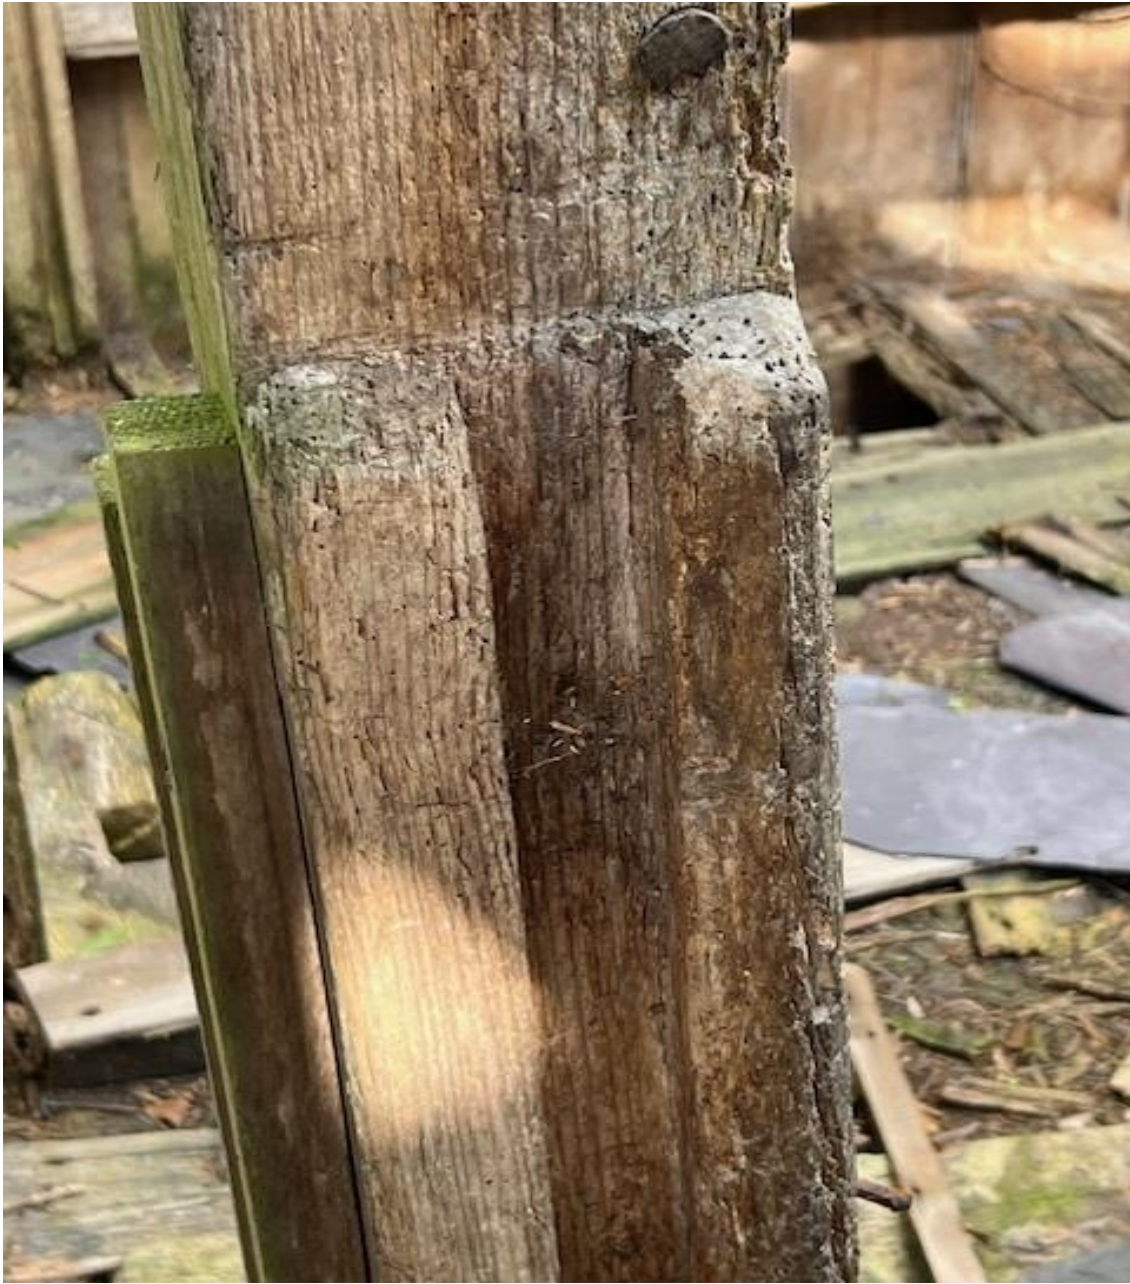
As above, the posts here are chamfered in style, but are now suffering from some slight wood boring insects and rot.

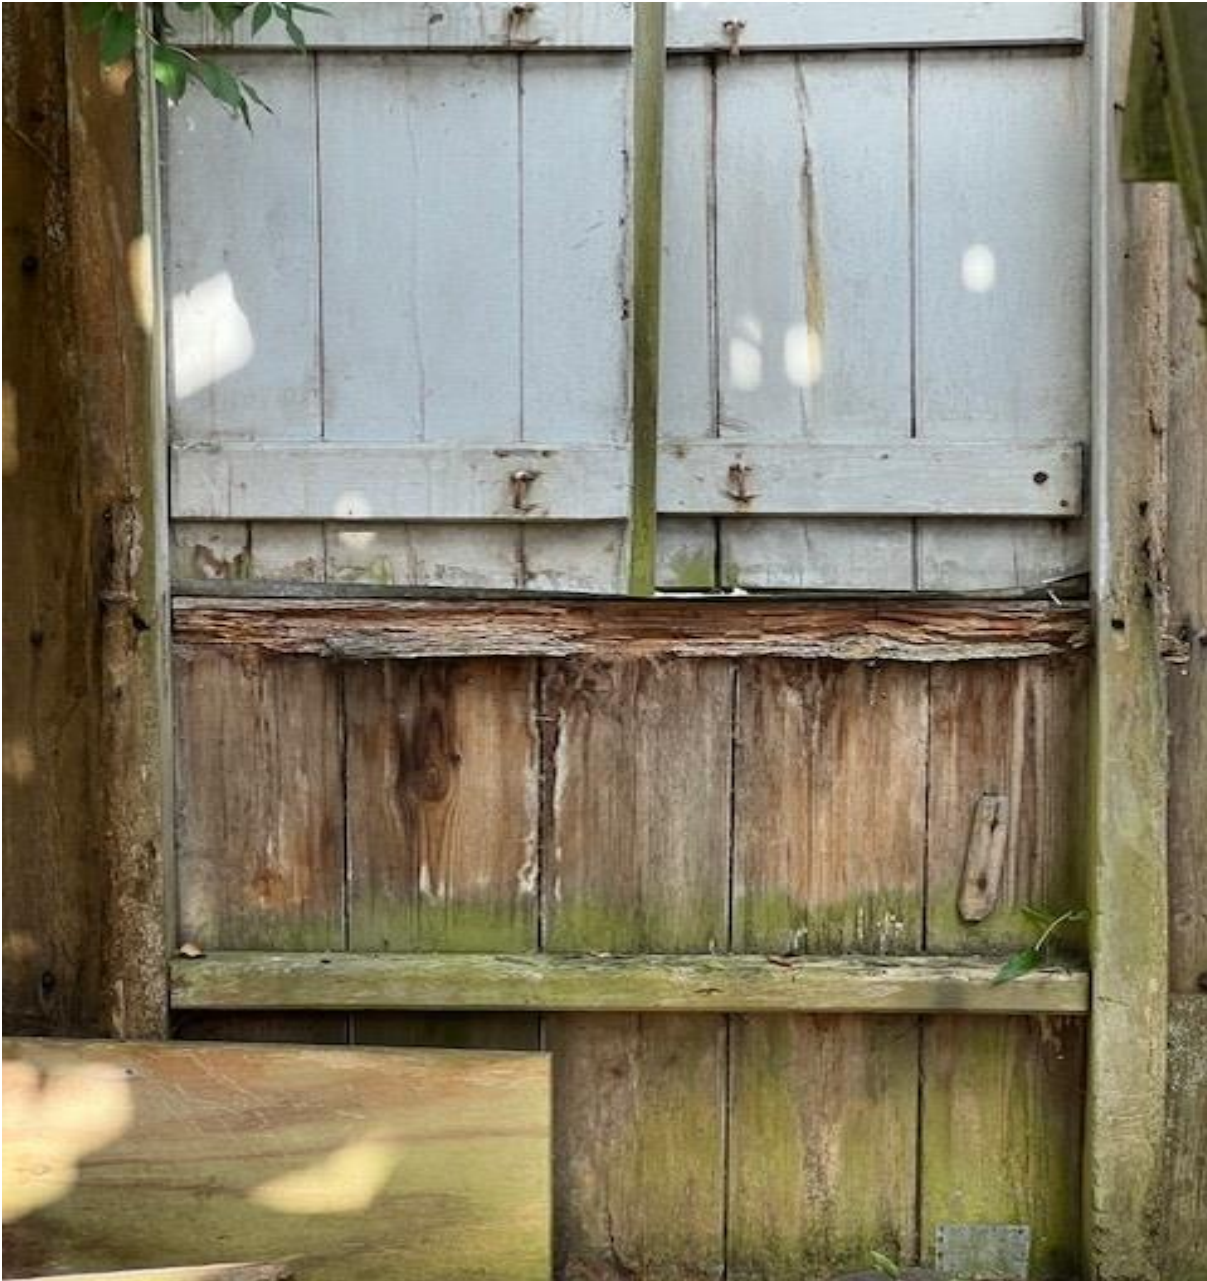
The timbers that sit under the shutter windows at W4 are decayed not only at the vertical timbers but also at the supporting horizontal timbers.

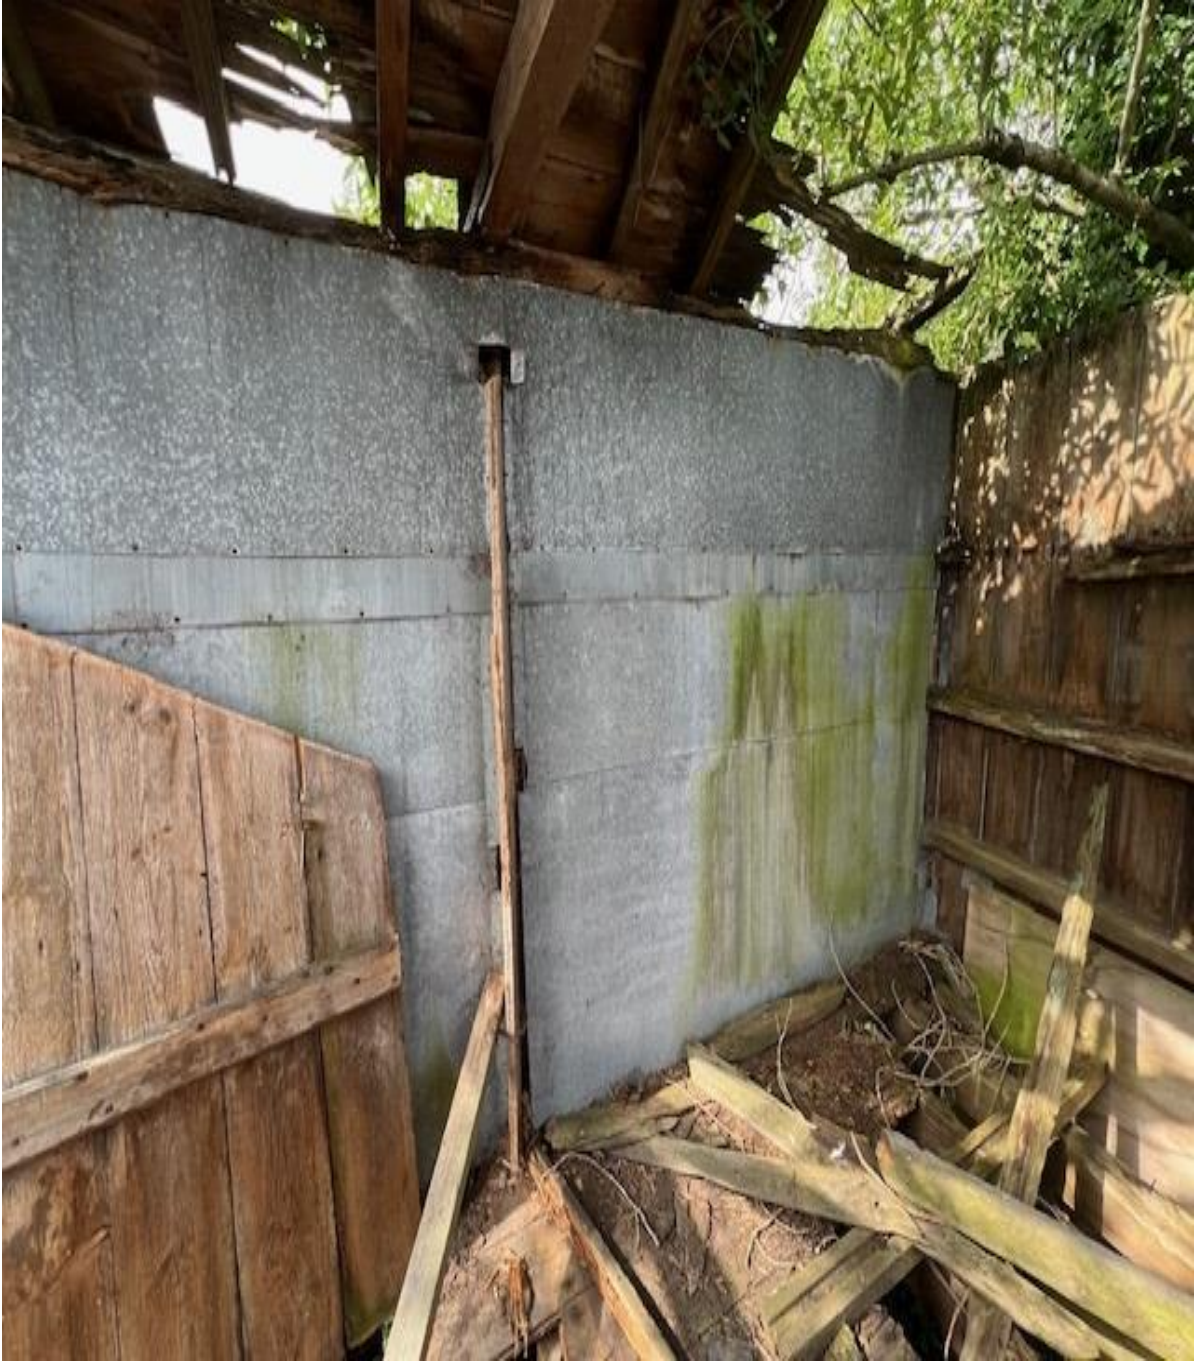
Here the photo details the wall/roof and floor condition at the corner of W3/W4.

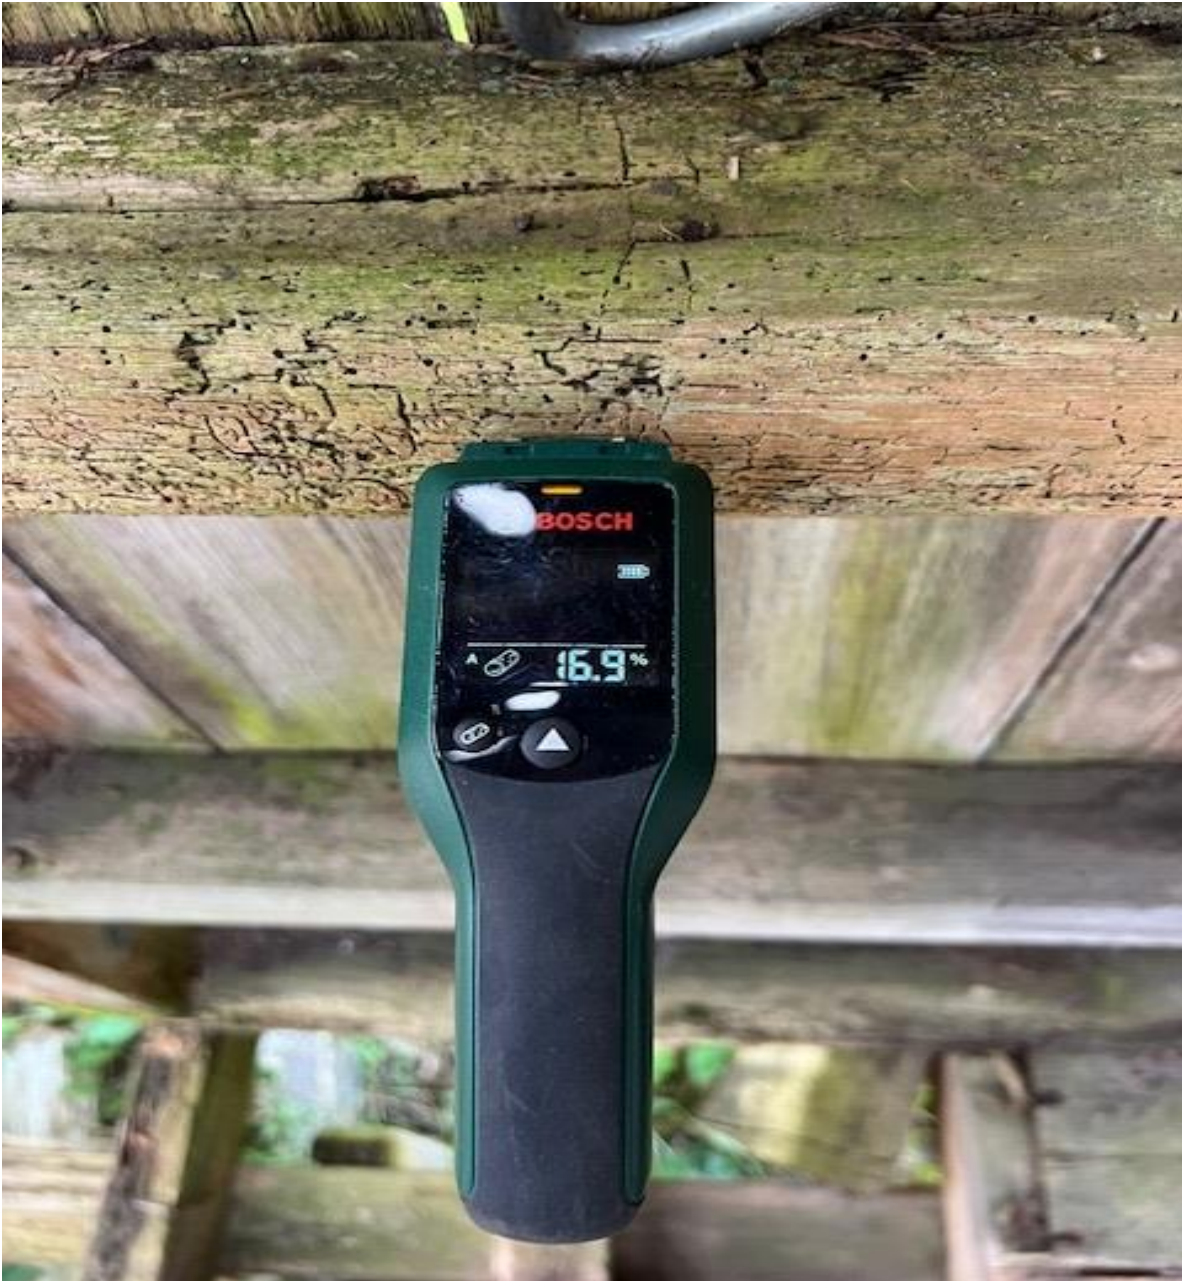
Timbers need to be ventilated, given there is no roof, most of the walls allow ventilation due to their condition, timbers should be dry and around 10-12% moisture, here we have a reading of 16.9% the timbers are wet and this is the case in most areas, the decay of wet rot and the beetle attack is extensive throughout the vast majority of the timbers, the timbers are soft, and break away in many locations when touched.

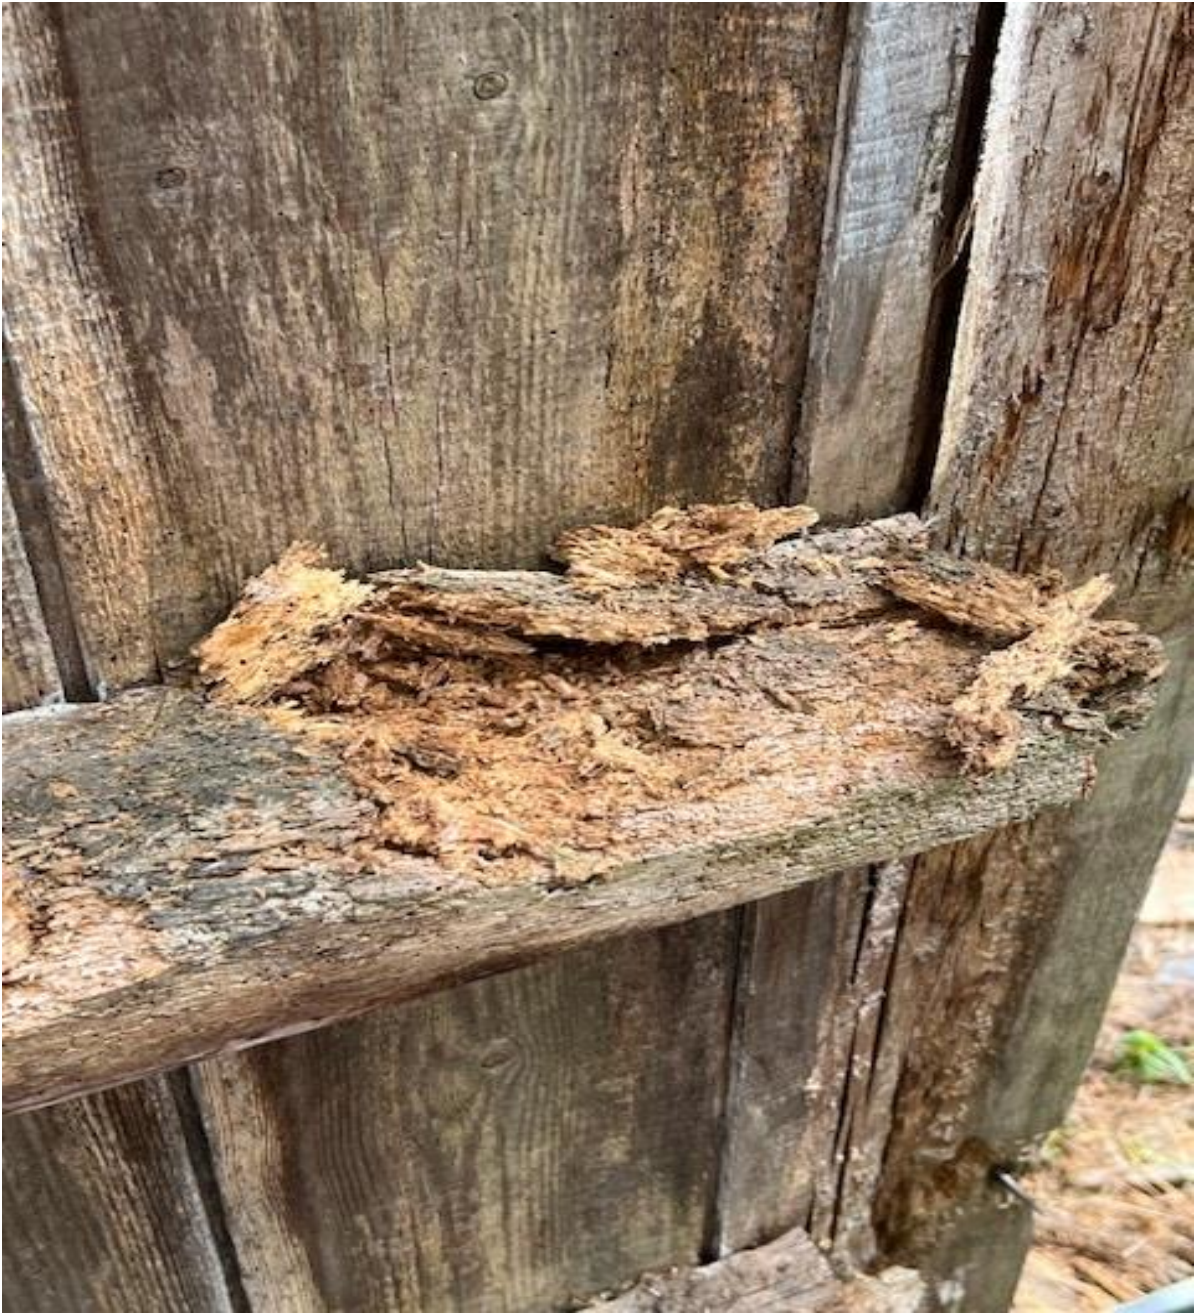
Timber condition of the horizontal brace timber at W1

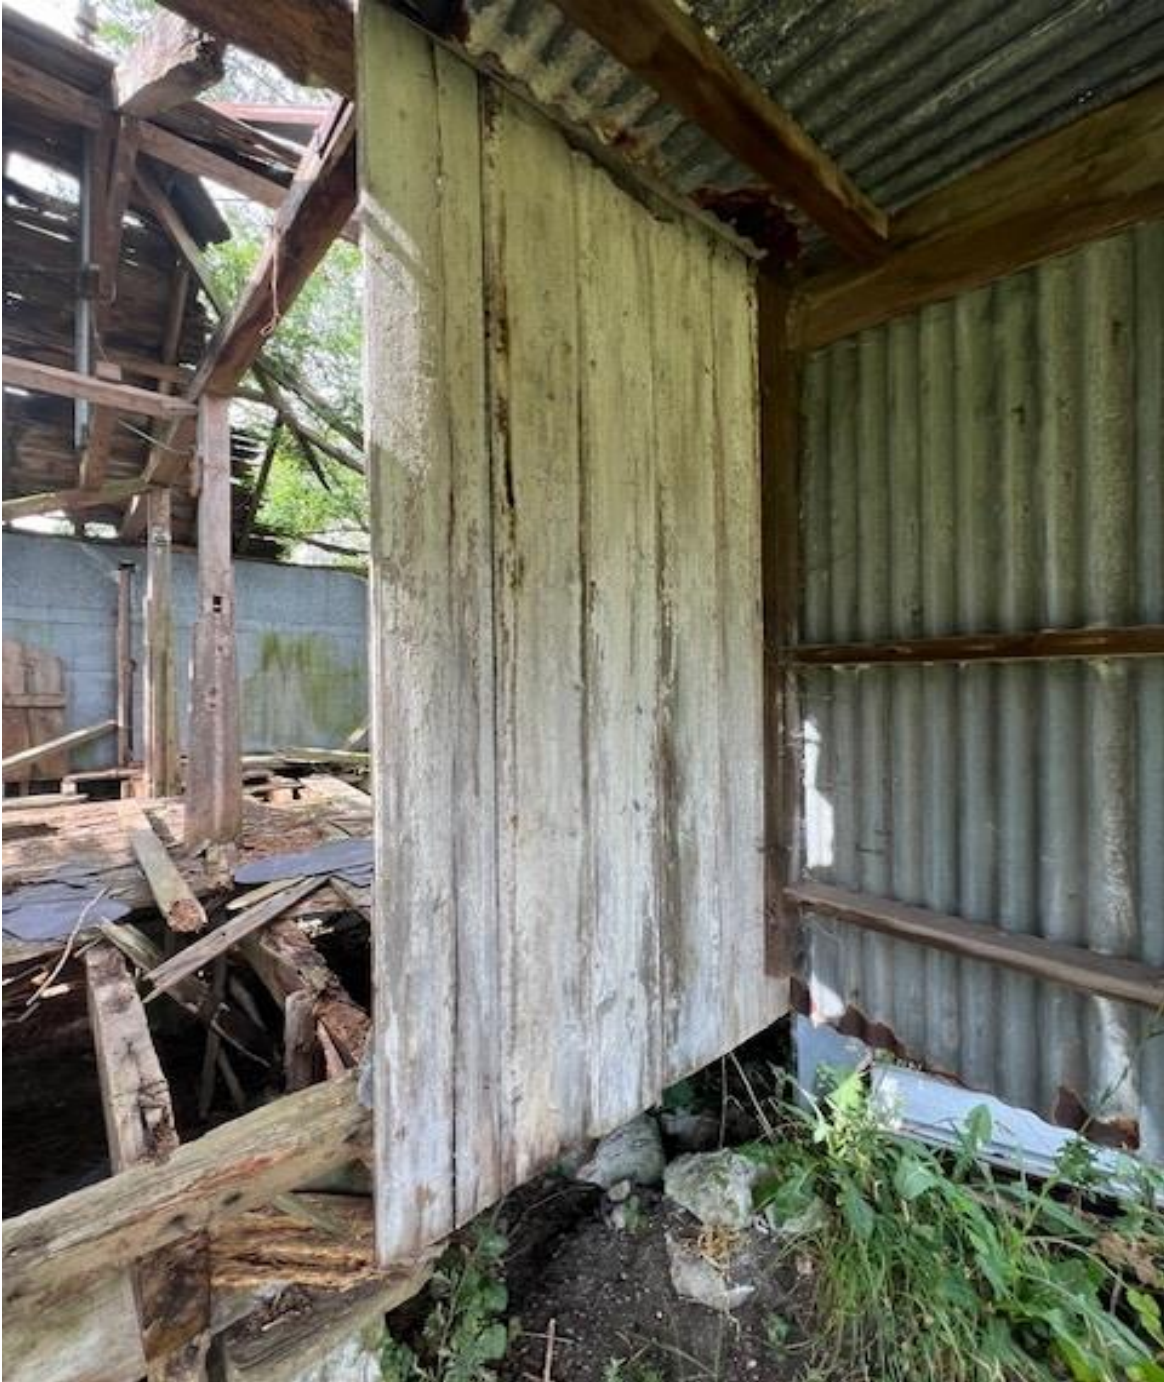
The vertical timbers at W1 have been somewhat protected by the more modern metal canopy and corrugated roofing, but still details as decayed.
