Shore Associates Ltd
Chartered & Heritage Building Surveyors

Building A Condition Survey Report

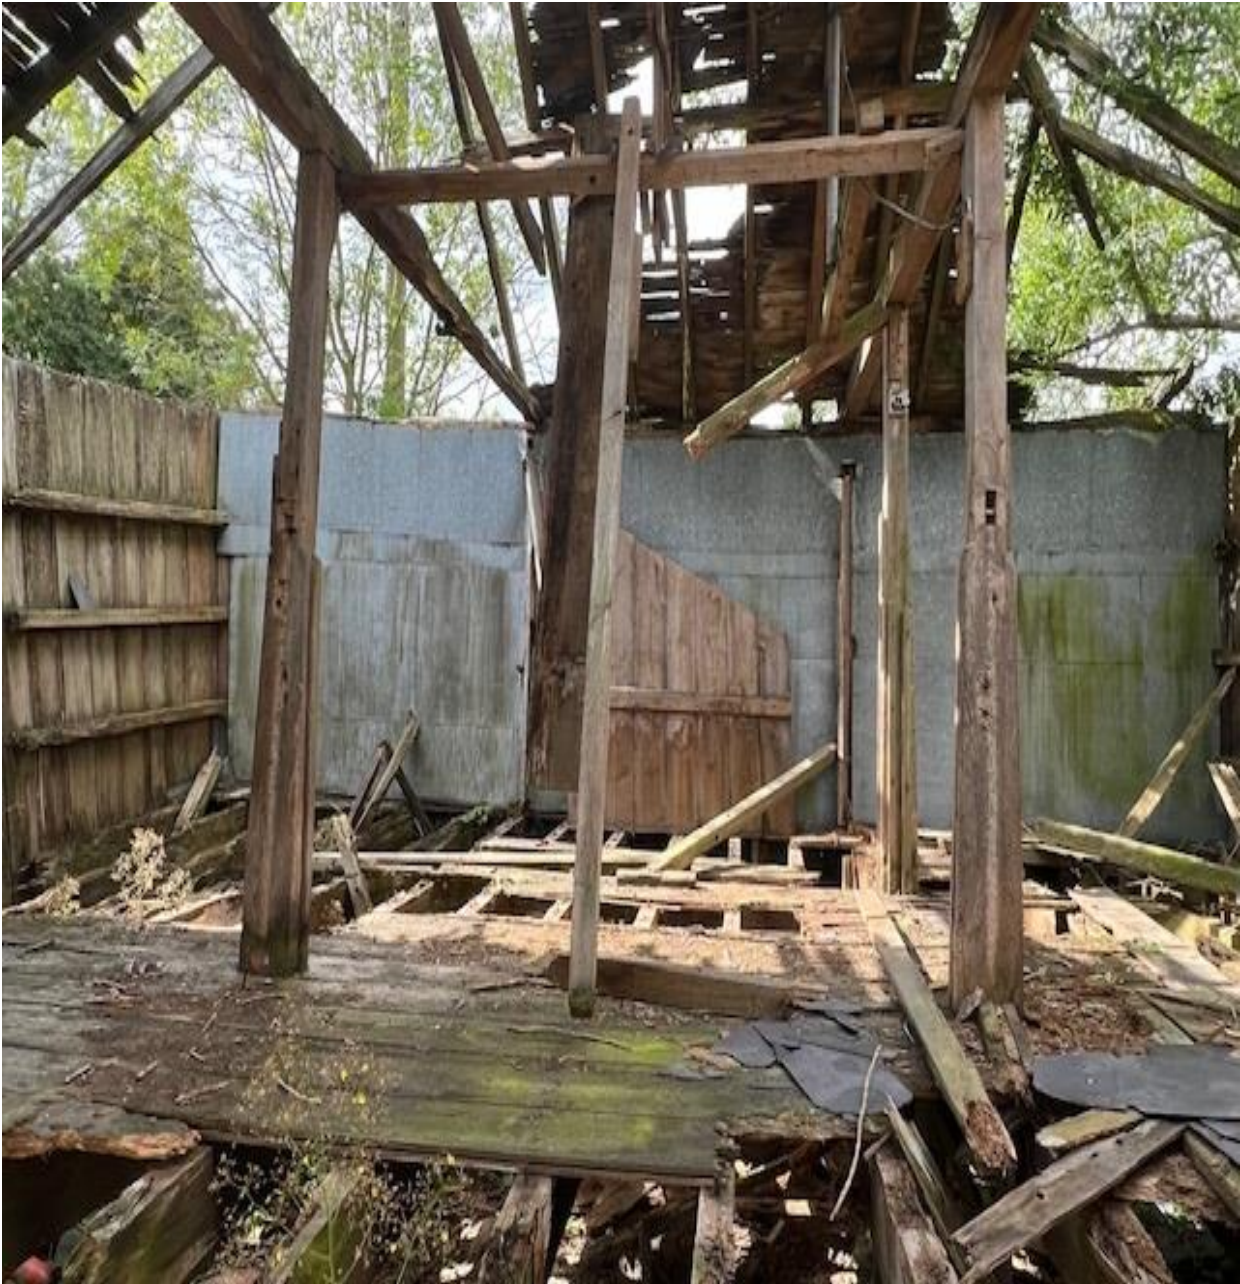
The internal braces, and walls

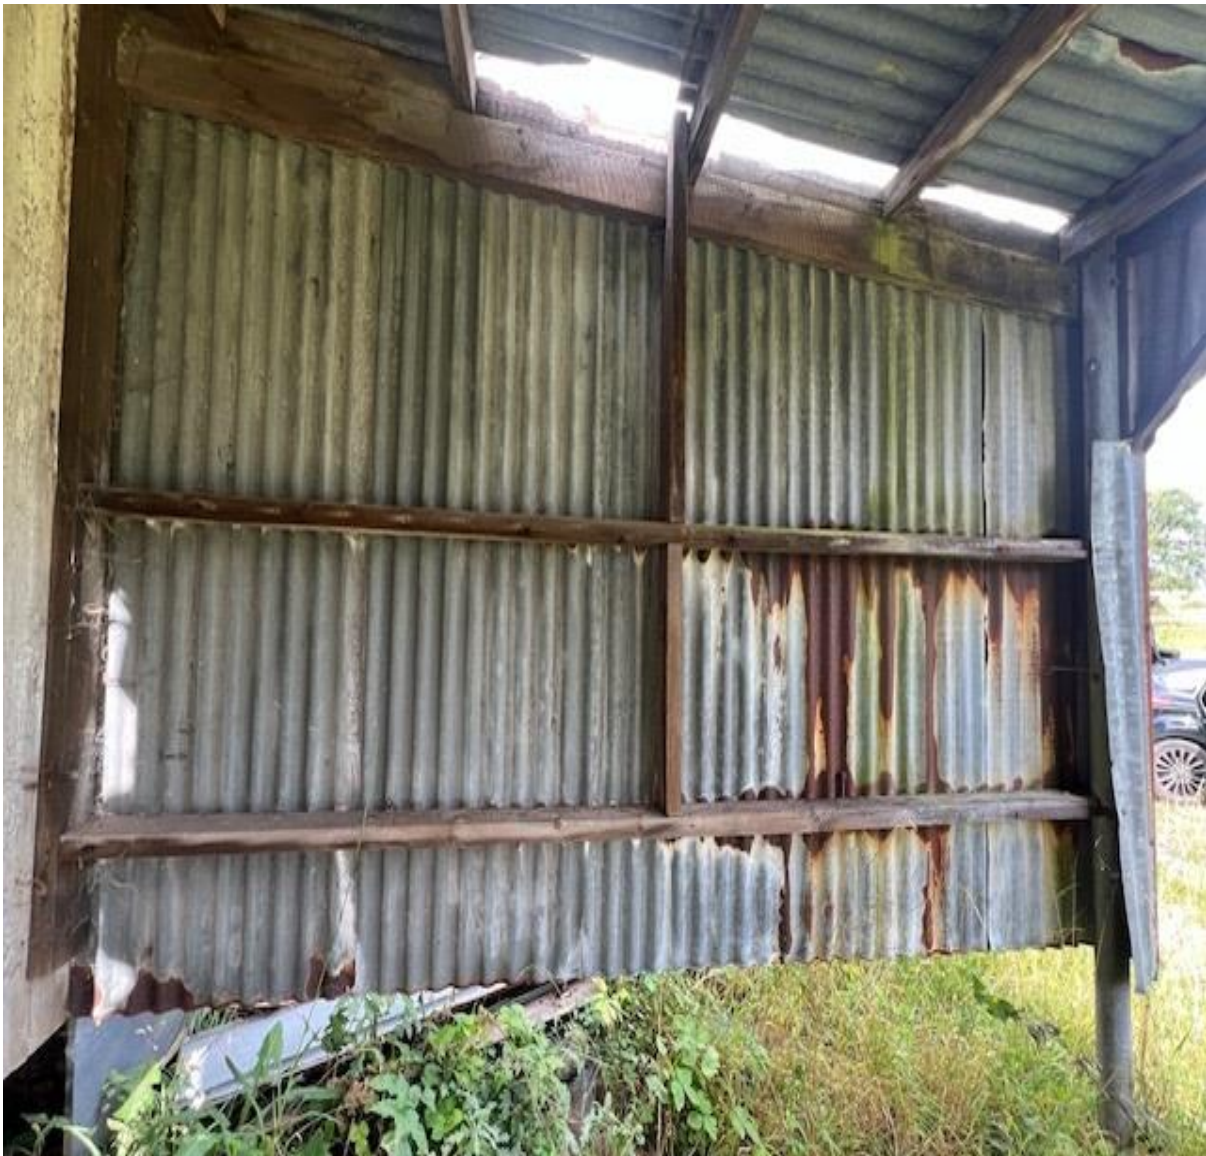
The external corrugated sheeting that sits over and at the W4 side at W1 elevation is of a far more modern construction with timber framing and metal support posts, the timbers are still supportive, are modern sawn timbers, but again due to the missing roof coverings here as well have become saturated due to water ingress and are now starting to show signs of decay.

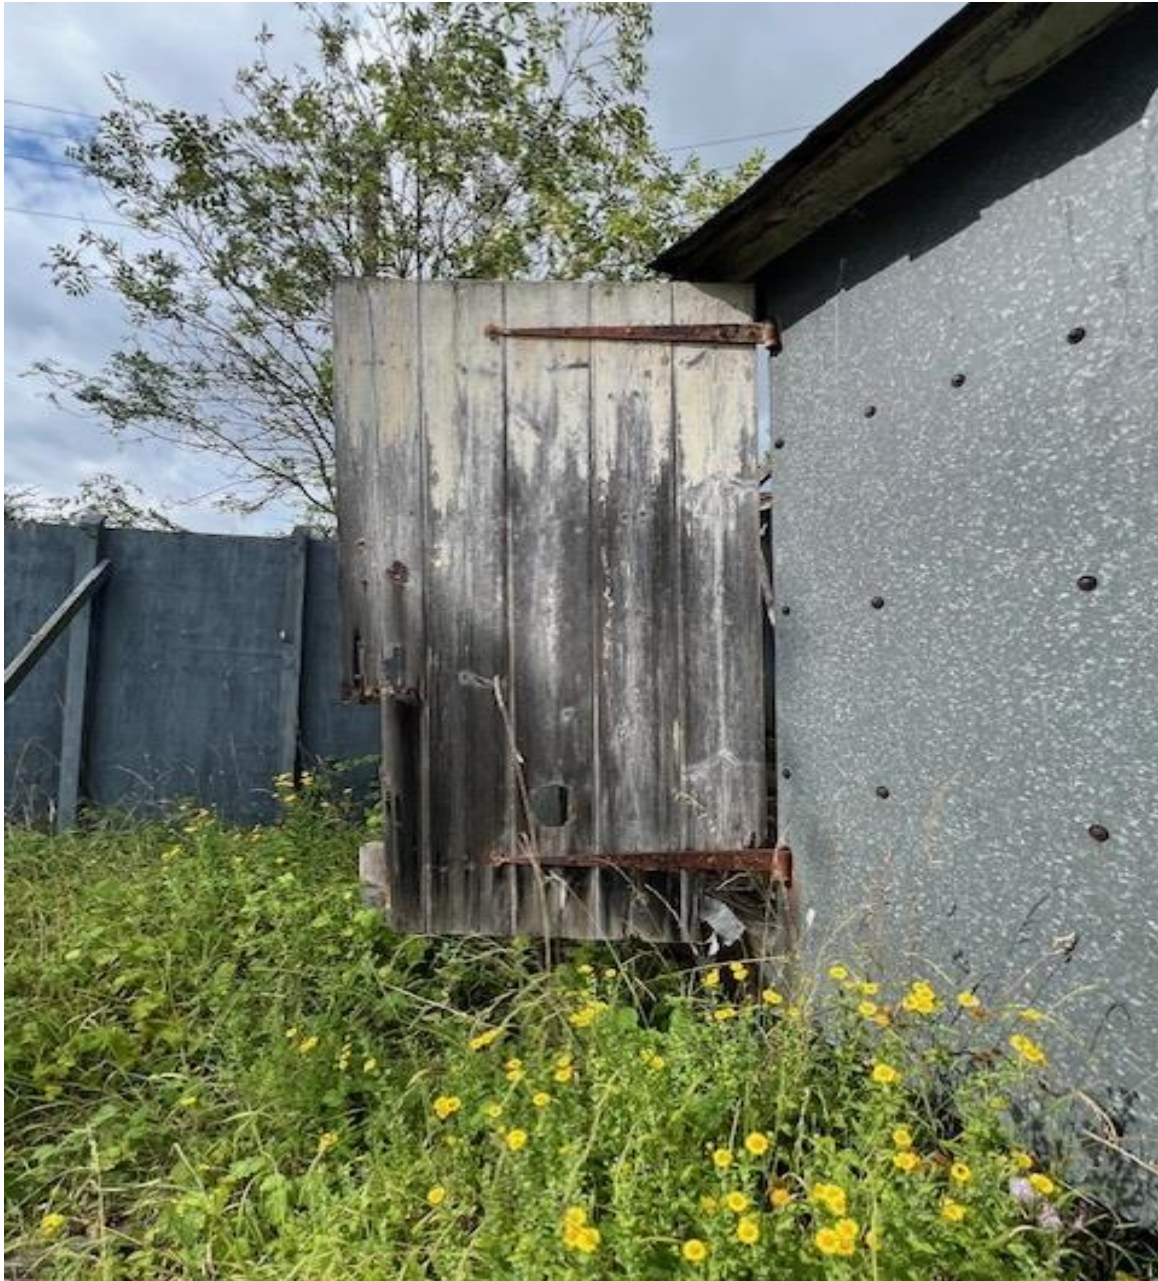
At the W2 elevation, similar as those at W4 there are timber openings with metal hinges, here as opposed to a window, there are double doors, the timbers are again extensively decayed.

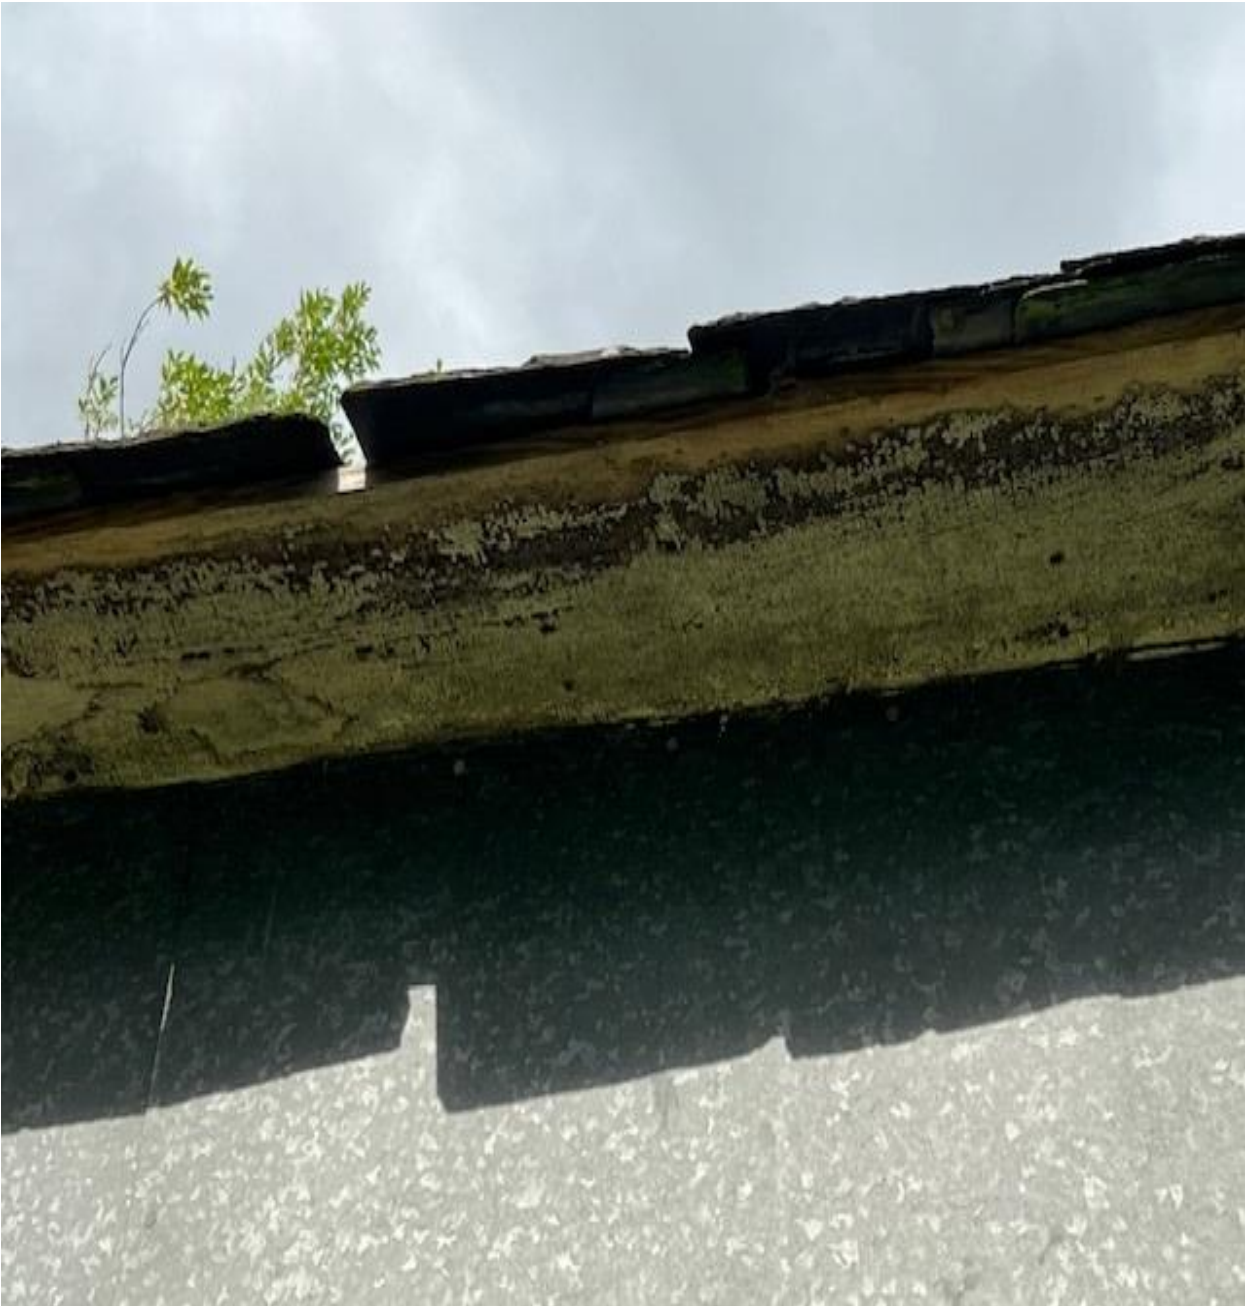
Where soffits sit, these areas are timber, again where protected by overhanging slate, these are in fairer condition, where the roof sections are missing, the timbers at the soffit are decayed, missing or non-existent.

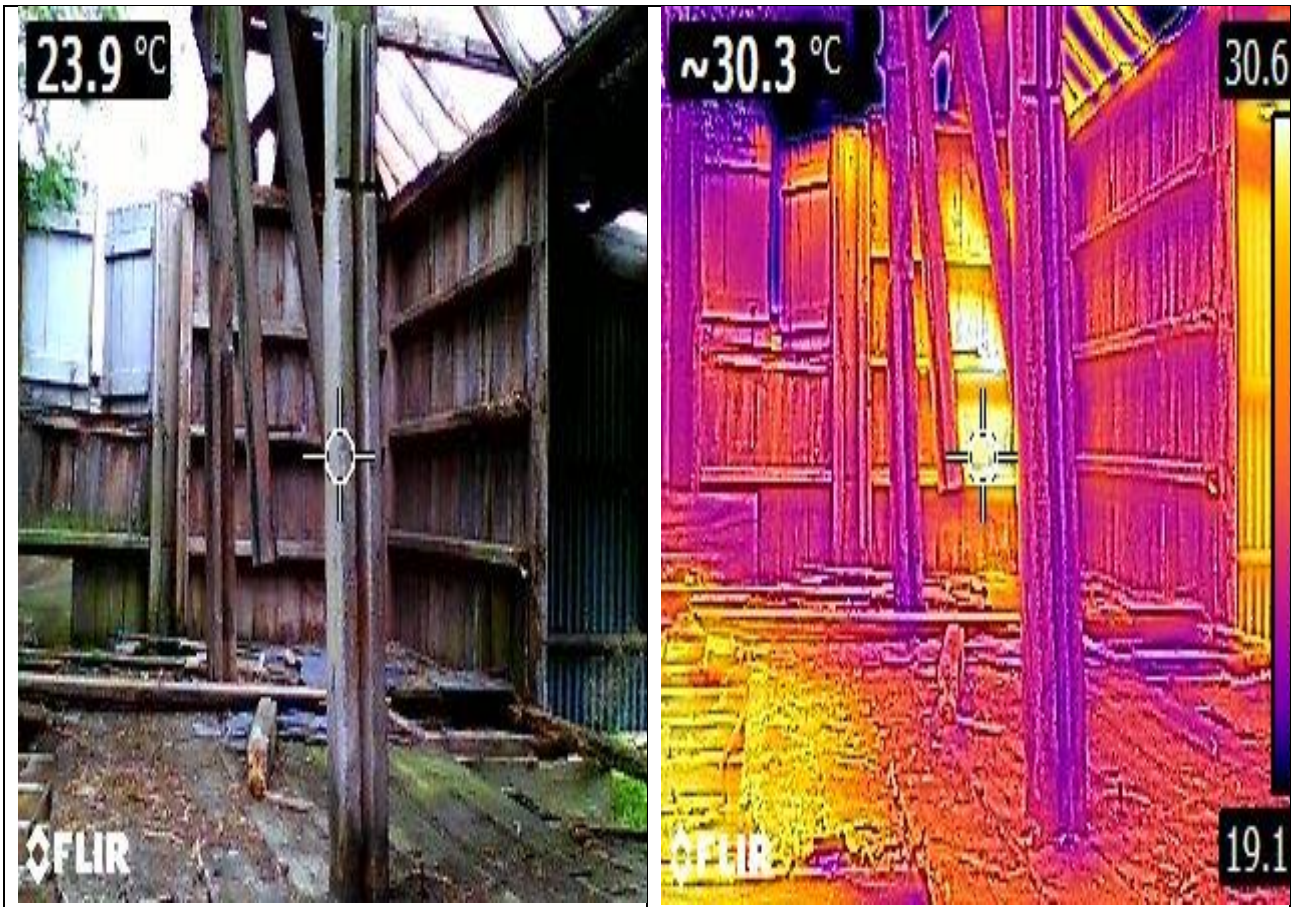
Thermal imaging photos were taken from inside the building, here the thermal camera pictures on the left detail that seen through a normal lens, that on the right is that seen through a thermal lens.

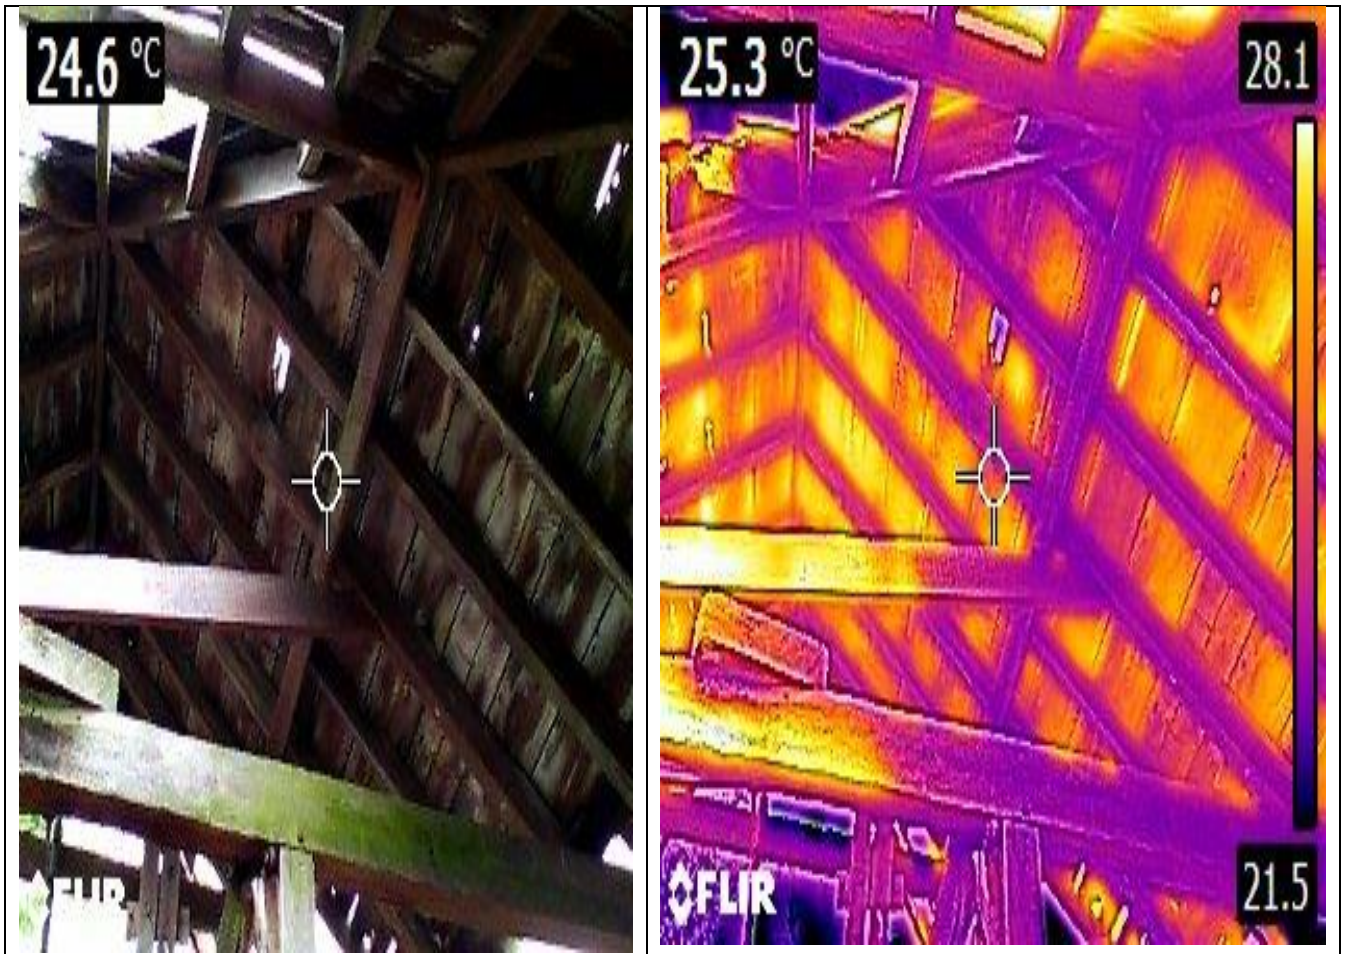
Thermal imaging of the roof timbers gives a clear example of wet timbers, the close boarding that still exists is warmed through sun light and is detailed in the yellow, the blue details the saturation at the timbers.
