Hertsfield Barn, Marden, Kent, TN12 9BW

STATEMENT OF

Dr Paul Ellis, BSc, PhD, CGeol

Subject Matter: The potential for groundwater flooding resulting from the unauthorised development at the neighbouring property known as Monk Lakes.

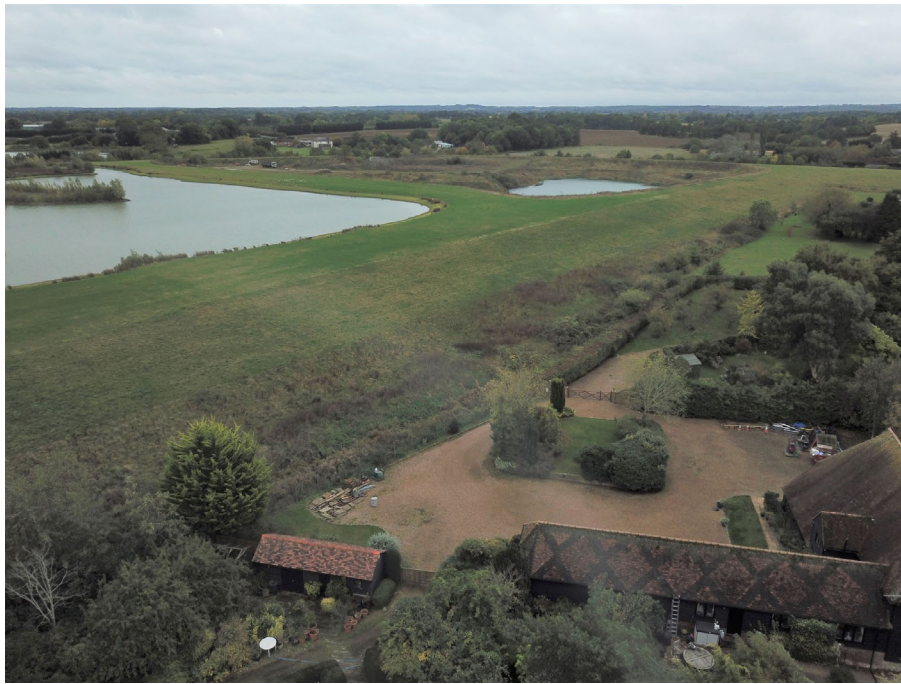
Figure 1. View looking south of Hertsfield Barn and Monk Lakes 1 and 2 (October 2019).

- 1.3.11 Mr Padden continues to report ongoing impacts on his property: a reported loss of trees in his orchard due to waterlogging; flooding of his pond and driveway; infiltration to his sewage treatment plant; and internal damp affecting his property (a Grade II listed building). Photographs highlighting some of these impacts are presented in Appendix B and D. A photograph, taken from a drone, showing the close proximity of the unauthorised development and the vulnerability of Mr Padden's property is included above in Figure 1.

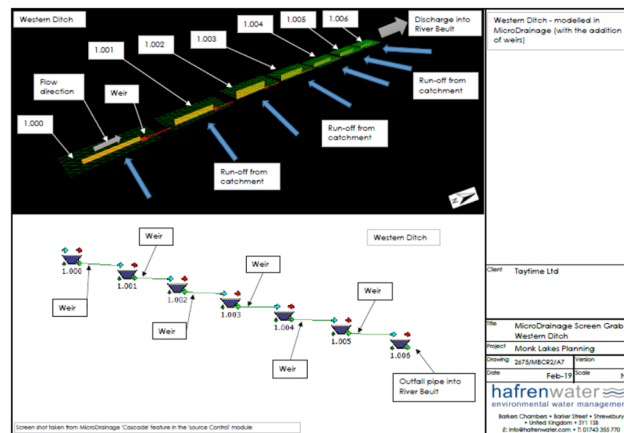
Figure 2, Schematic surface water attenuation scheme #
 (after 2675/MBCR2/A7, Vol2 part F of the ES, section 4.1 of Hafren 2019, pdf page 325 of the ES).

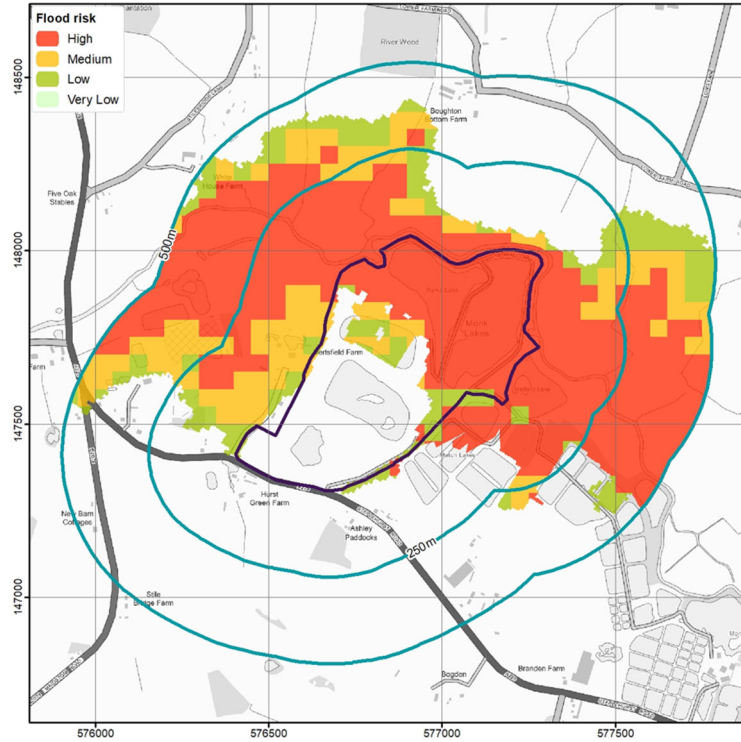
Figure 3 Environment Agency Risk of flooding from Rivers and Sea (ROFRAS)

Fluvial flooding is acknowledged as a risk, and will require the implementation of a flood storage compensation scheme to mitigate the impact on other receptors. I note that parts of the site currently designated at Low risk in Flood Zone 1, are likely to have been at a lower elevation (and therefore at higher risk) under baseline (pre-development) conditions. It is evident from the data in Figure 3, the Environment Agency model used to define the flood zones is using the recent topography after land raising has occurred.

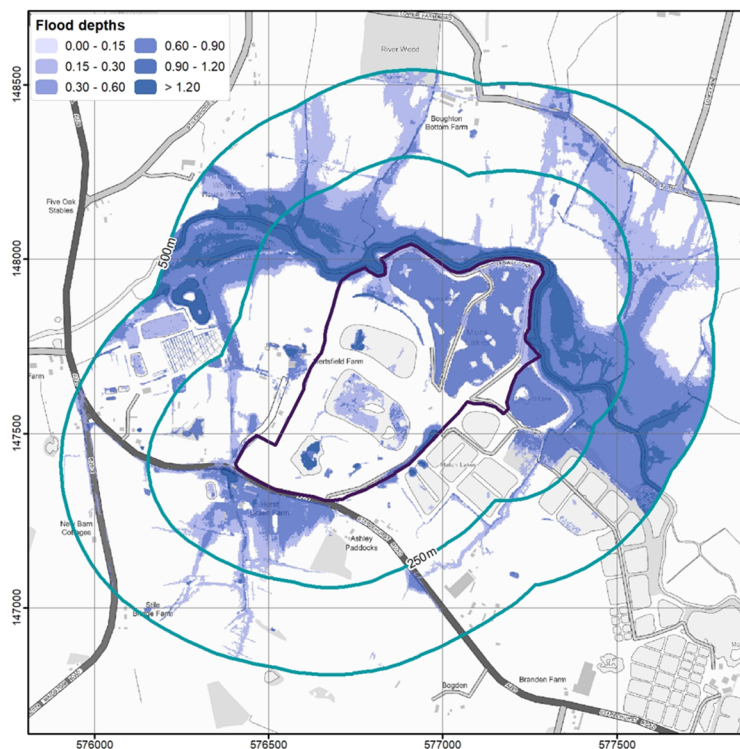
Information on the pluvial (surface water) flood depth is presented showing the extreme (1 in 1000, 0.1% AEP) and medium risk (1 in 100, 1% AEP) scenarios. The extreme case has a low probability of occurring, but highlights the risk areas around Hertsfield Barn and the A229 to the south. The risk of surface water flooding is likely to be increased along the western margin of the development due to the presence of a steep slope and the low permeability of the material used to create the raised lake. The cumulative impact of the development on the existing off-site, surface water flood risk should therefore be considered within the impact assessment.

Figure 6 Environment Agency Surface Water flood depths for the 1 in 1000 year event.

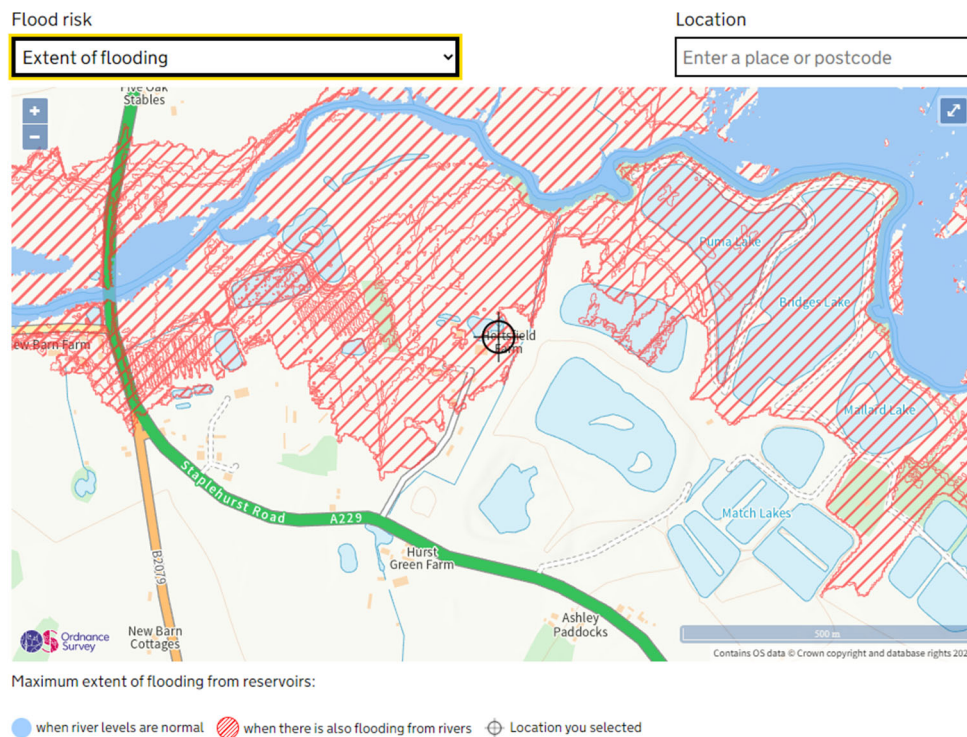
As indicated in Figure 8, Hertsfield Barn lies within the extent of reservoir flooding when there is also flooding from rivers. There will be additional cumulative risk from the adjacent raised reservoir which should be included within the impact assessment. There will remain a residual risk for as long as the raised fishing lakes are in operation, and the degree of risk will depend on the ongoing inspection and maintenance of the lake banks. To provide context, Figure 1 is a photograph taken from a drone showing the close proximity of Hertsfield Barn to the raised lakes.

Figure 8 Environment Agency Maximum extent of flooding from reservoirs.

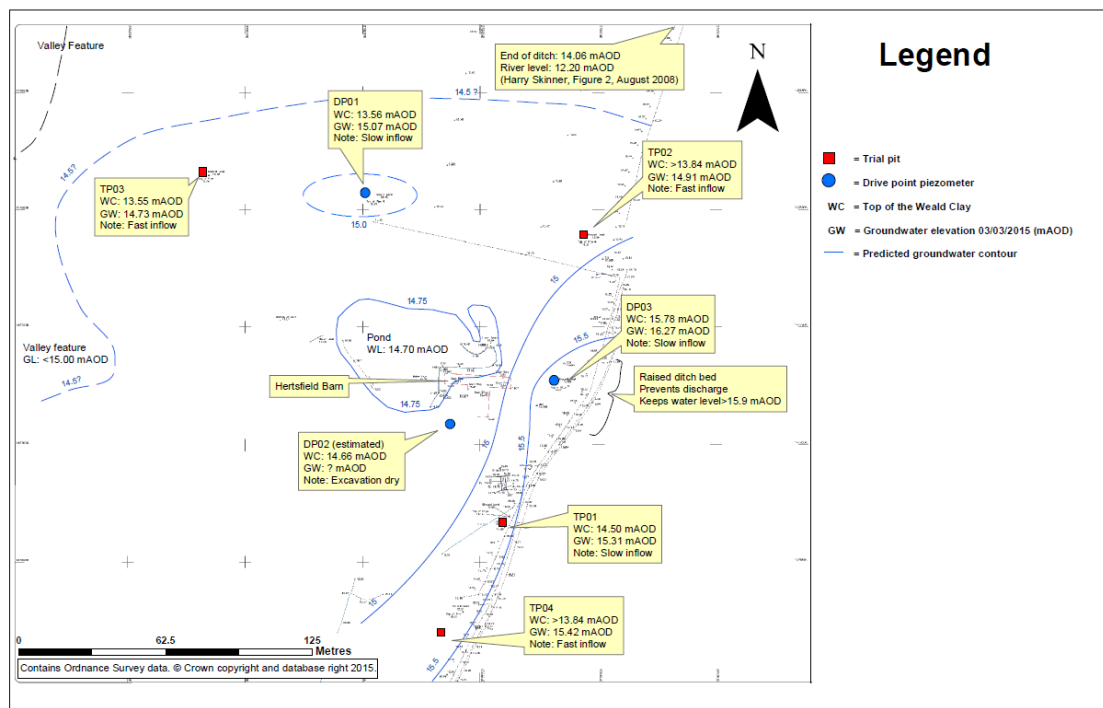
Figure 1 Estimated groundwater contours (from ESI,2015, Figure 8)

Groundwater contours should include the groundwater low around Hertsfield pond and make reference to the earlier trial pit and groundwater data presented in ESI 2015. As Taytime have not collected any data outside the Western Boundary then the information provided within the ESI report should be considered. If this information is disregarded, then the applicant should state the reasons for this and provide an alternative explanation for the high groundwater and flooding observed.

The groundwater level labelled on the revised contour plot for BH04 is incorrectly labelled as 15.66mAOD when in fact it should be 15.26mAOD, the level recorded on

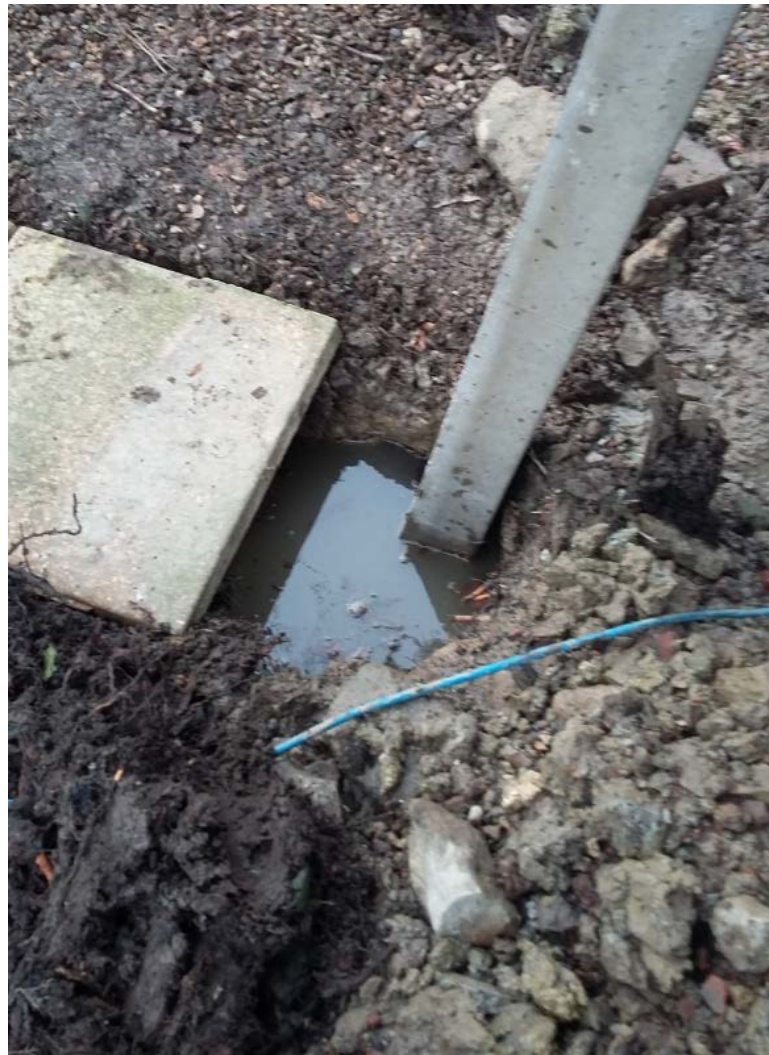
1. Holes filling with water from when the fence along our boundary with 3 Oast, was replaced 18/1/2016. Every hole they dug, from our entrance gate down to the pond, filled up with water.

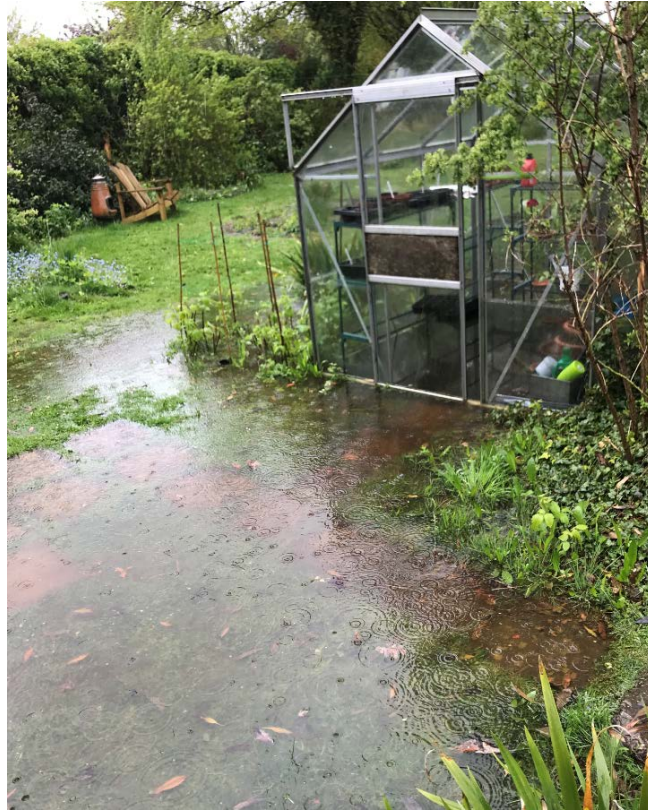
2. Garden of our neighbours at 3 Oast, which is beside the fence that was replaced.
Photo taken May 2018.

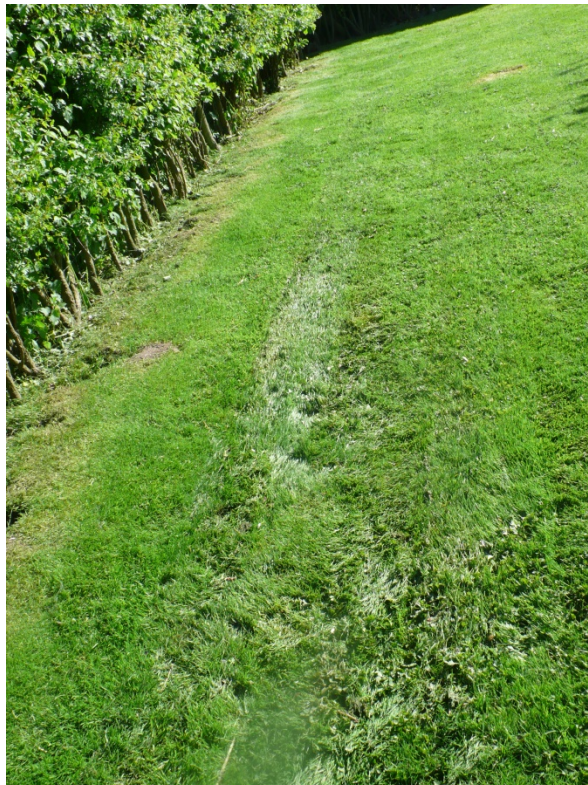
3. Sodden ground in Hertsfield Orchard – May 2018.

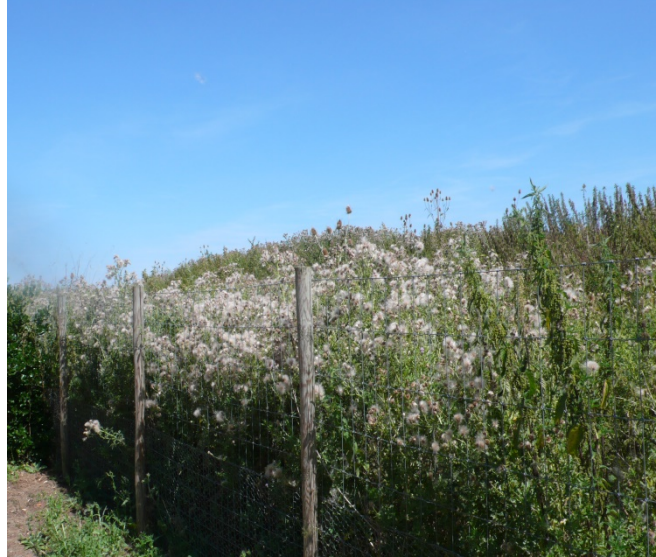
4. Despite “vegetation” that they say will help with any groundwater issues – we certainly have “vegetation” in the ditches – never been cleared since the day they were badly dug – but doesn’t make a difference.

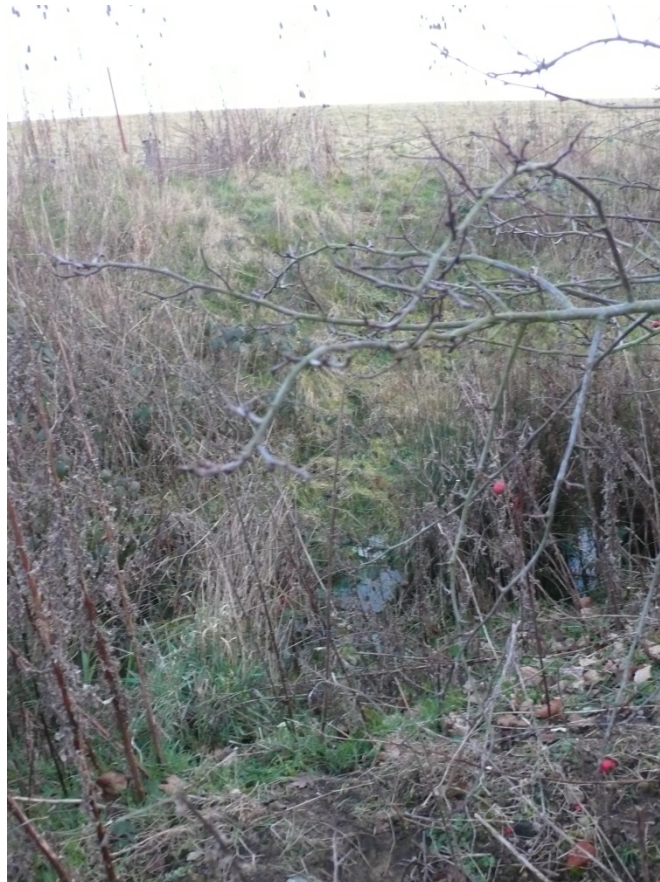
5. After rain, the water in the ditch sits – it doesn’t drain away immediately, it doesn’t run down the ditch channel - it sits in the ditch and then drains through the ground.

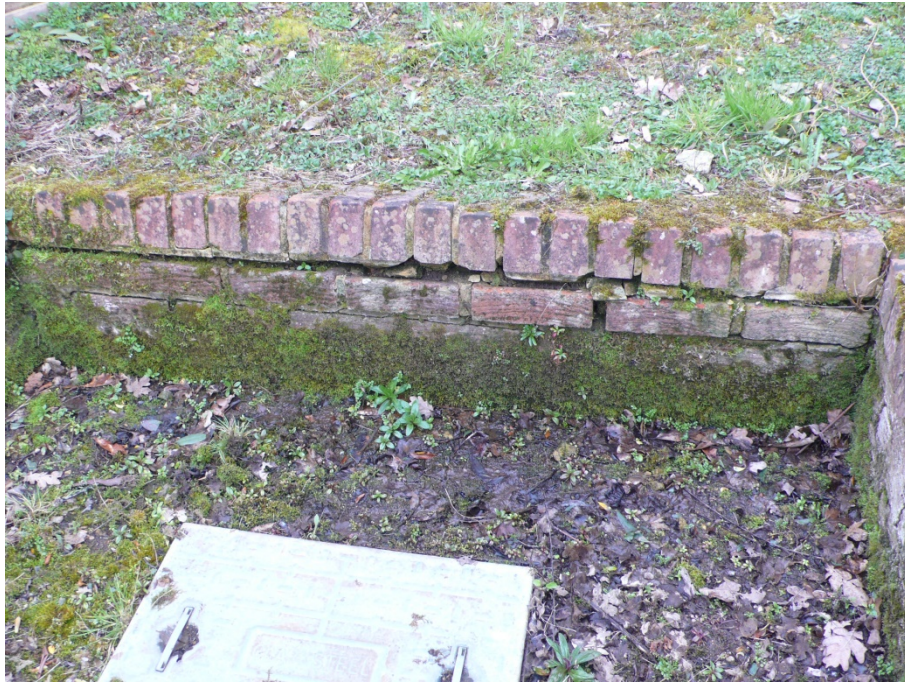
6. Klargester brickwork is constantly damp.

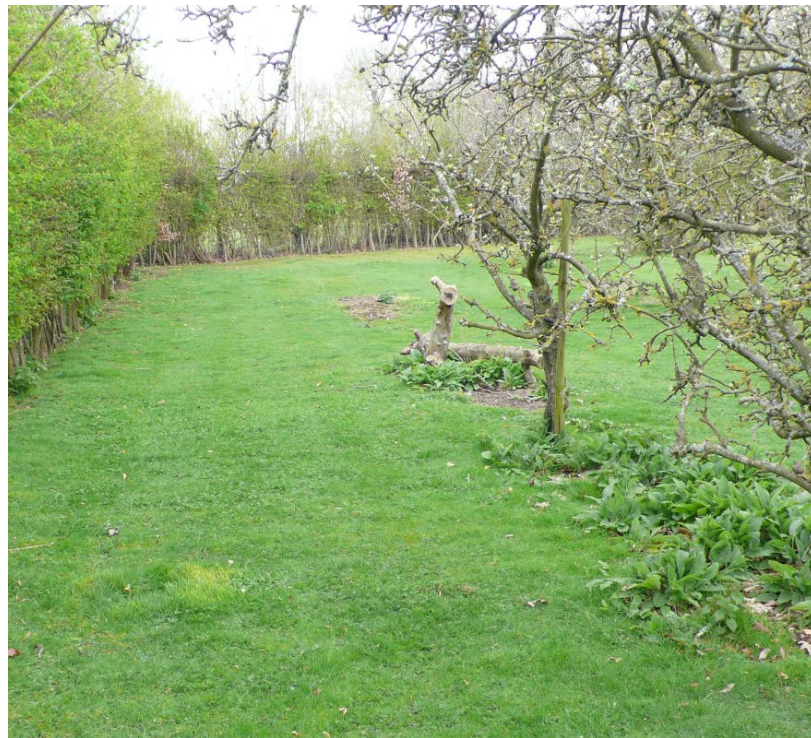
7. Numerous trees have died in the orchard now.

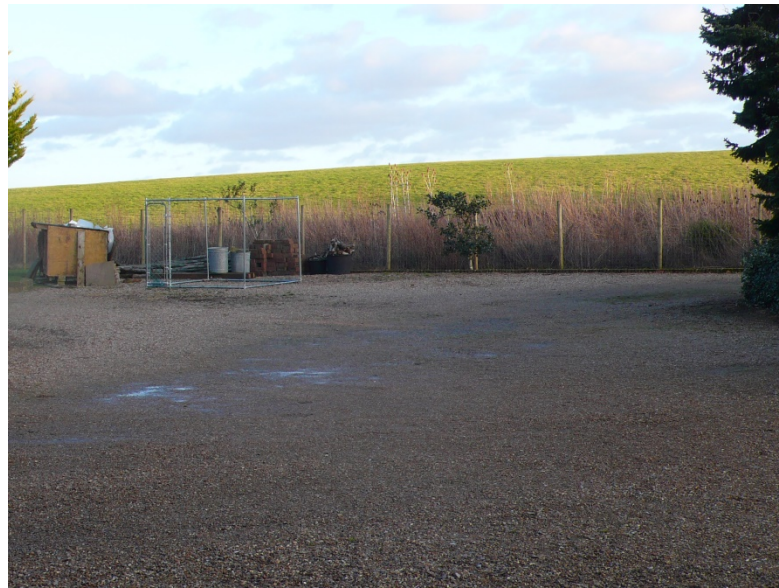
8. Water across our driveway. The area is waterlogged after rain, and runs across the drive into the garage, plus onto the garden at the front and side.

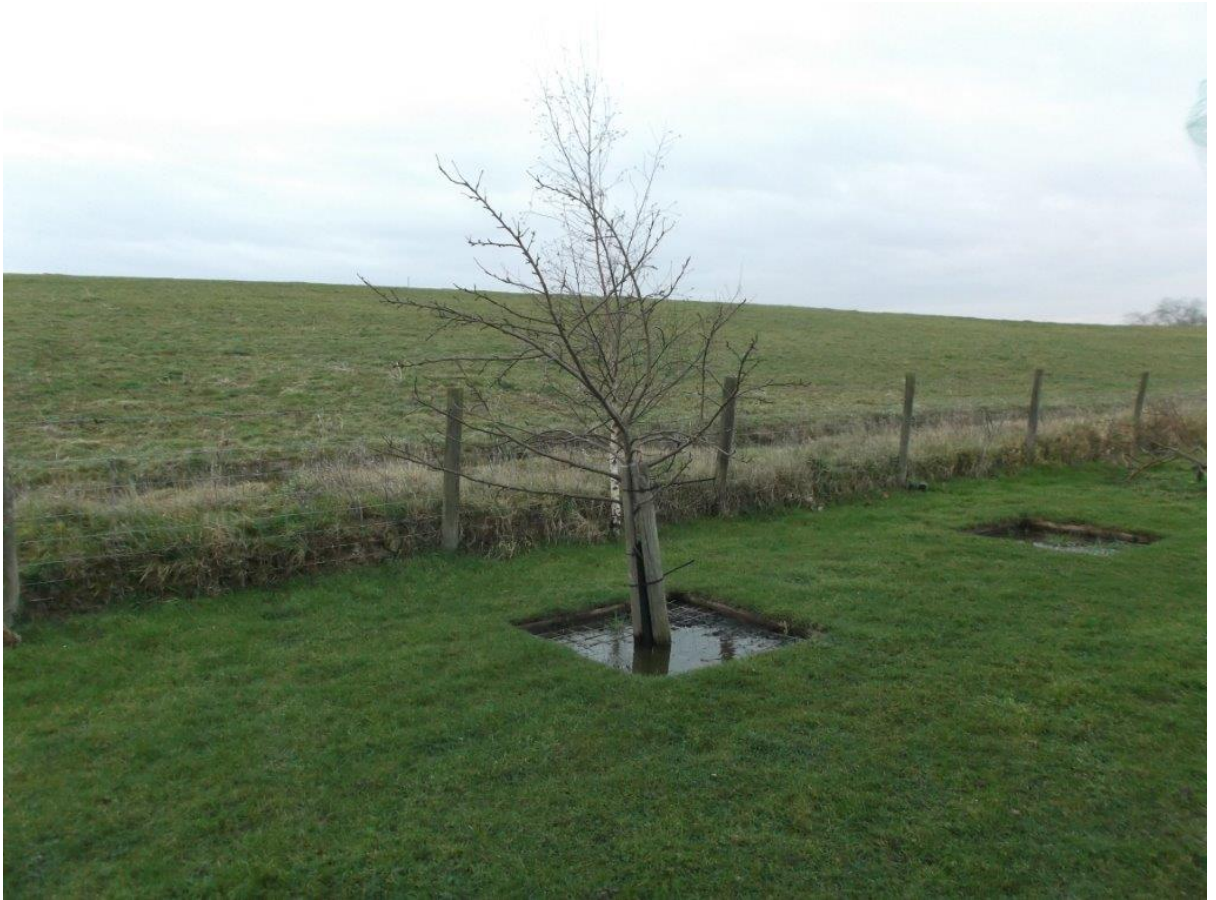
10. 12th February 2016 photograph from Alan Mathie, who is in the cottage next to Leigh Highwood and has lost 3 fruit trees. Shows the western ditch behind the fence.

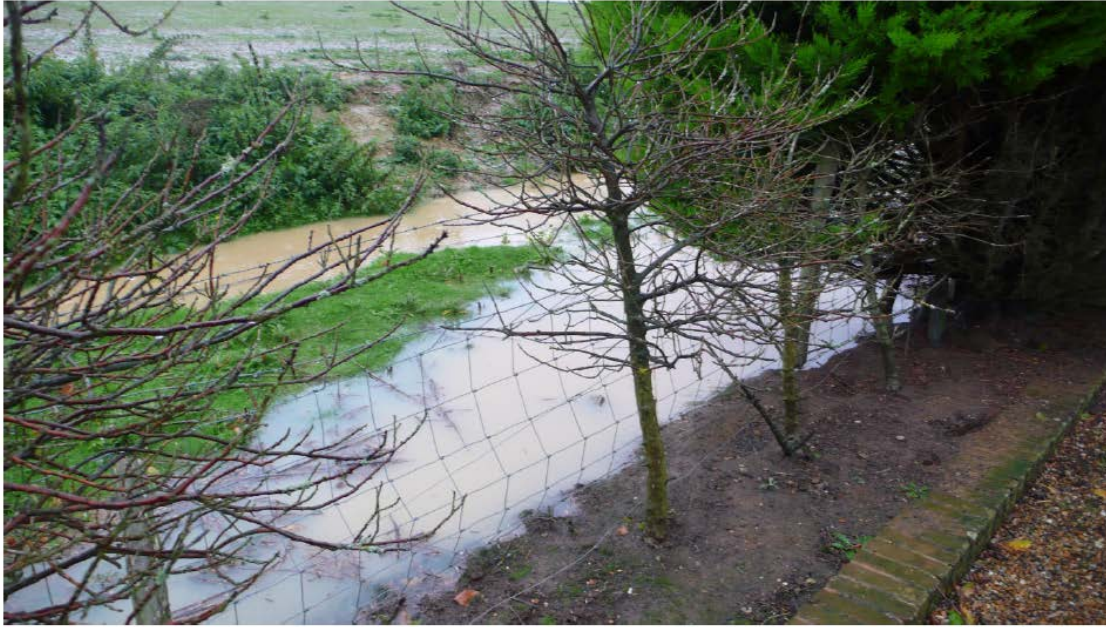
Figure 1. Flooding from Monk Lakes western ditch beside Hertsfield Barn package treatment works (taken 13/10/13) from ESI (August 2014).

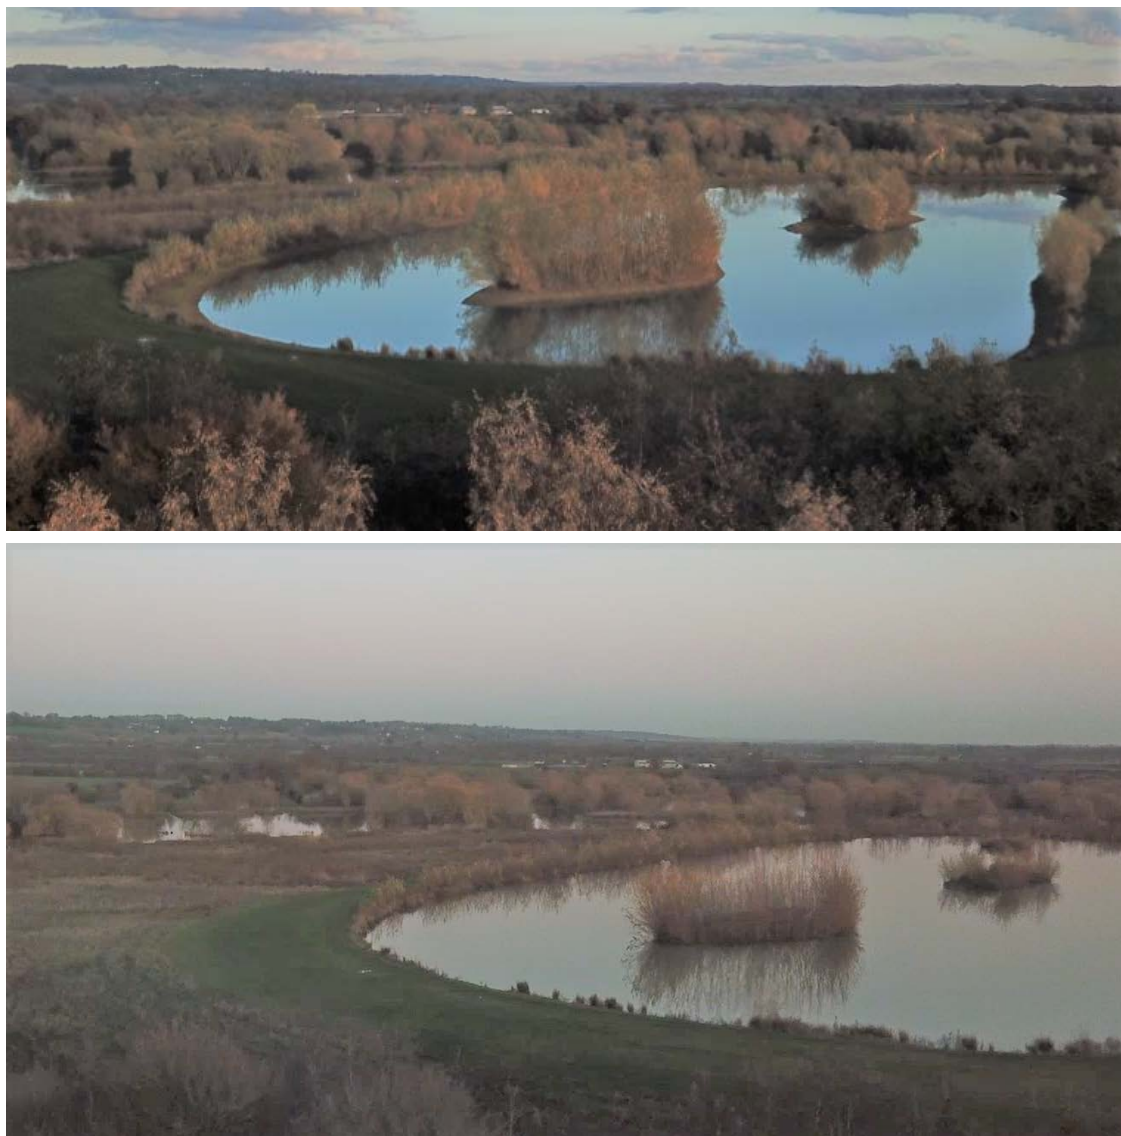
Figure 3. View south of Hertsfield Barn to Lake 3 on a) 10/11/19 top b) 29/11/19 bottom, showing significant variation in water levels.

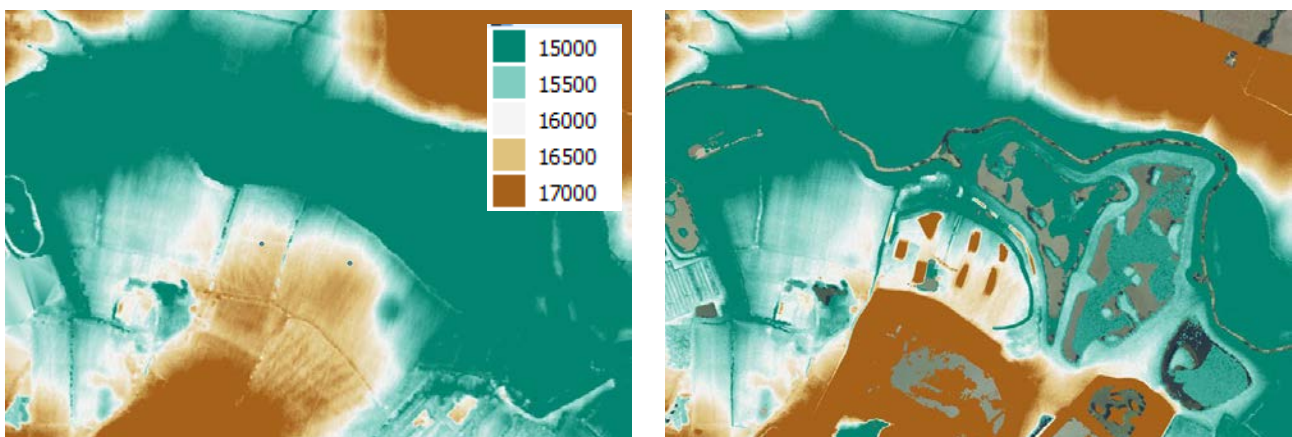
Hafrens findings (October 2019) indicate that the impact on flood plain storage is less than previously calculated, however, this has been done on the basis of a volumetric calculation using a flood level derived from previous work and topographic LIDAR data available from 2002. LIDAR data is also available from 2008 and shows ground levels to be significantly lower than the 2002 levels (Figure 4), presumably as a result of soil removal and other activities.

Figure 4 LiDAR data showing elevation in mm. Left 2002, Right 2008.

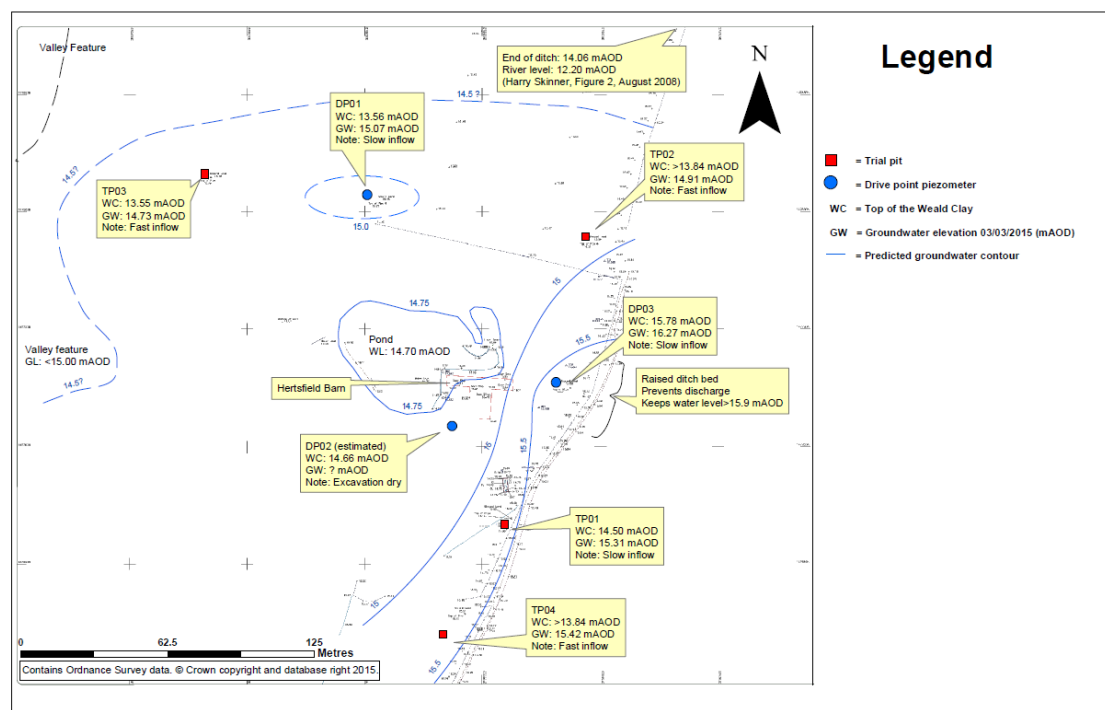
Figure 1 Estimated groundwater contours (from ESI,2015, Figure 8)

Groundwater contours should include the groundwater low around Hertsfield pond and make reference to the earlier trial pit and groundwater data presented in ESI 2015. As Taytime have not collected any data outside the Western Boundary then the information provided within the ESI report should be considered. If this information is disregarded, then the applicant should state the reasons for this and provide an alternative explanation for the high groundwater and flooding observed.

The groundwater level labelled on the revised contour plot for BH04 is incorrectly labelled as 15.66mAOD when in fact it should be 15.26mAOD, the level recorded on

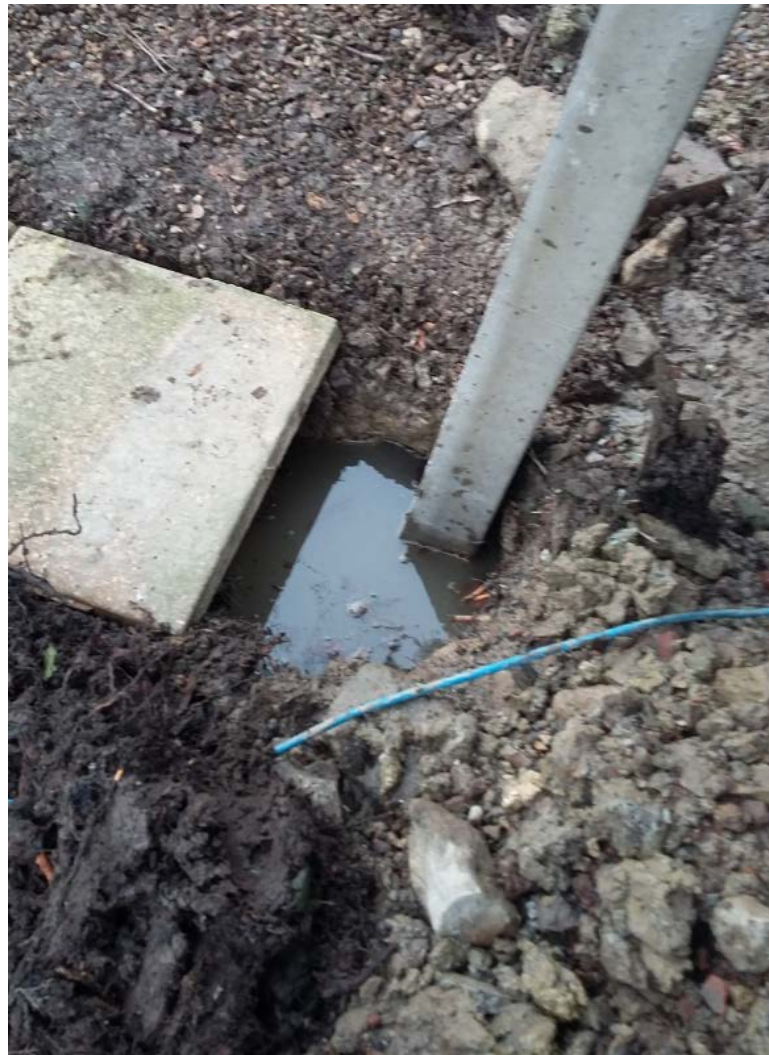
1. Holes filling with water from when the fence along our boundary with 3 Oast, was replaced 18/1/2016. Every hole they dug, from our entrance gate down to the pond, filled up with water.

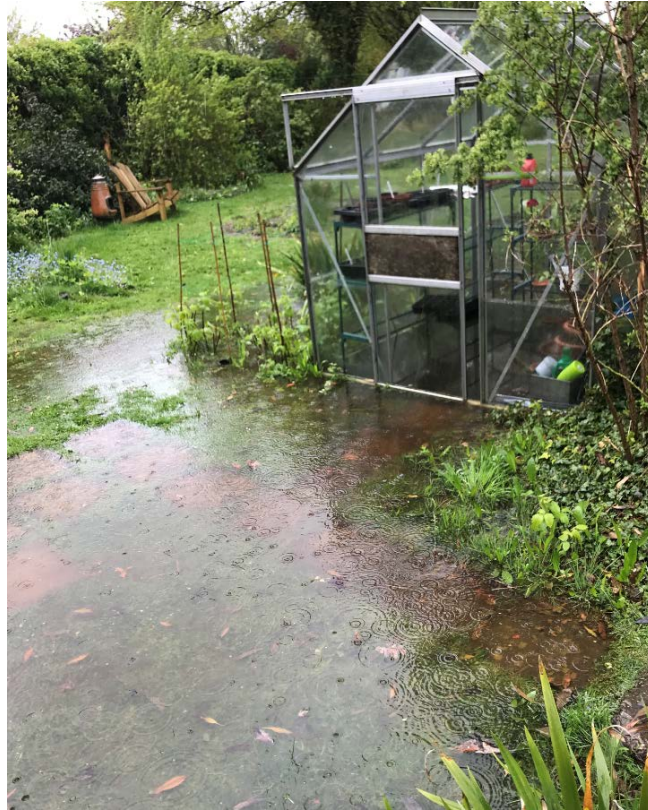
2. Garden of our neighbours at 3 Oast, which is beside the fence that was replaced.
Photo taken May 2018.

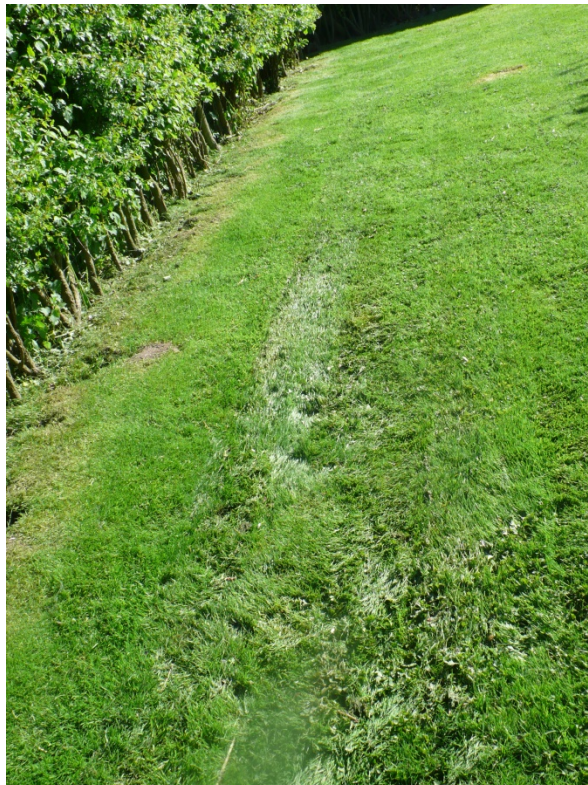
3. Sodden ground in Hertsfield Orchard – May 2018.

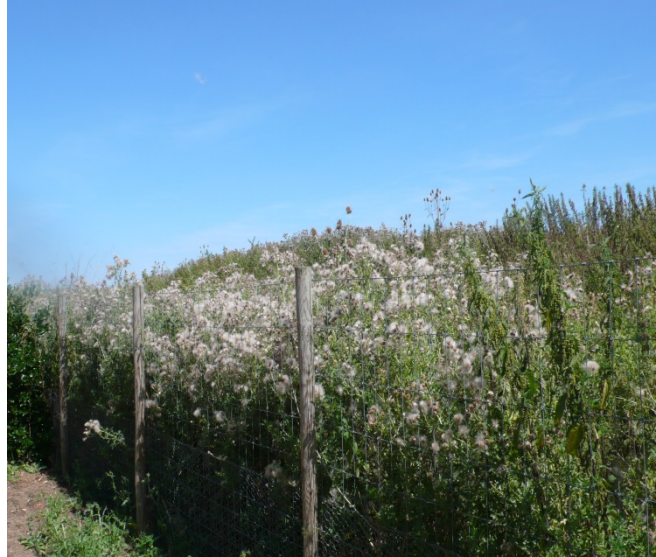
4. Despite “vegetation” that they say will help with any groundwater issues – we certainly have “vegetation” in the ditches – never been cleared since the day they were badly dug – but doesn’t make a difference.

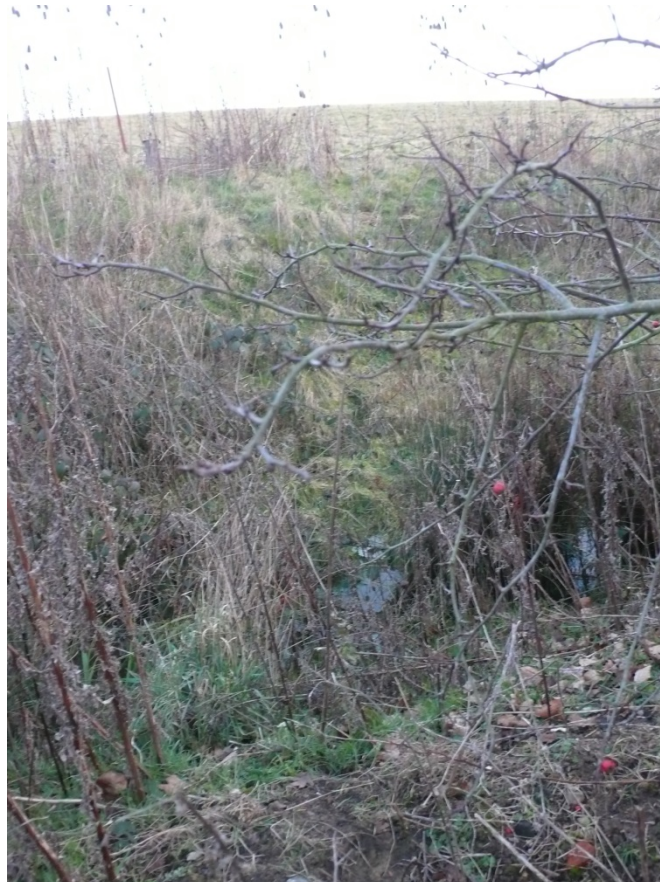
5. After rain, the water in the ditch sits – it doesn’t drain away immediately, it doesn’t run down the ditch channel - it sits in the ditch and then drains through the ground.

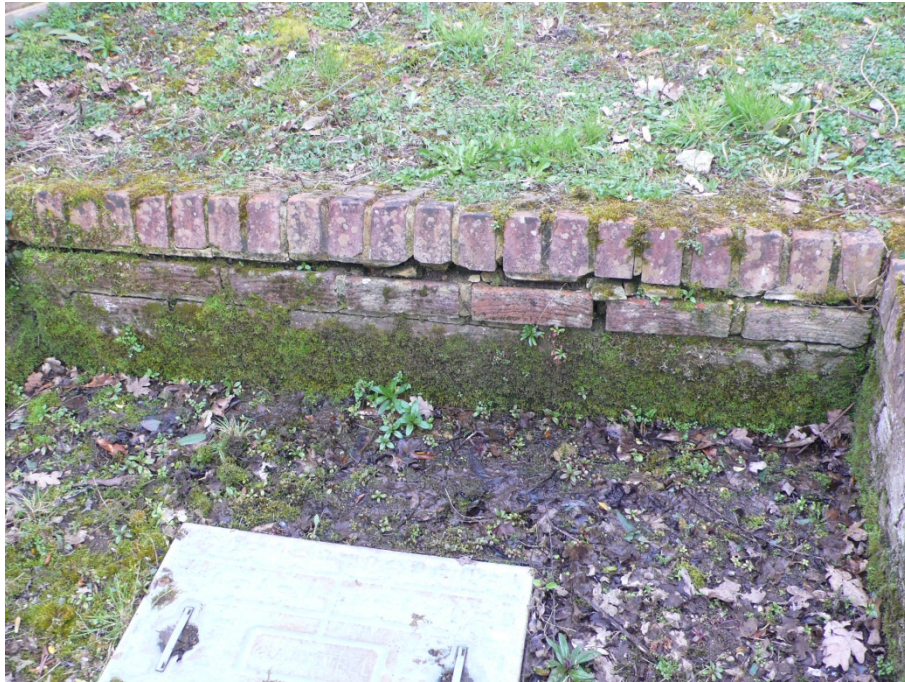
6. Klargester brickwork is constantly damp.

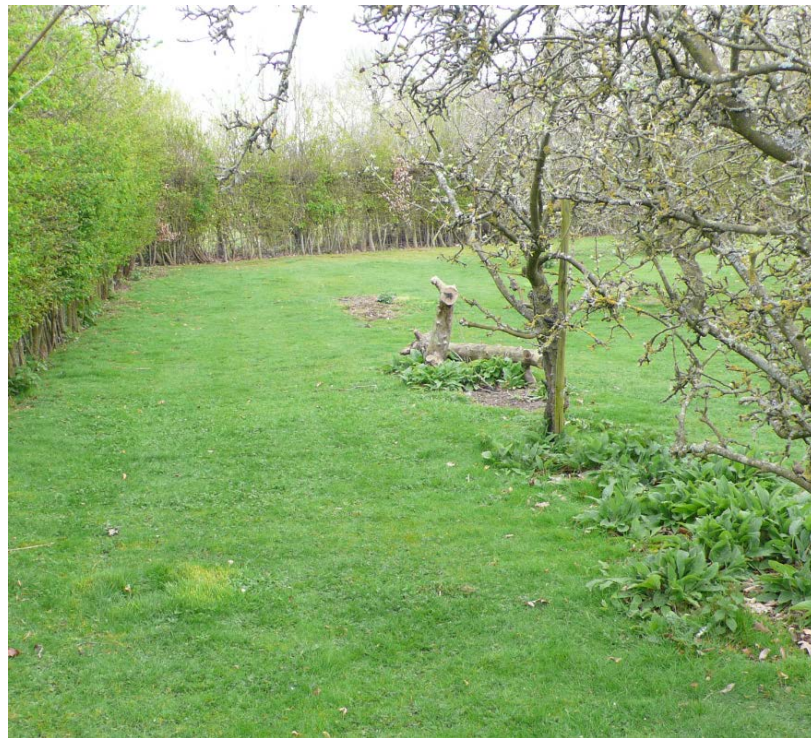
7. Numerous trees have died in the orchard now.

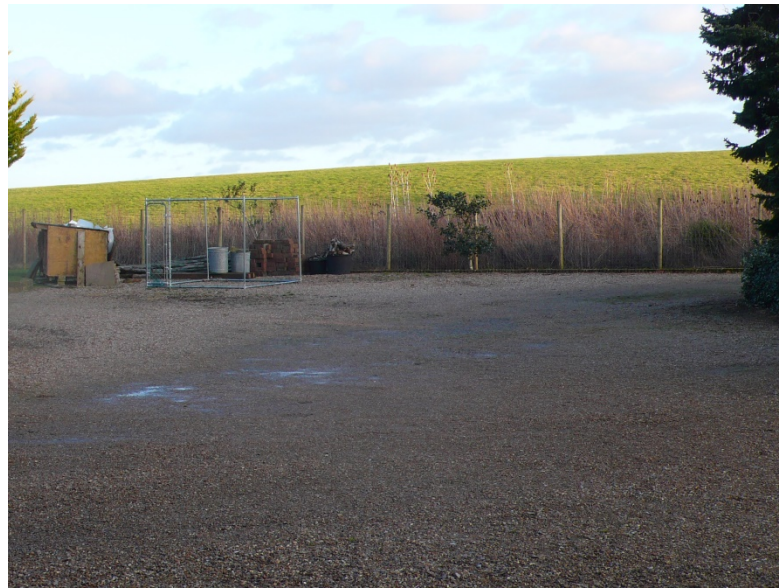
8. Water across our driveway. The area is waterlogged after rain, and runs across the drive into the garage, plus onto the garden at the front and side.

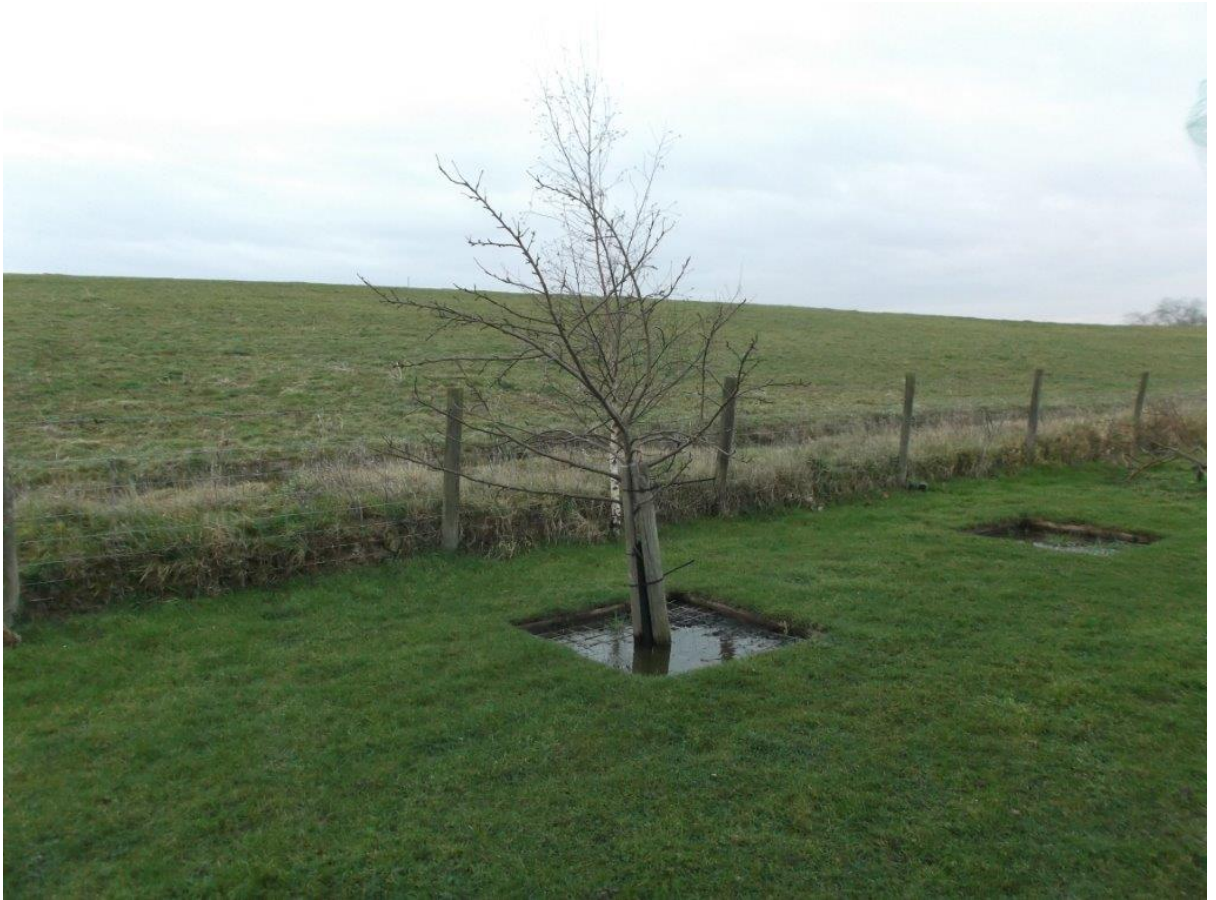
10. 12th February 2016 photograph from Alan Mathie, who is in the cottage next to Leigh Highwood and has lost 3 fruit trees. Shows the western ditch behind the fence.

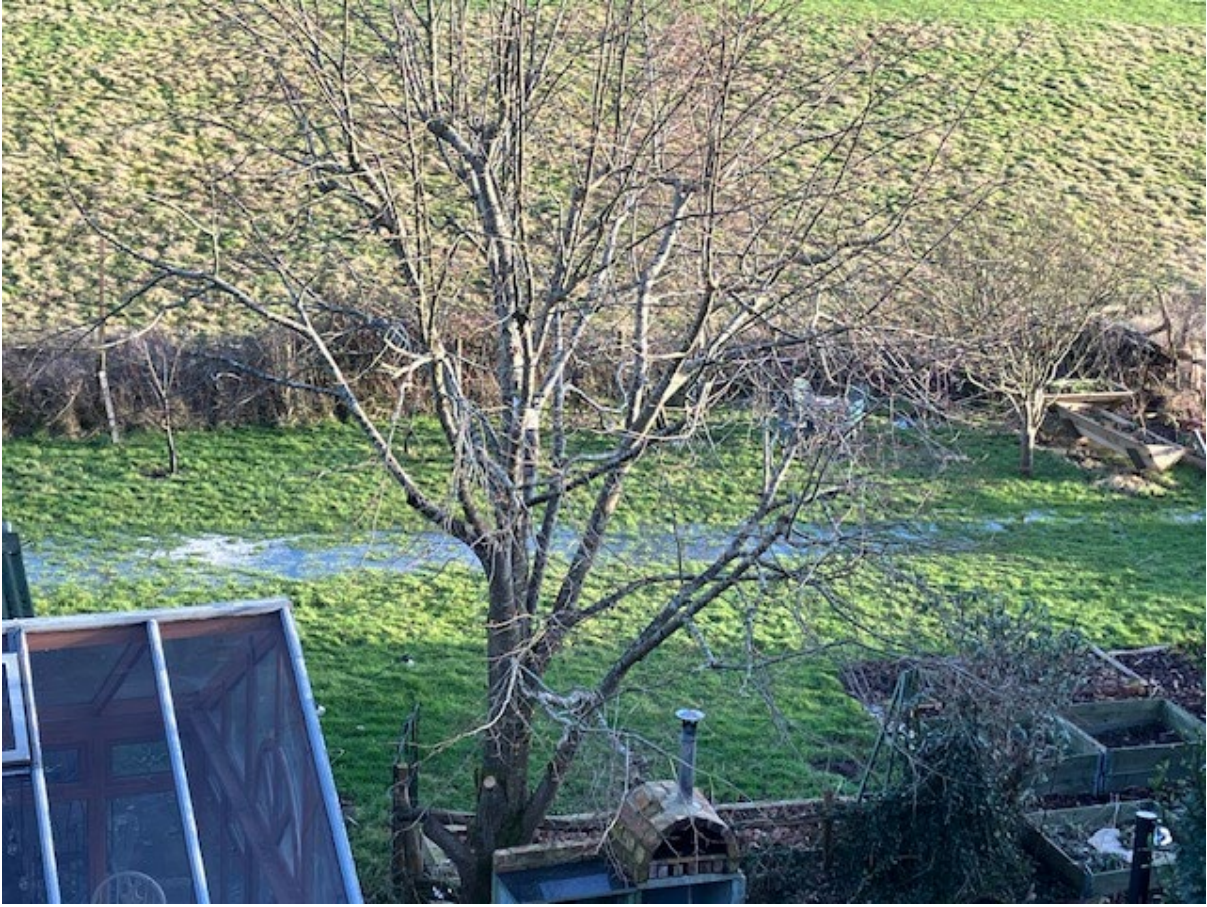
Recent photograph showing flooding from along Western Margin, Hertsfield Cottages

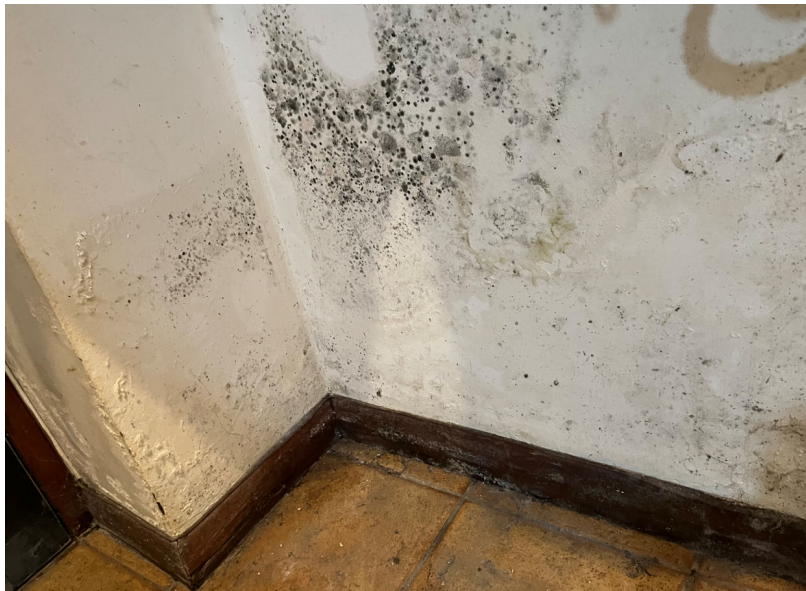
Damp within the property

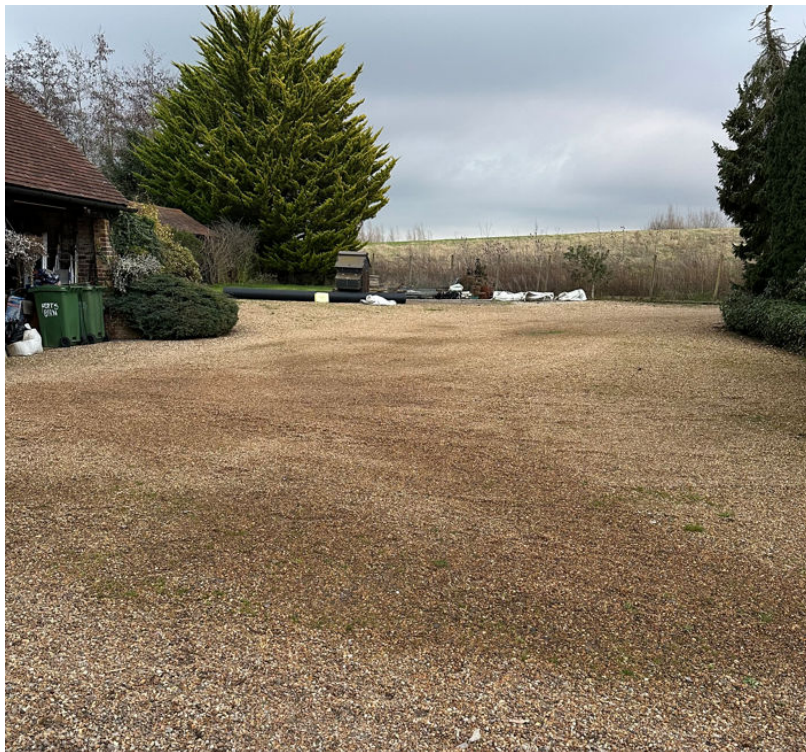
Water tracking across the driveway towards the house

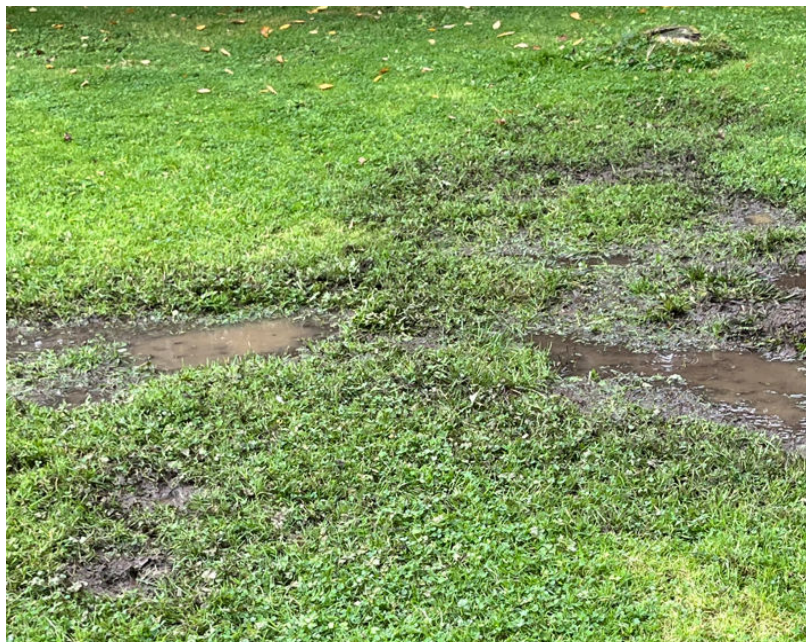
Garden flooded even in dry spells
