Construction Engineer's Report
under the Reservoirs Act 1975

Monk Lake No 2

Staplehurst

August 2024

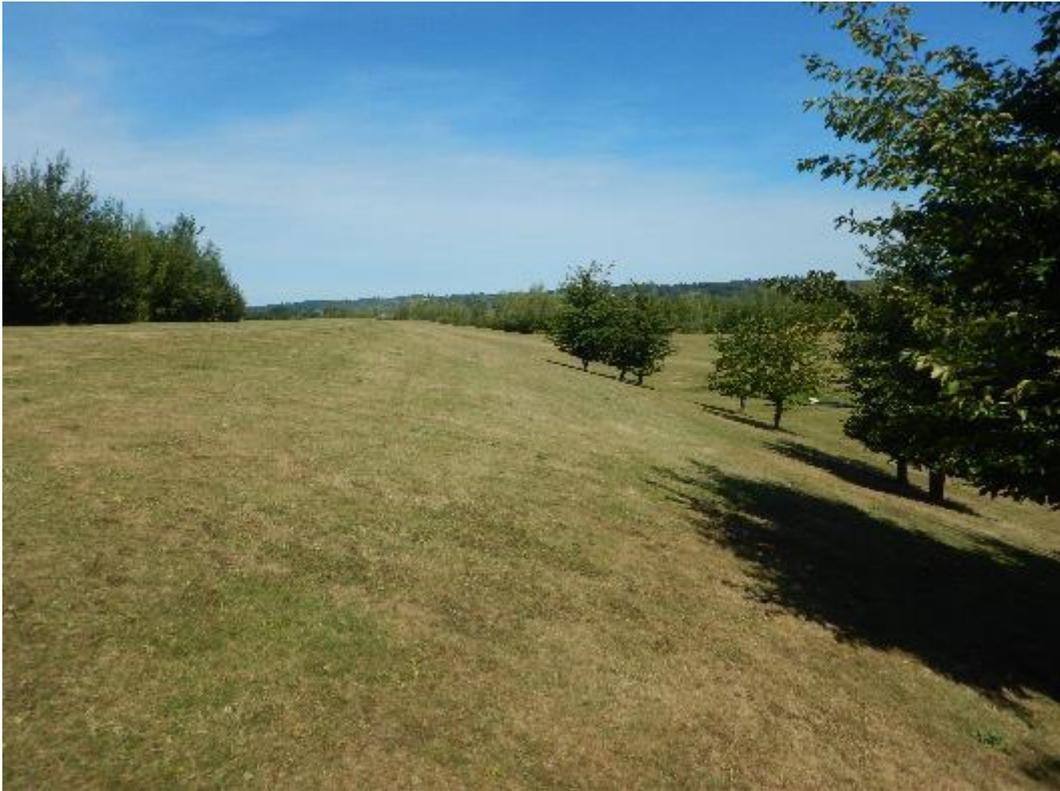
In this section the embankment was about 4 m high. The outer slope was at about 1 in 3.5 and covered with close mown grass. There were a few small to medium sized trees on the slope. The crest width was at least 15 metres and covered with close cut grass and the surface was a little undulating.

Photograph 1 East embankment outer slope

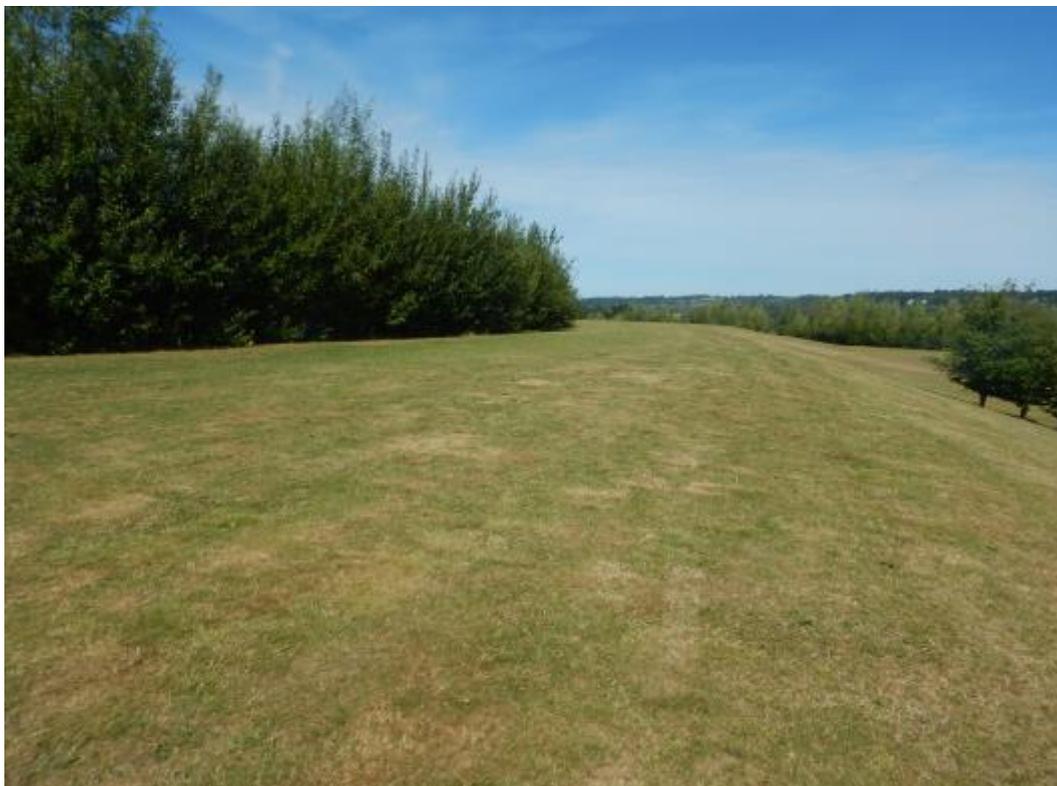
Photograph 2 East embankment crest

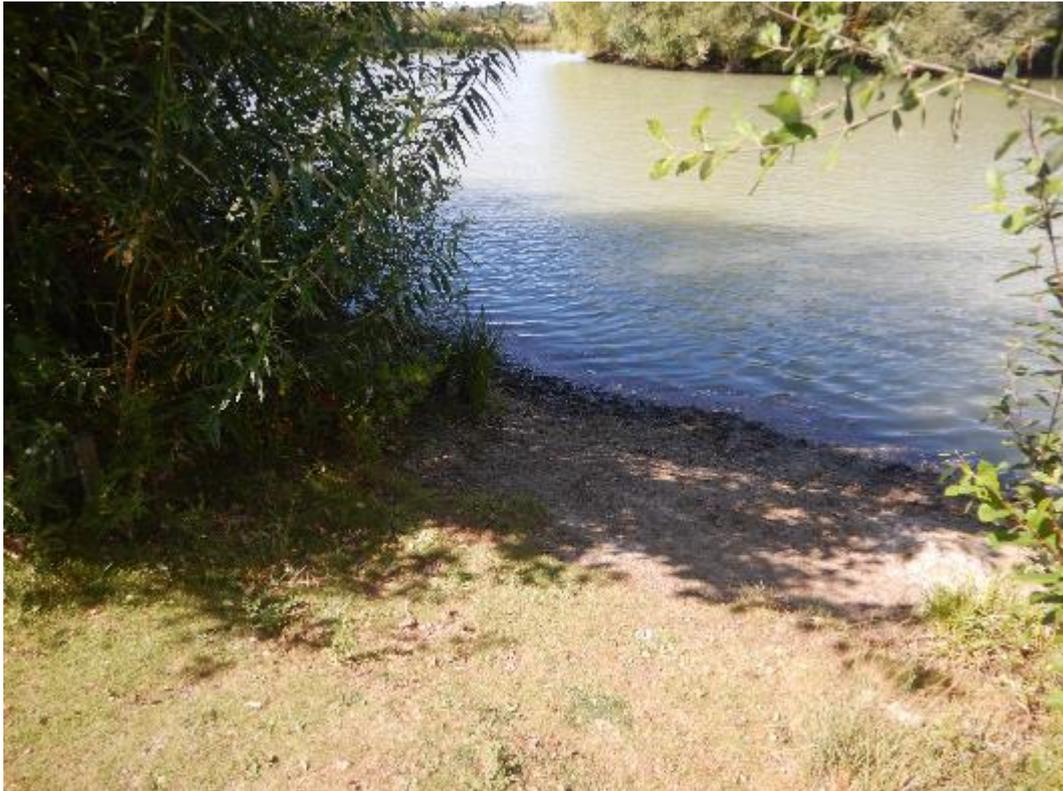
On the inner slope was a dense covering of small willow saplings. On a short section the vegetation had been cut back to provide access for the fishermen. The slope was at about 1 in 4. There was no evidence of wave erosion. The water level at the time was about 800 mm below the crest.

Photograph 3 East embankment inner slope

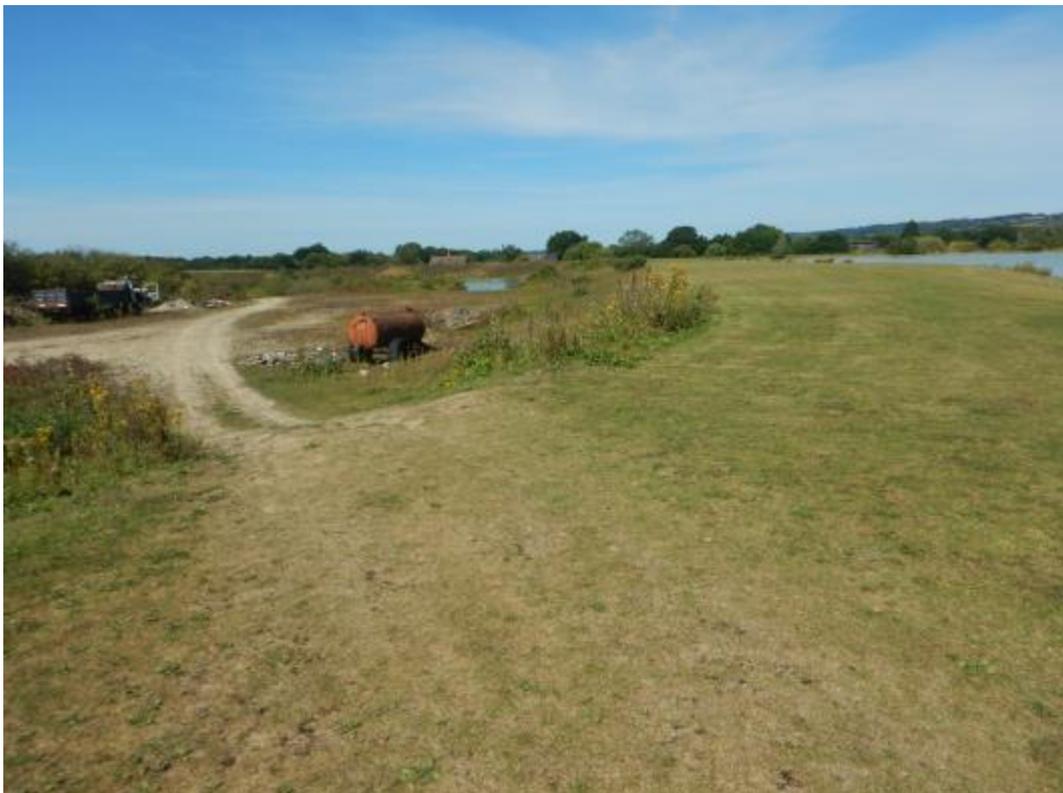
The outer slope was about 3 metres high and had a slope of about 1 in 3.5 and covered with rough grass and various weeds and occasional shrubs. The crest in this area varied between about 12 and 18 metre wide. The inner slope was at 1 in 3 and covered with short grass but along the water line was sedge and some small willows. There was no evidence of wave erosion.

Photograph 4 South embankment outer slope

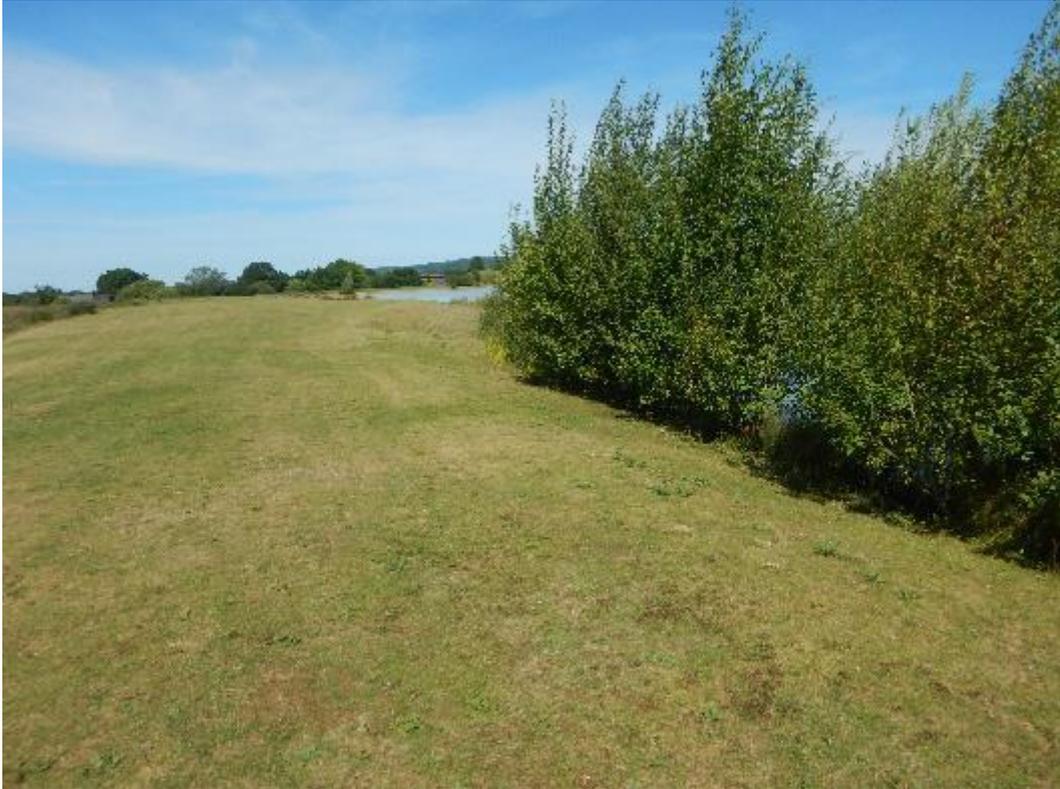
Photograph 5 South embankment crest and inner slope

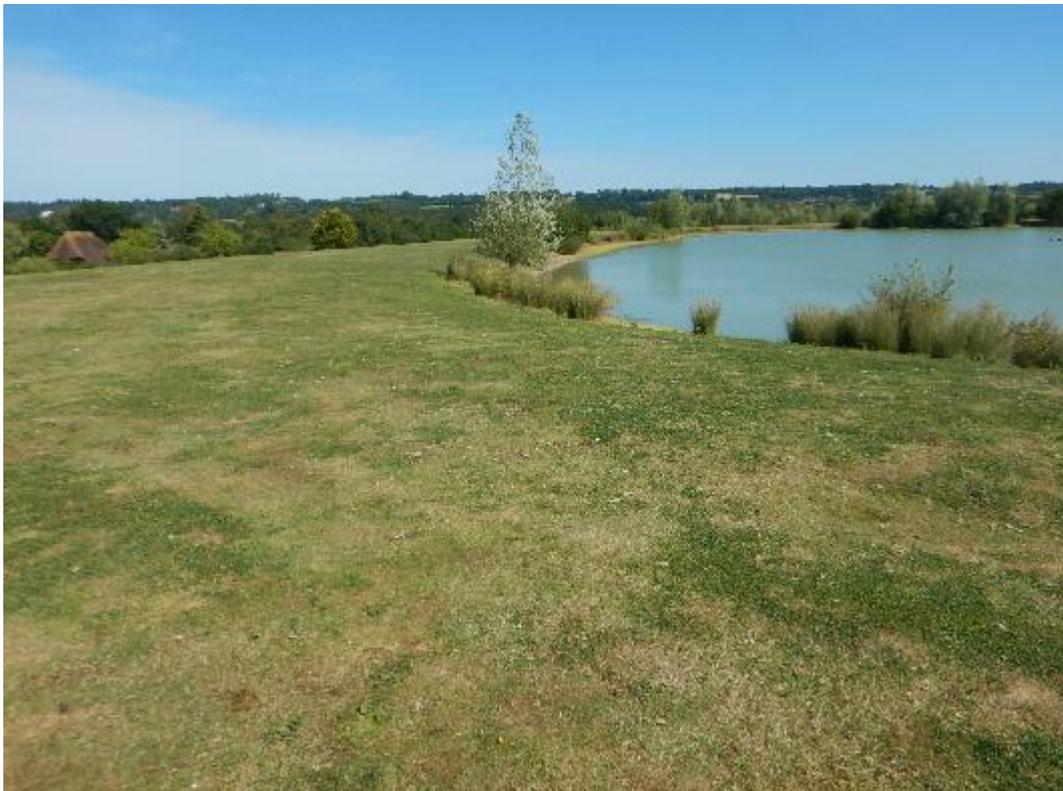
Photograph 6 West embankment crest and inner slope

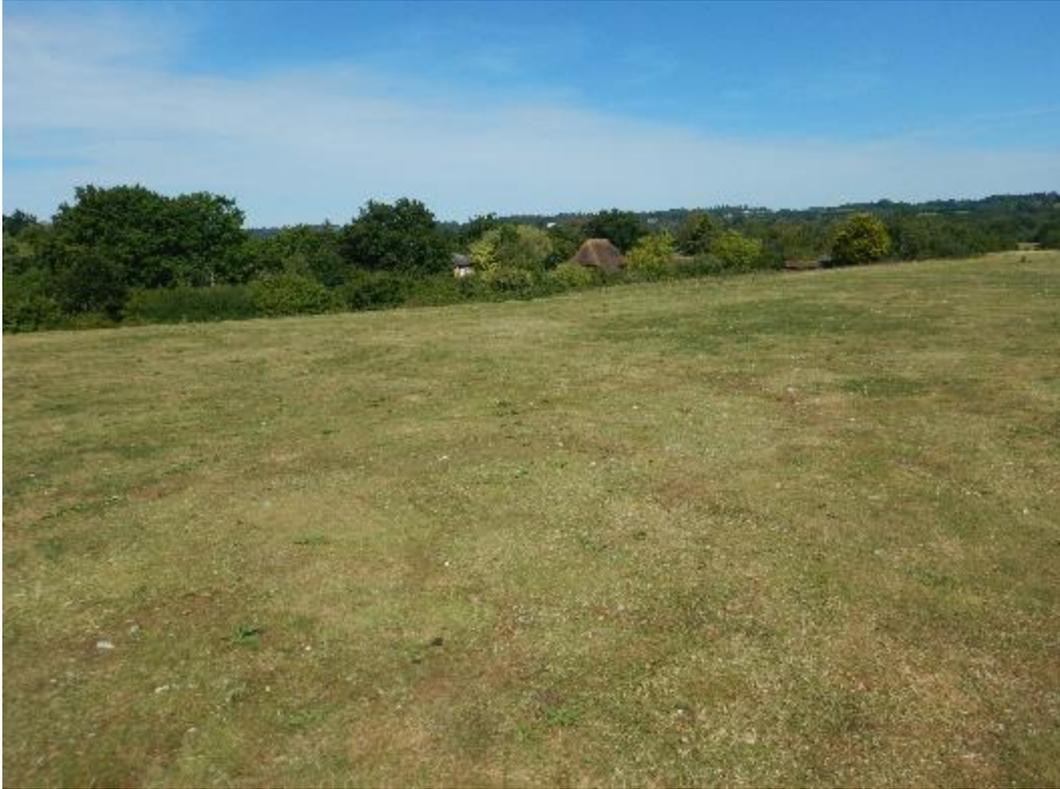
On the west embankment the outer slope was very shallow at about 1 in 6 or flatter. The upper part was covered with short mown grass and in the lower part rather tufted grass with thistles. Below the slope is Hertfield Farm and adjacent properties. The overall height of the slope here was estimated to be about 4 metres.

Photograph 7 West embankment outer slope

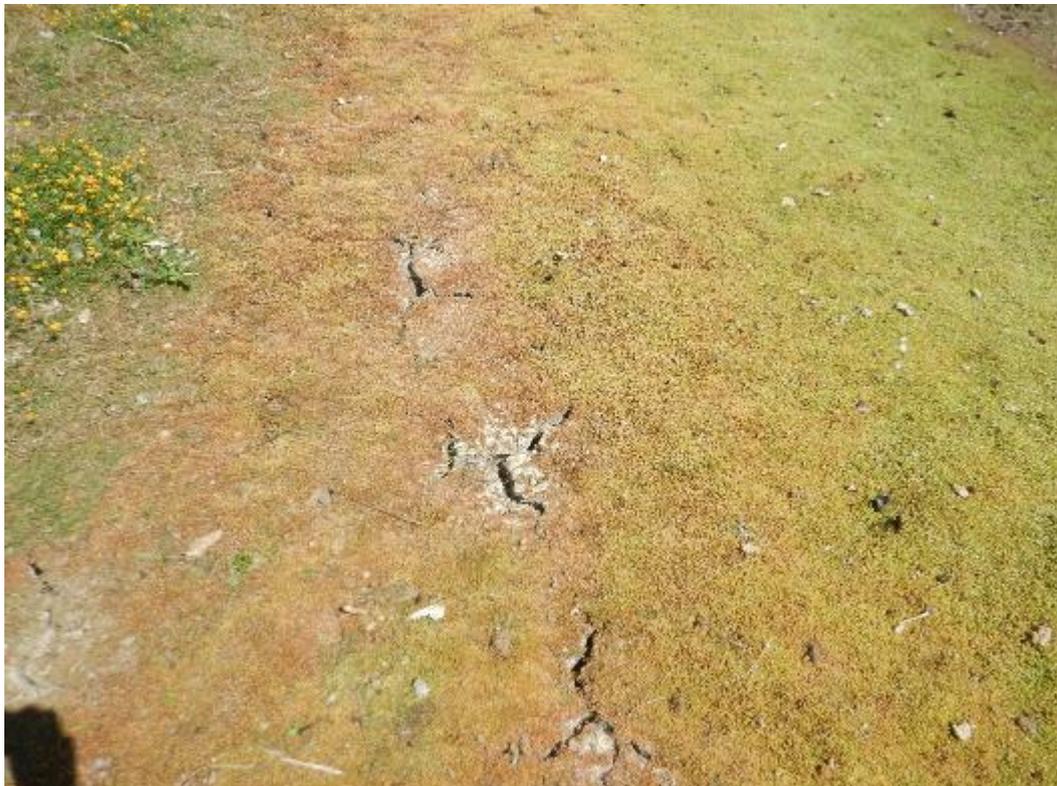
There was no evidence of movement in the slopes. Some desiccation cracking was apparent. The surface was undulating so it was not possible to assess if there had been localised settlements **Error! Reference source not found.**

Photograph 8 Desiccation cracking in clay

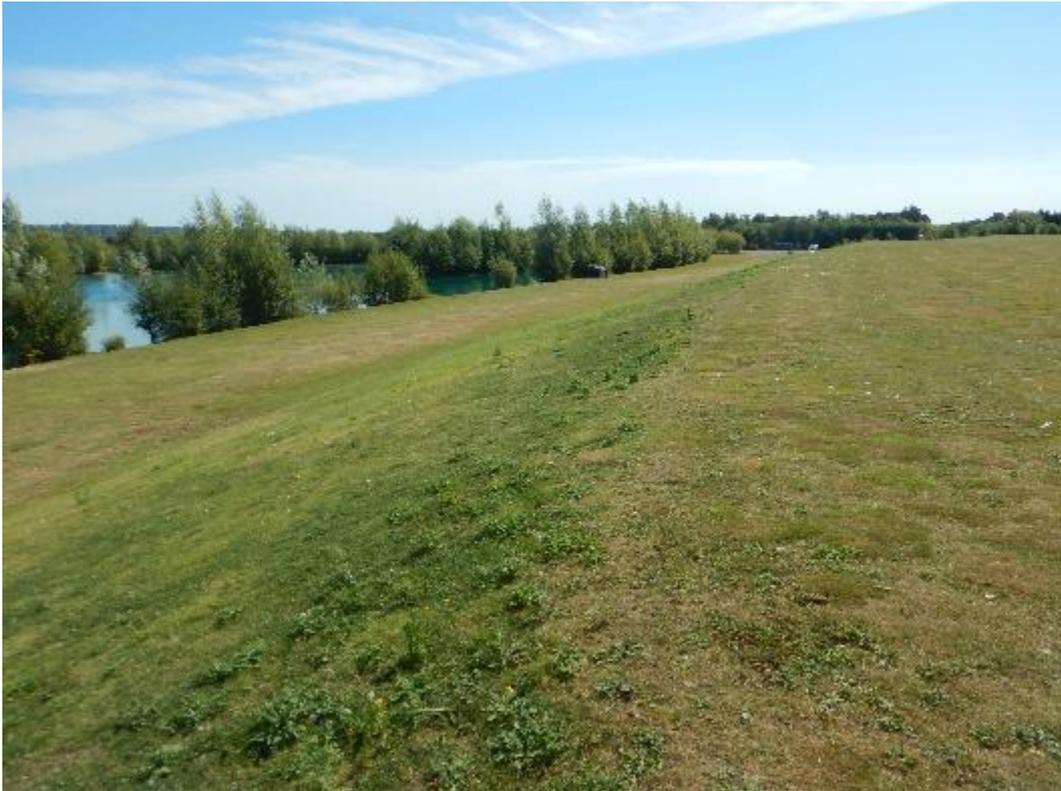
The outer slope of the embankment was about 3 to 4 metres high and a slope of 1 in 3.5 and covered with short cut grass and occasional weeds. The crest was very wide here being in excess of 20 metres. The inner slope was at about 1 in 4 to 1 in 5 and covered with tree saplings to about 3 or 4 metres high. There were occasional breaks in the tree cover. There was no evidence of wave erosion.

Photograph 9 North embankment outer slope

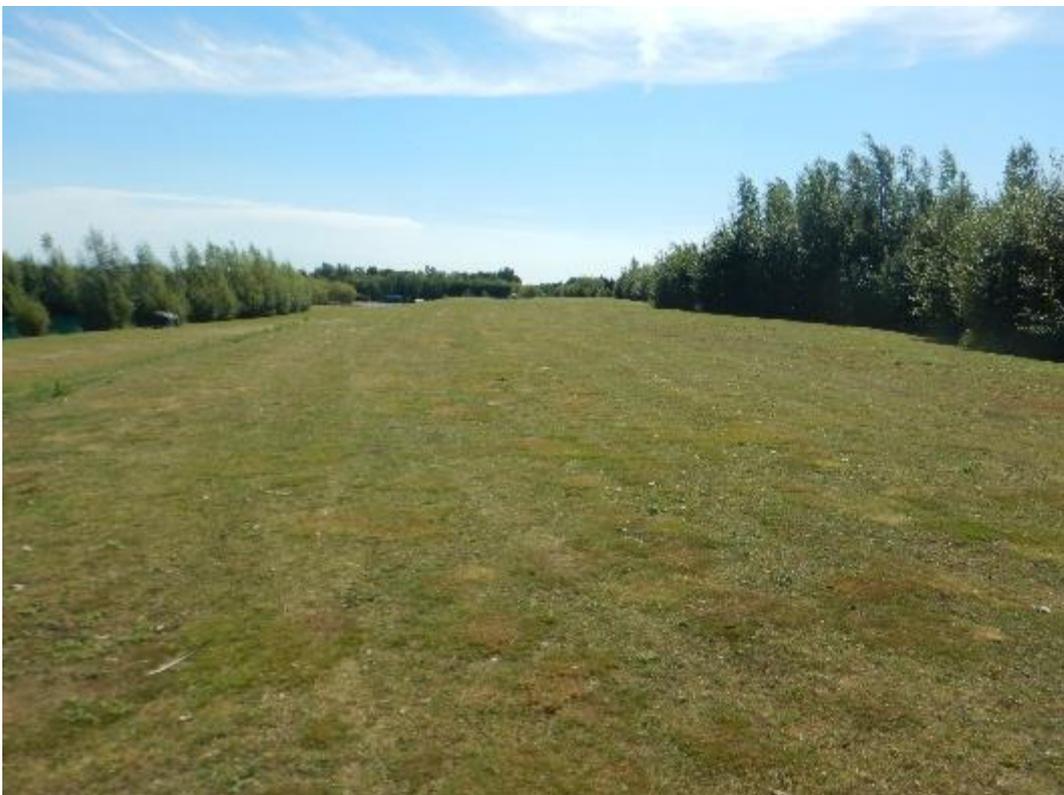
Photograph 10 North embankment crest

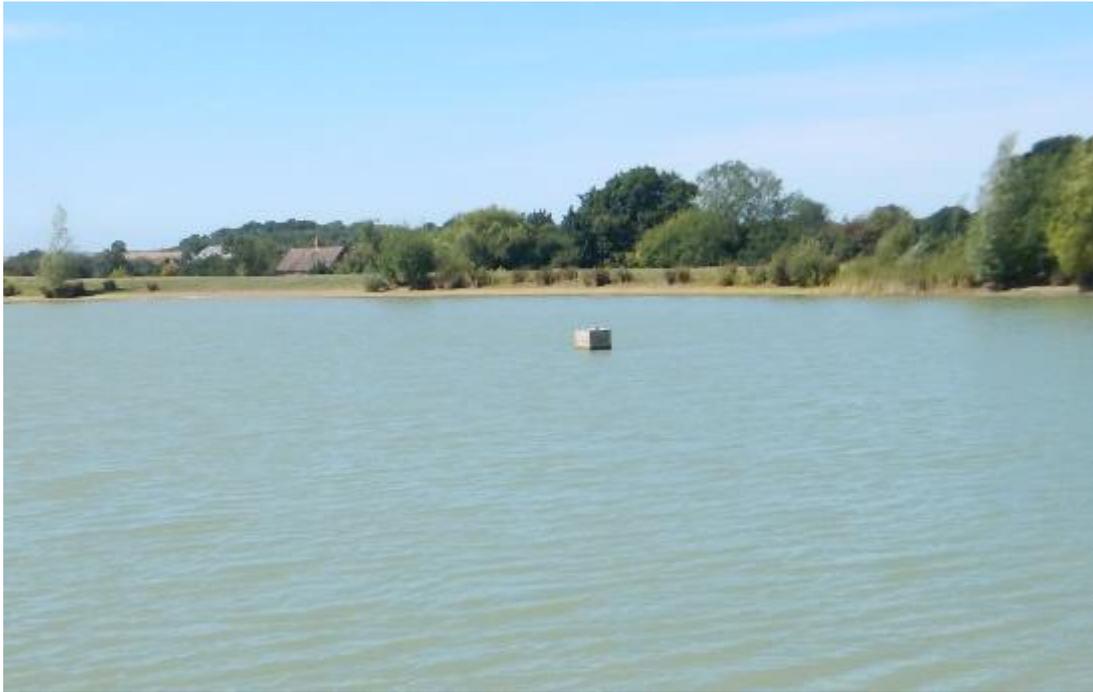
There are no drawing showing details of the overflow. From my site inspection there appears to be 100 mm plastic pipe within a concrete support. The overflow discharges probably into Lake No 3.

Photograph 11 Overflow viewed from embankment

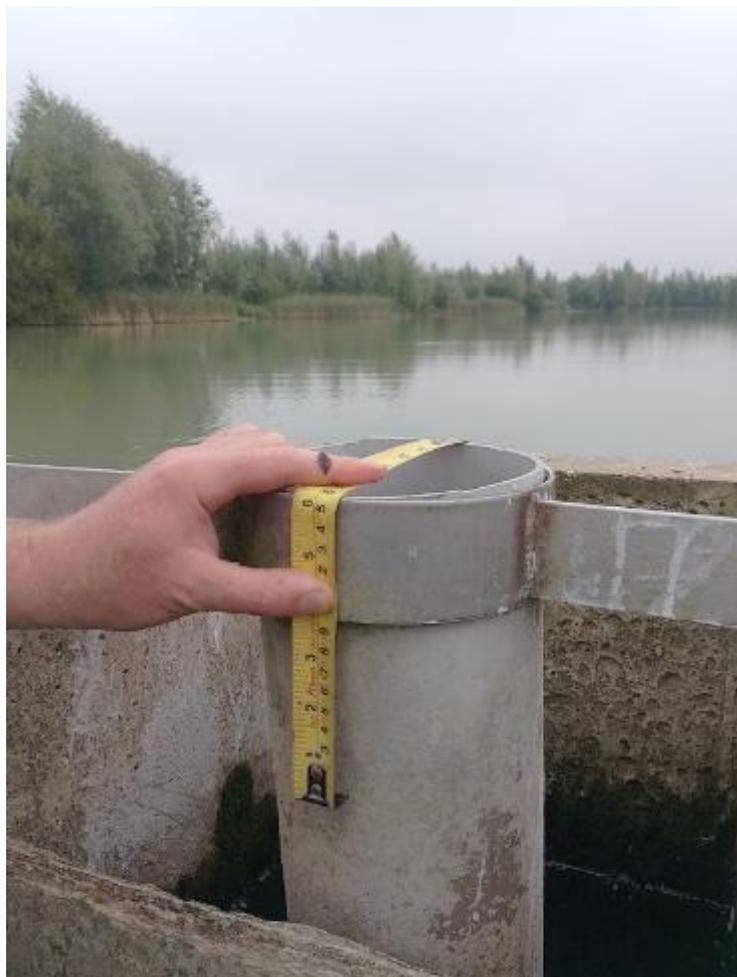
The latest survey information (JC White Surveys) indicates a minimum crest level on the east embankment of 21.91 m. The design crest level was supposed to be 22.0 m OD. A Preliminary Certificate has been given with a top water level of 21.6 m OD. The freeboard is less than proposed in the design and is 310 mm. Another issue is that the overflow pipe, although it has

been reduced by 150 mm, it has an estimated elevation of 21.77 m OD which gives a freeboard of only 140 mm.

Photograph 12 Measuring overflow pipe before cutting 150 mm

In this email he recommended that the overflow pipe be reduced by 150 mm.

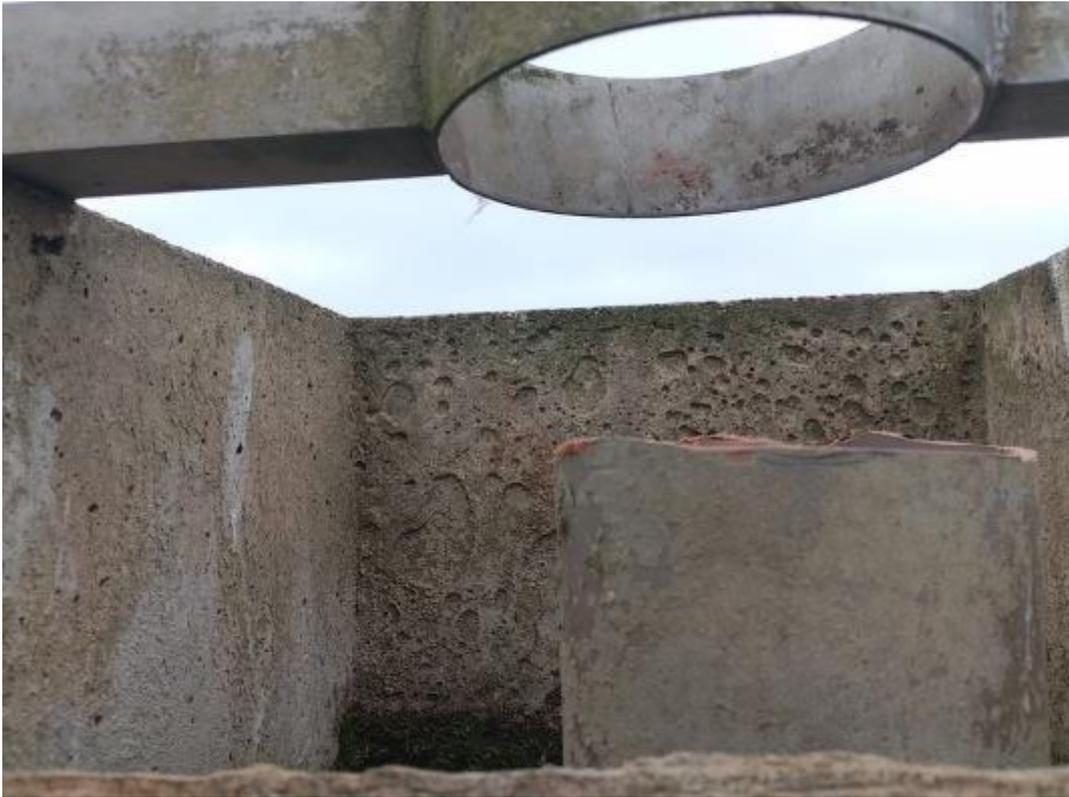
Photograph 13 Overflow pipe after cutting

As part of the conditions on issuing the Preliminary Certificate it was required that a survey was carried out. This was undertaken by JC White Geomatics and from the survey it was found that there was insufficient freeboard. It was recommended that the overflow was lowered by 150 mm. This was completed in August 2024.
