Monk Lake No 2

RESERVOIRS ACT 1975

CERTIFICATE OF EFFICIENT EXECUTION OF WORKS UNDER SECTION 7(6)

Report on the Inspection of Monk Lakes (Lake 2) Reservoir Under the Reservoirs Act 1975

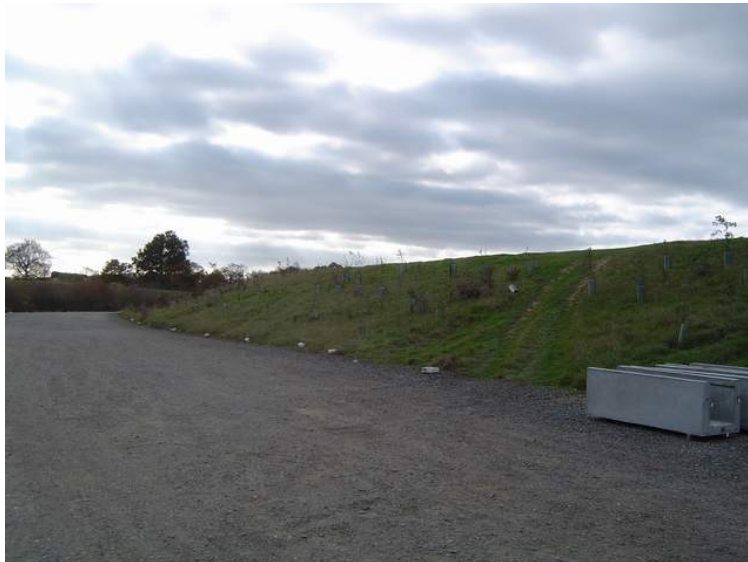
Eastern corner at the parking area looking south-westwards

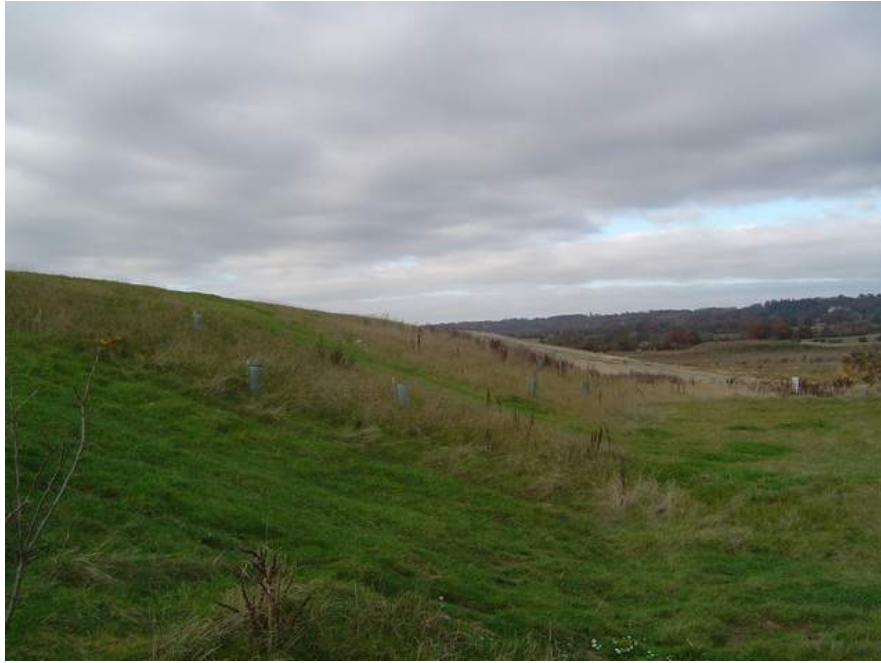
Eastern corner from the parking area looking north-westwards

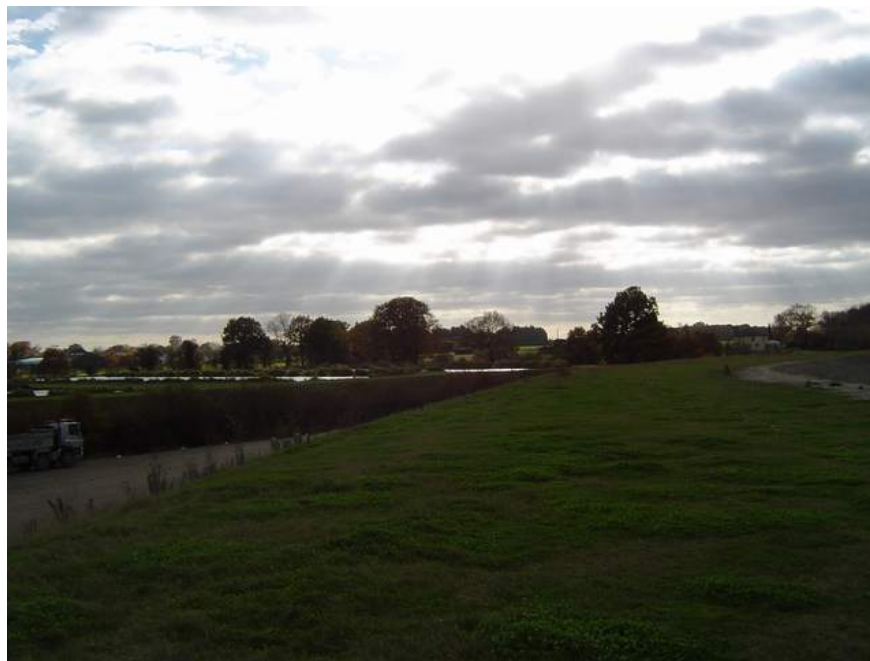
The crest is in good condition and is generally level, as seen in the two photographs below.

Crest near eastern corner looking south-westwards

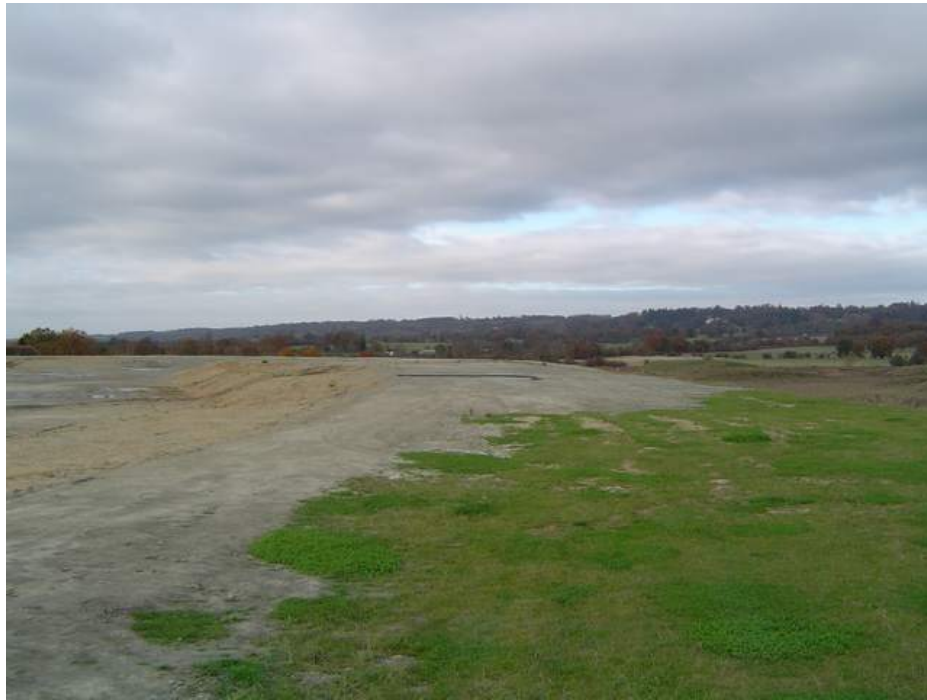
Crest near eastern corner looking north-westwards

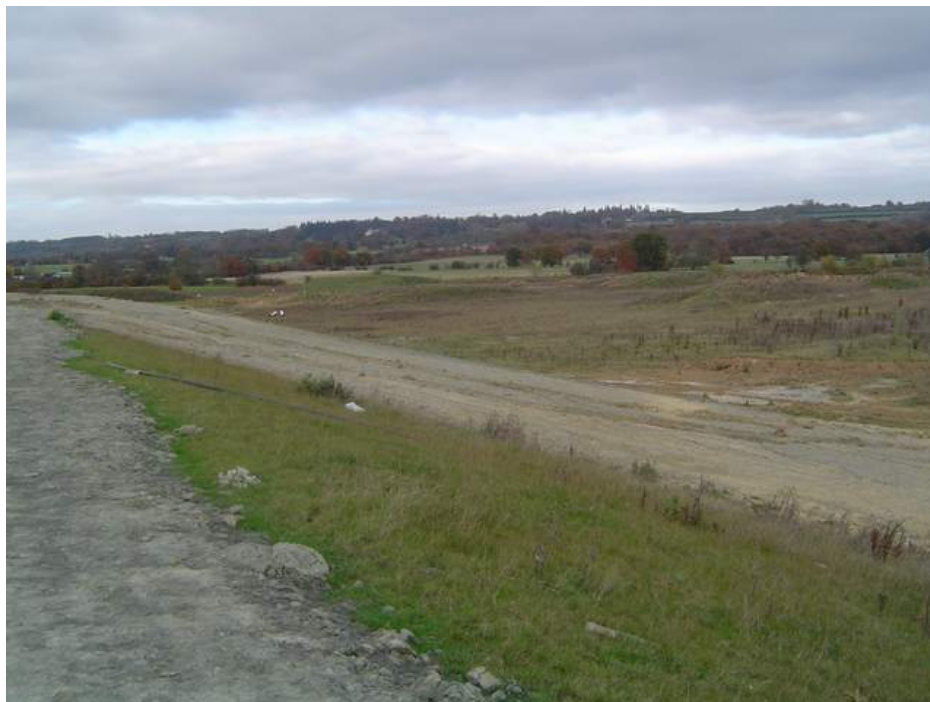
There is an access ramp to the crest approximately 100 m from the eastern corner, as shown below. It is assumed that this ramp will be retained when the three lakes are completed.

Access ramp

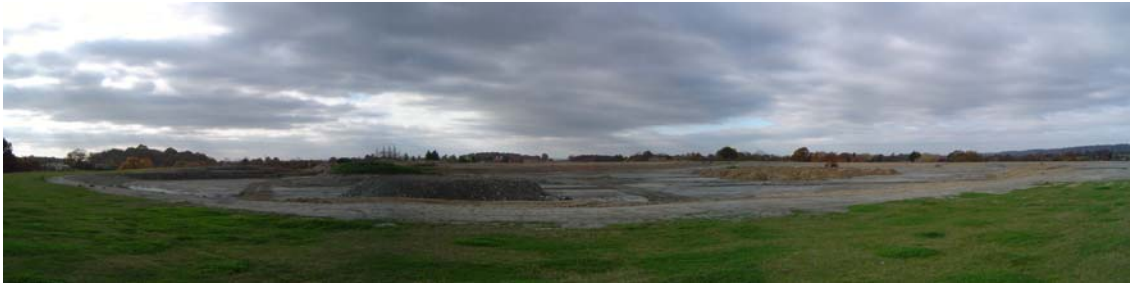
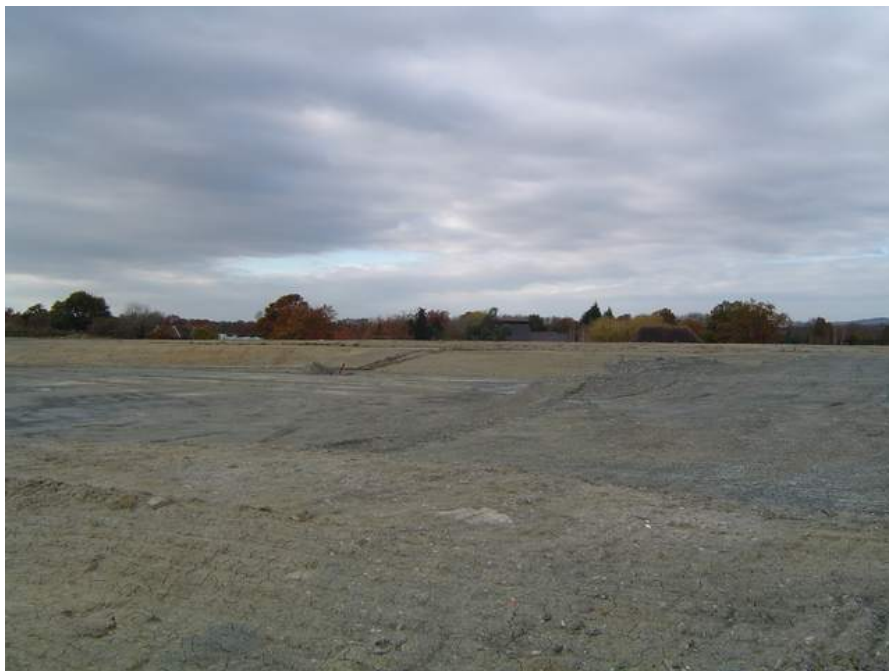
The reservoir basin has been largely completed as shown in the panorama below. Note the islands and the generally flat base of the reservoir.

Reservoir basin

In the above photo it should be noted that the clay on the floor of the basin is a little desiccated, due to a period of dry weather, and there is an outlet pipe visible in the centre of the photo. Nearby houses are also visible.

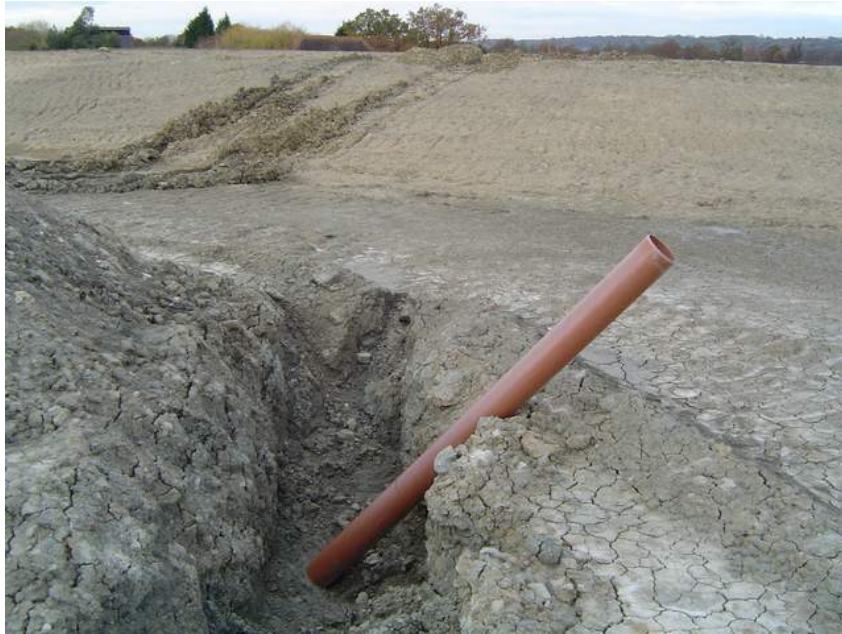
Close-up of outlet pipe

It is proposed that the water level is controlled by an outlet pipe shown above. Care will be needed to prevent blockage of the pipe, especially as reeds will be encouraged within parts of the reservoir. It is unclear why the pipe is at an angle, or where it exits. It is recommended that when the embankment is raised a short section, about 5 m wide, should be left 200 mm below the crest elevation to permit water to flow from Lake 1 → Lake 2 → Lake 3 in the event of overpumping and blockage of the outlet. Water would eventually be discharged from Lake 3 safely towards the River Beult.

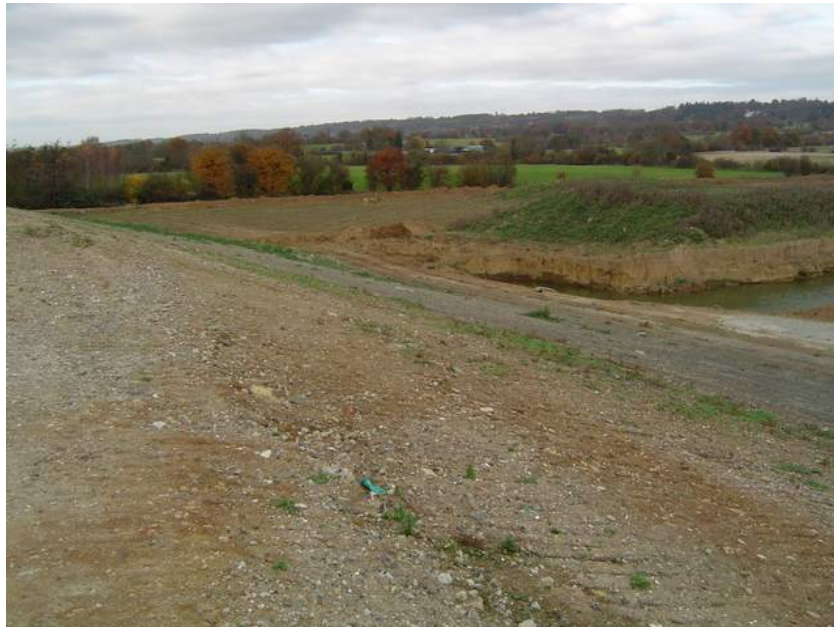
The external slope near the northern corner was noted to be in good condition, as shown below. It will eventually form the embankment between Lakes 2 and 3.

External slope at northern corner from embankment crest

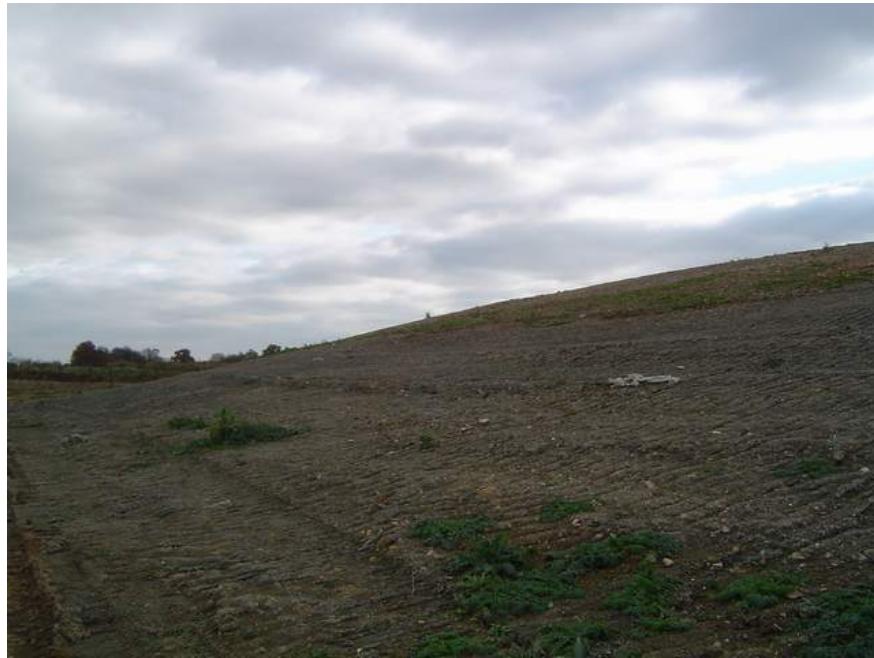
External slope at northern corner from embankment toe

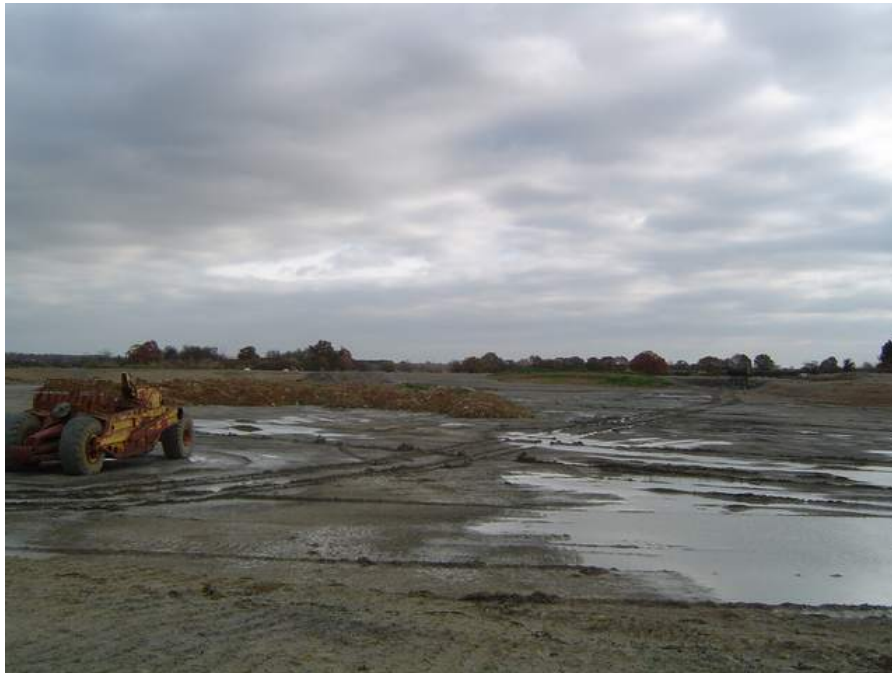
There was a small amount of water in this proposed wetland area, in a low spot, at the time of the inspection, as seen in the photo below.

Internal floor of reservoir basin in the wetland area

The above photo also shows earthfill material within the basin which will be reprofiled to form an island.

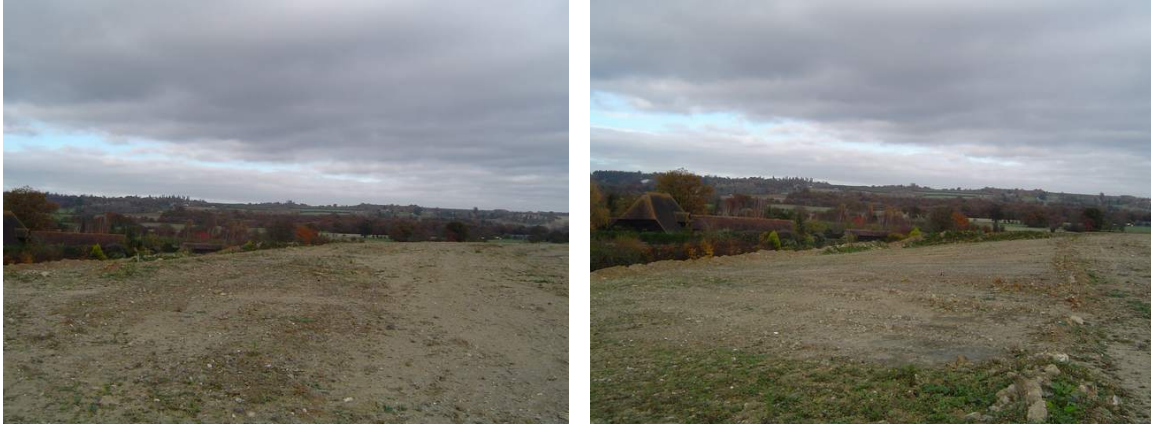
The external slope on the north-western side is close to existing housing and has been placed at a shallow slope, 1V:8H, to improve visual impact. Both the slope and crest have yet to be completed or vegetated, see photos below.

North-western slope and crest. Note houses close by

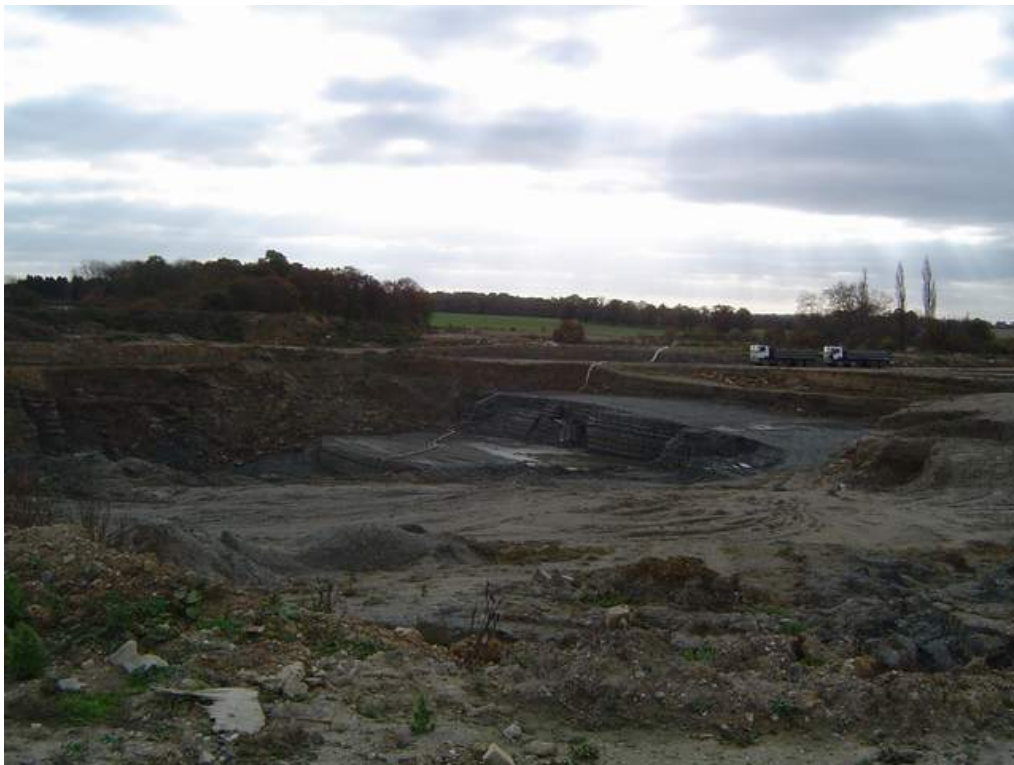
Clay material is currently being excavated from an area to the south-west of the proposed Lake 2, as noted below.

Clay quarry

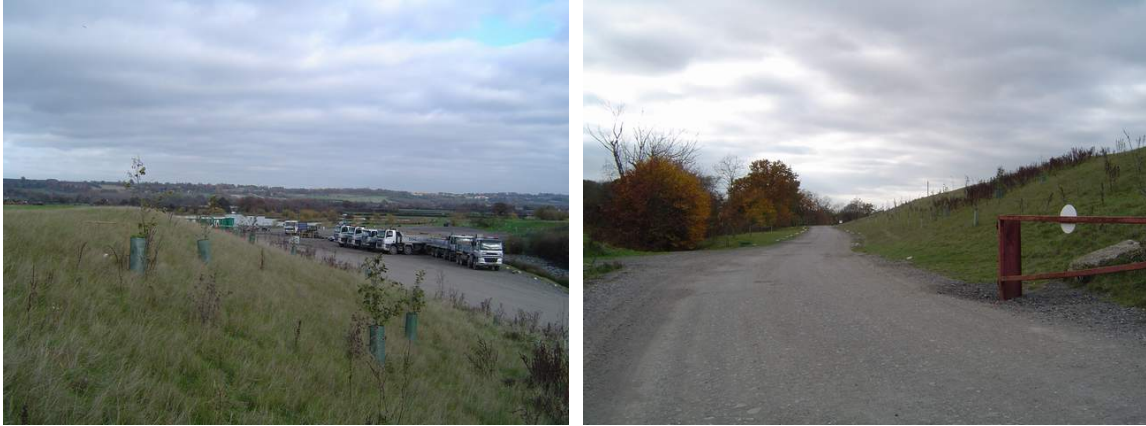
The south-eastern embankment is in good condition and has been planted to soften its visual appearance from the A229 and access track. The tree planting is approved due to the size of the embankment at this point.

South-east embankment alongside access track

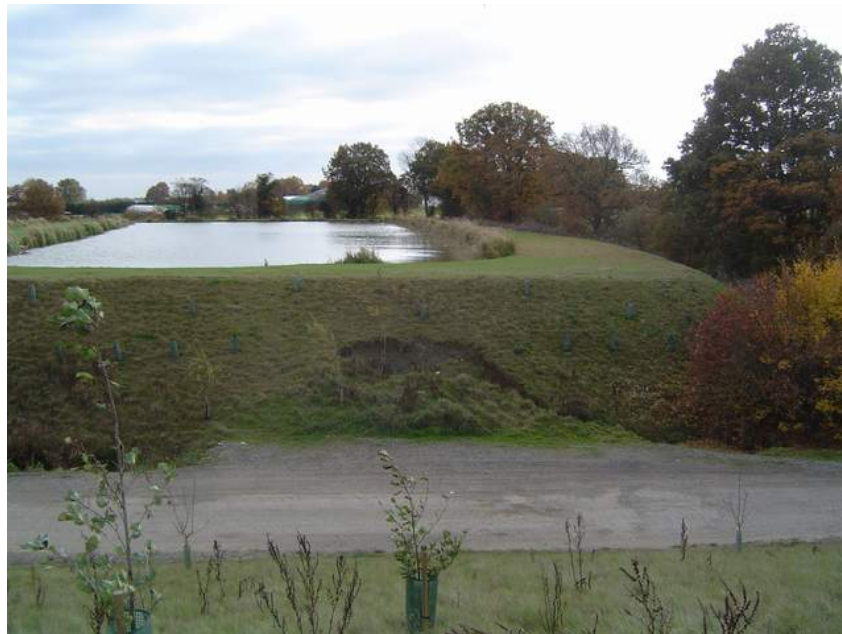
Slope failure has clearly occurred and has been exacerbated by a blocked/broken outlet pipe. This illustrates the dangers of oversteepened side-slopes when Weald Clay is used as a construction material, see photo below:

Slope failure on nearby reservoir embankment

Although not part of this report it is recommended that the pipe is repaired and the slope is repaired and flattened, possibly by a buttress.

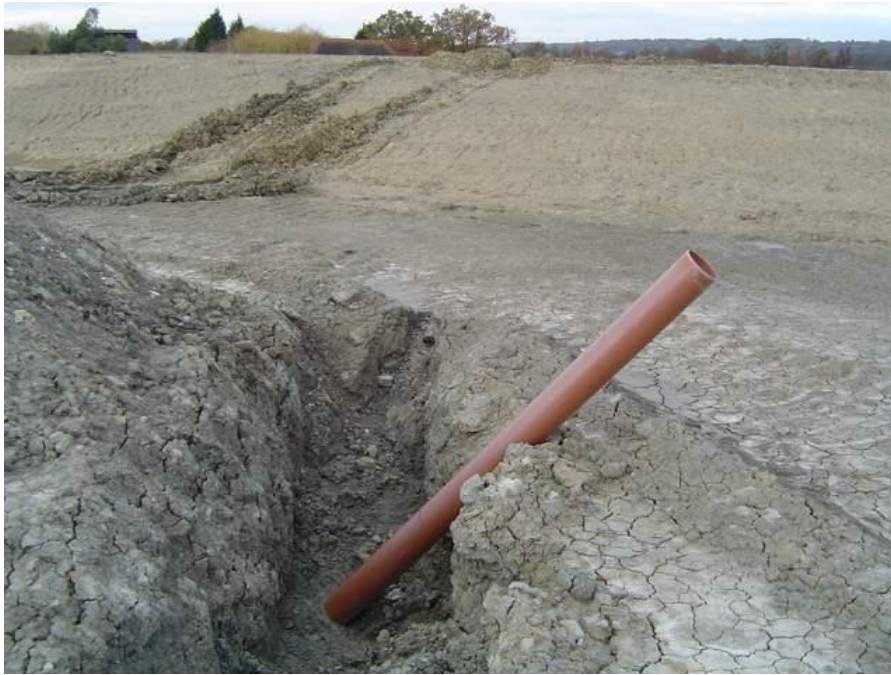
Close-up of outlet pipe

It is proposed that the water level is controlled by an outlet pipe shown above. Care will be needed to prevent blockage of the pipe, especially as reeds will be encouraged within parts of the reservoir. It is unclear why the pipe is at an angle, or where it exits. It is recommended that when the embankment is raised a short section, about 5 m wide, should be left 200 mm below the crest elevation to permit water to flow from Lake 1 → Lake 2 → Lake 3 in the event of overpumping and blockage of the outlet. Water would eventually be discharged from Lake 3 safely towards the River Beult.

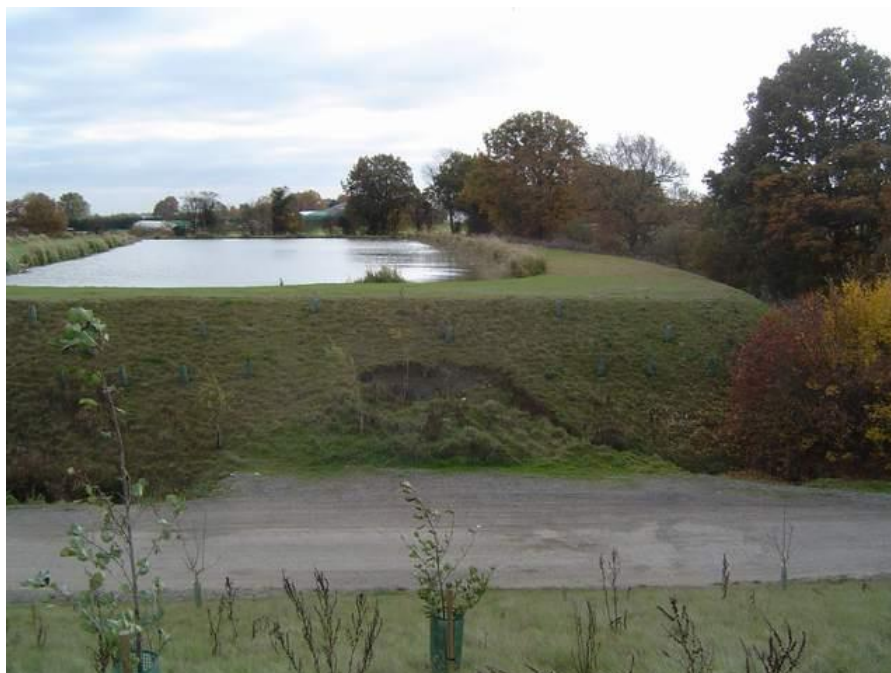
Slope failure has clearly occurred and has been exacerbated by a blocked/broken outlet pipe. This illustrates the dangers of oversteepened side-slopes when Weald Clay is used as a construction material, see photo below:

Slope failure on nearby reservoir embankment

Although not part of this report it is recommended that the pipe is repaired and the slope is repaired and flattened, possibly by a buttress.

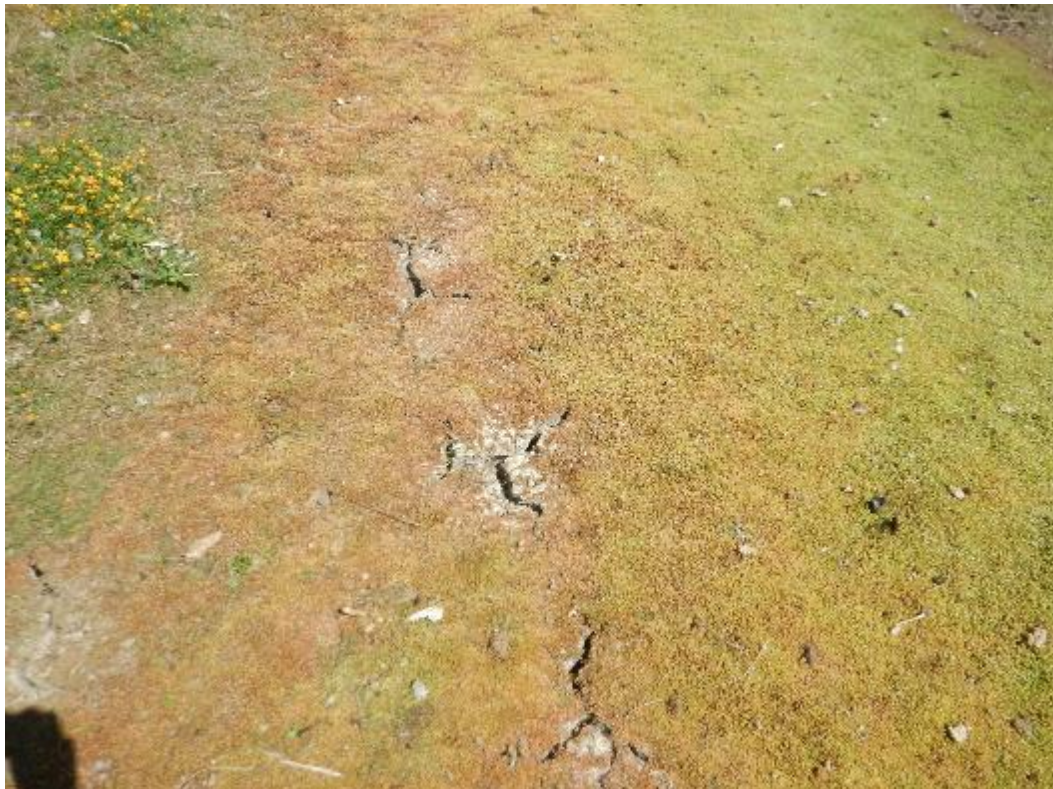
There was no evidence of movement in the slopes. Some desiccation cracking was apparent. The surface was undulating so it was not possible to assess if there had been localised settlements **Error! Reference source not found.**

Photograph 8 Desiccation cracking in clay

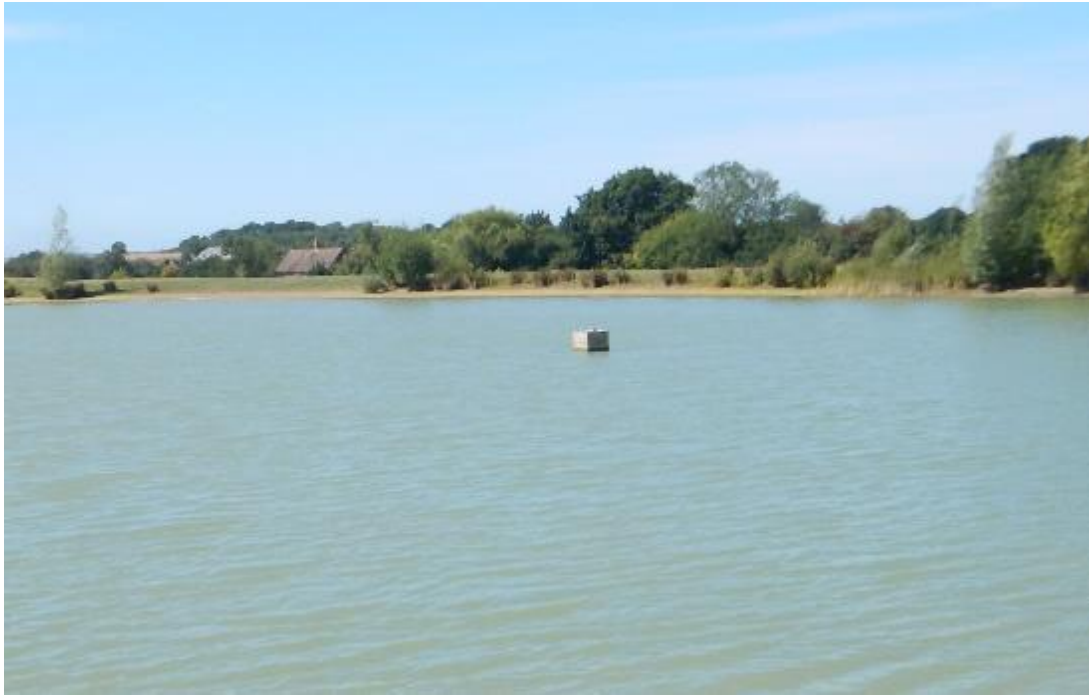
The condition of the overflow was assessed by viewing from the closest embankment and from close up photographs taken the previous week during lowering of the overflow pipe.

Photograph 11 Overflow viewed from embankment

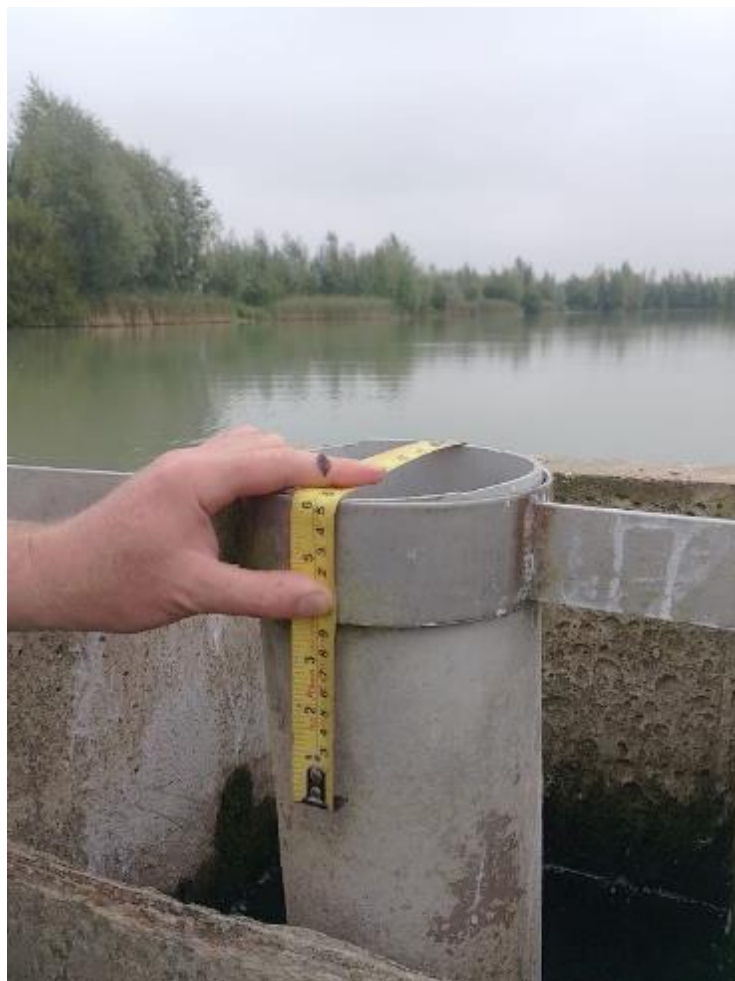
As part of the conditions on issuing the Preliminary Certificate it was required that a survey was carried out. This was undertaken by JC White Geomatics and from the survey it was found that there was insufficient freeboard. It was recommended that the overflow was lowered by 150 mm. This was completed in August 2024.

Photograph 12 Measuring overflow pipe before cutting 150 mm

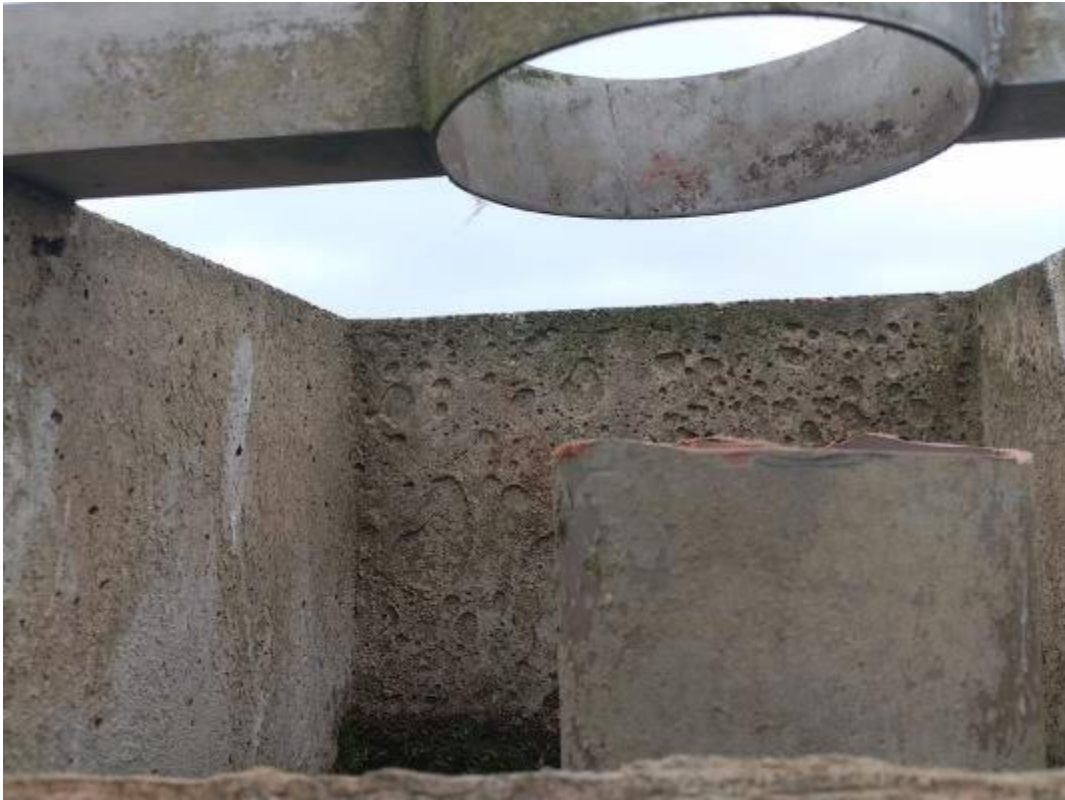
Photograph 13 Overflow pipe after cutting
