**Hertsfield Barn, Marden, Kent, TN12 9BW**

STATEMENT OF

**Dr Paul Ellis, BSc, PhD, CGeol**

Subject Matter: The potential for groundwater flooding resulting from the unauthorised development at the neighbouring property known as Monk Lakes.

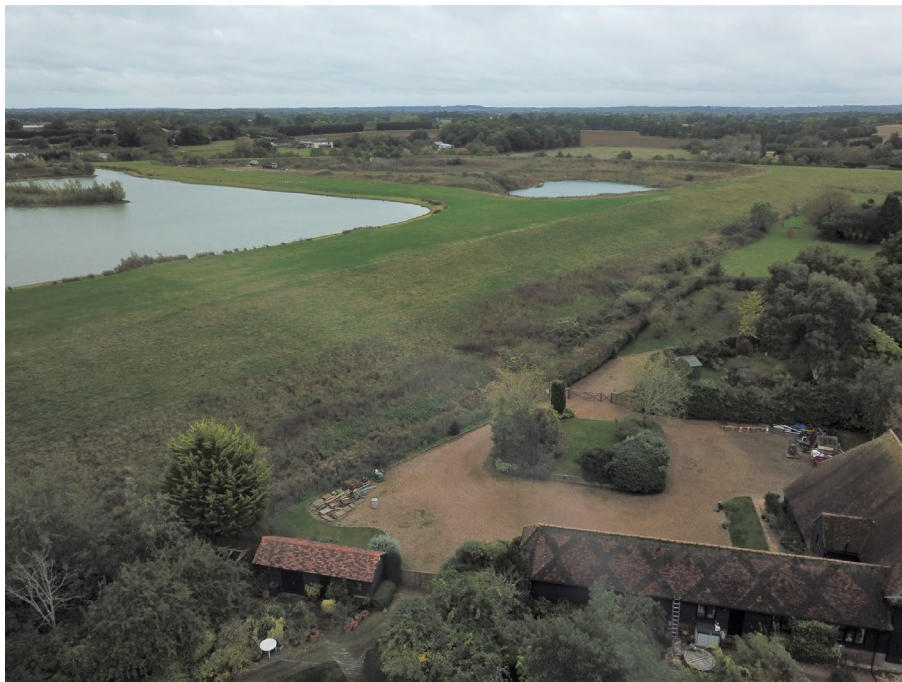
*Figure 1. View looking south of Hertsfield Barn and Monk Lakes 1 and 2 (October 2019).*

- 1.3.12 Mr Padden has presented evidence (Geosmart, 2019a) that indicates the lakes may be leaking, including the raised groundwater levels, and pictures from Mr Padden showing the drawdown in Lake levels during October 2019 and the requirement for additional pumping to top up the lakes.

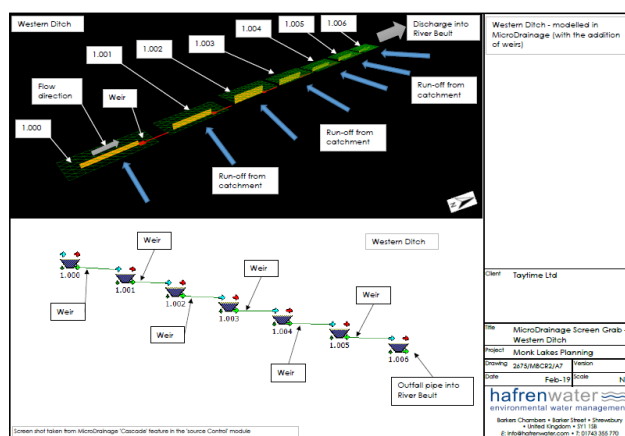
**Figure 2, Surface water drainage scheme**  
 (after 2675/MBCR2/A7, Vol2 part F of the ES, section 4.1 of Hafren 2019, pdf page 325 of the ES).

3.1.15 The condition references the strategy presented in Drawing 29431/001/SK03 prepared by Peter Brett Associates (3 July 2015). We note that this does not include the surface water attenuation basins and check dams that were agreed with Kent County Council (see Vol2 part F of the Environmental Statement, section 4.1 of Hafren 2019). Neither have these measures been included on the updated Landscape plans submitted with the Appeal. We recommend that these measures are considered further prior to planning permission being granted given the space constraints along the western margin and the need to avoid placing mitigation measures within the flood plain.

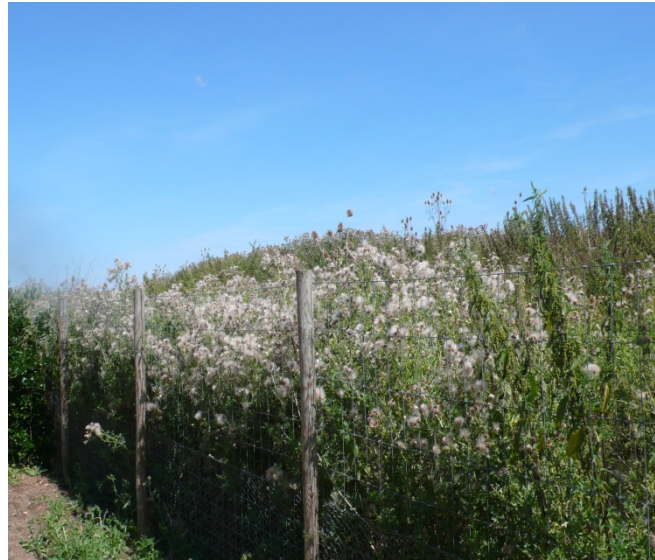
4. Despite “vegetation” that they say will help with any groundwater issues – we certainly have “vegetation” in the ditches – never been cleared since the day they were badly dug – but doesn’t make a difference.

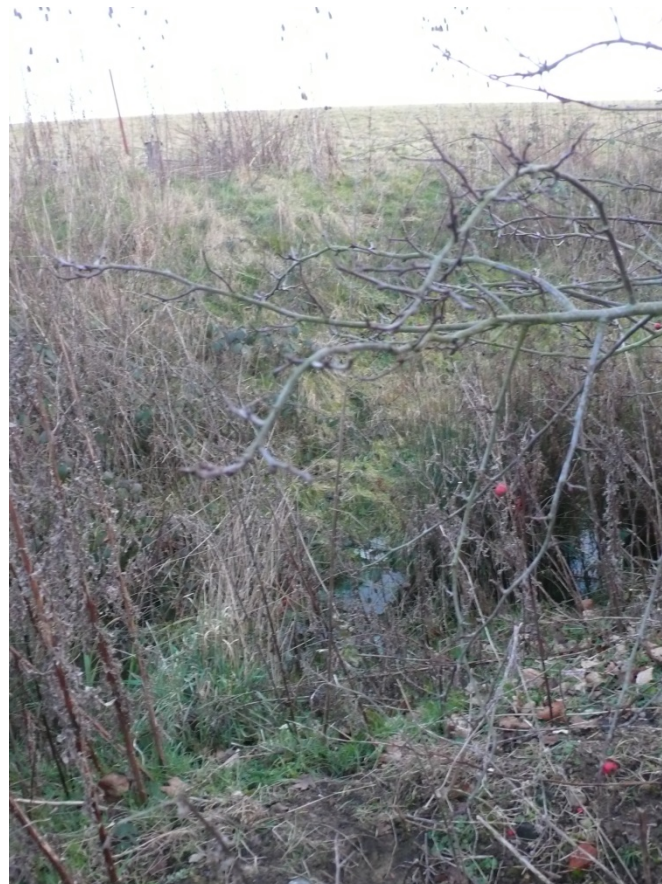
5. After rain, the water in the ditch sits – it doesn’t drain away immediately, it doesn’t run down the ditch channel - it sits in the ditch and then drains through the ground.

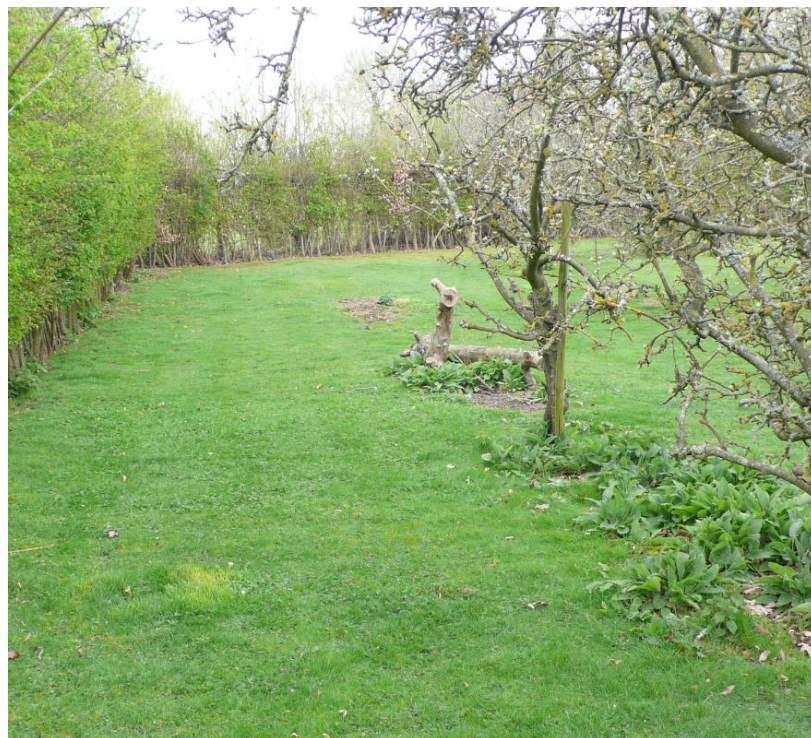
7. Numerous trees have died in the orchard now.

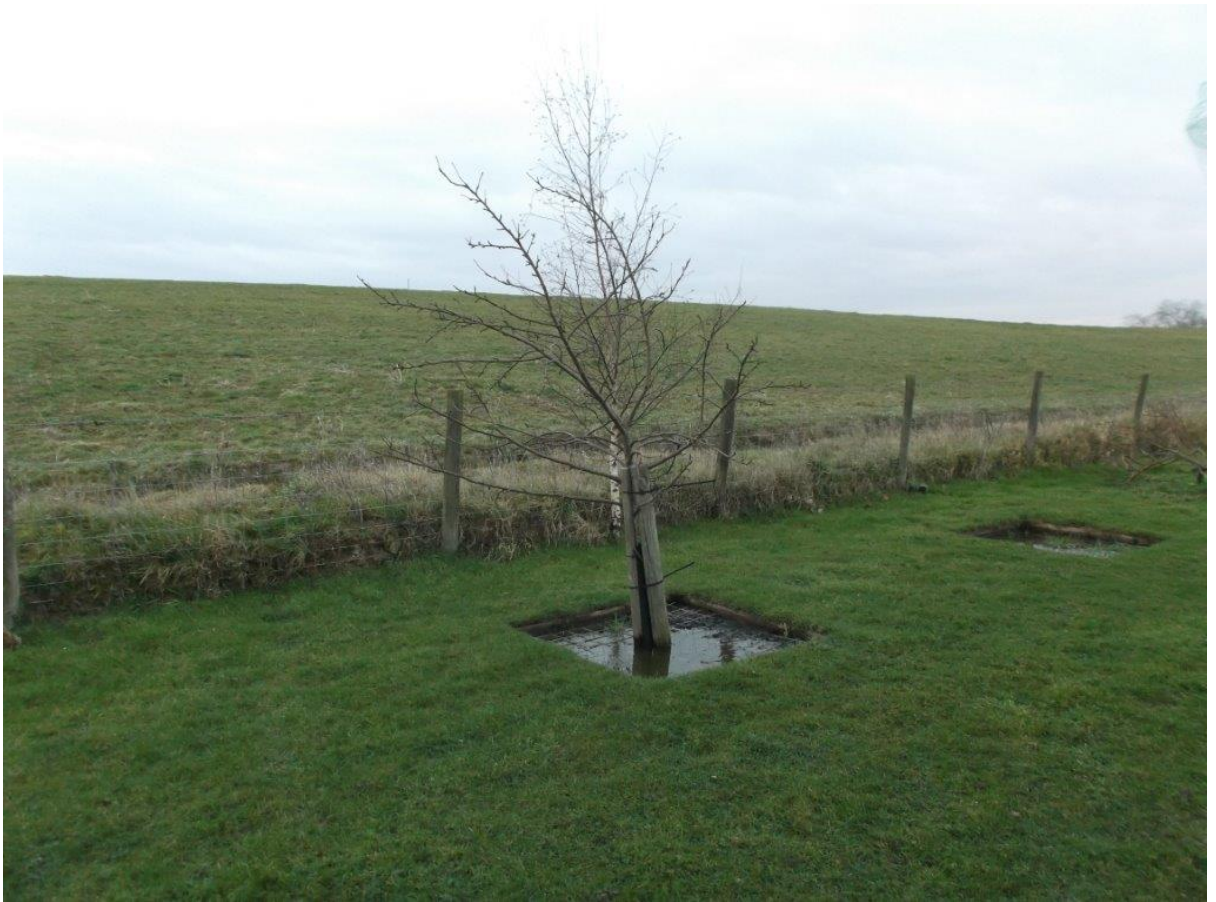
10. 12th February 2016 photograph from Alan Mathie, who is in the cottage next to Leigh Highwood and has lost 3 fruit trees. Shows the western ditch behind the fence.

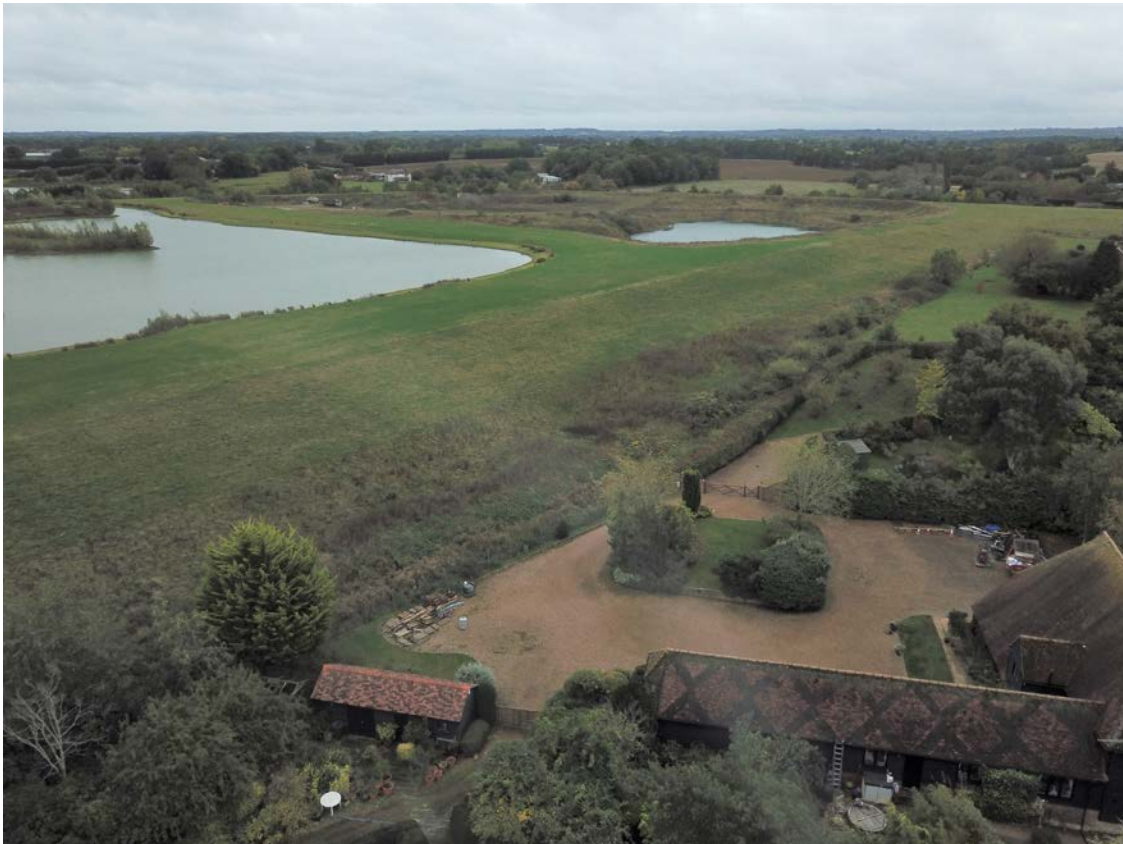
*Figure 2. View looking south of Hertsfield Barn and Monk Lakes 1 and 2 (taken October 2019).*

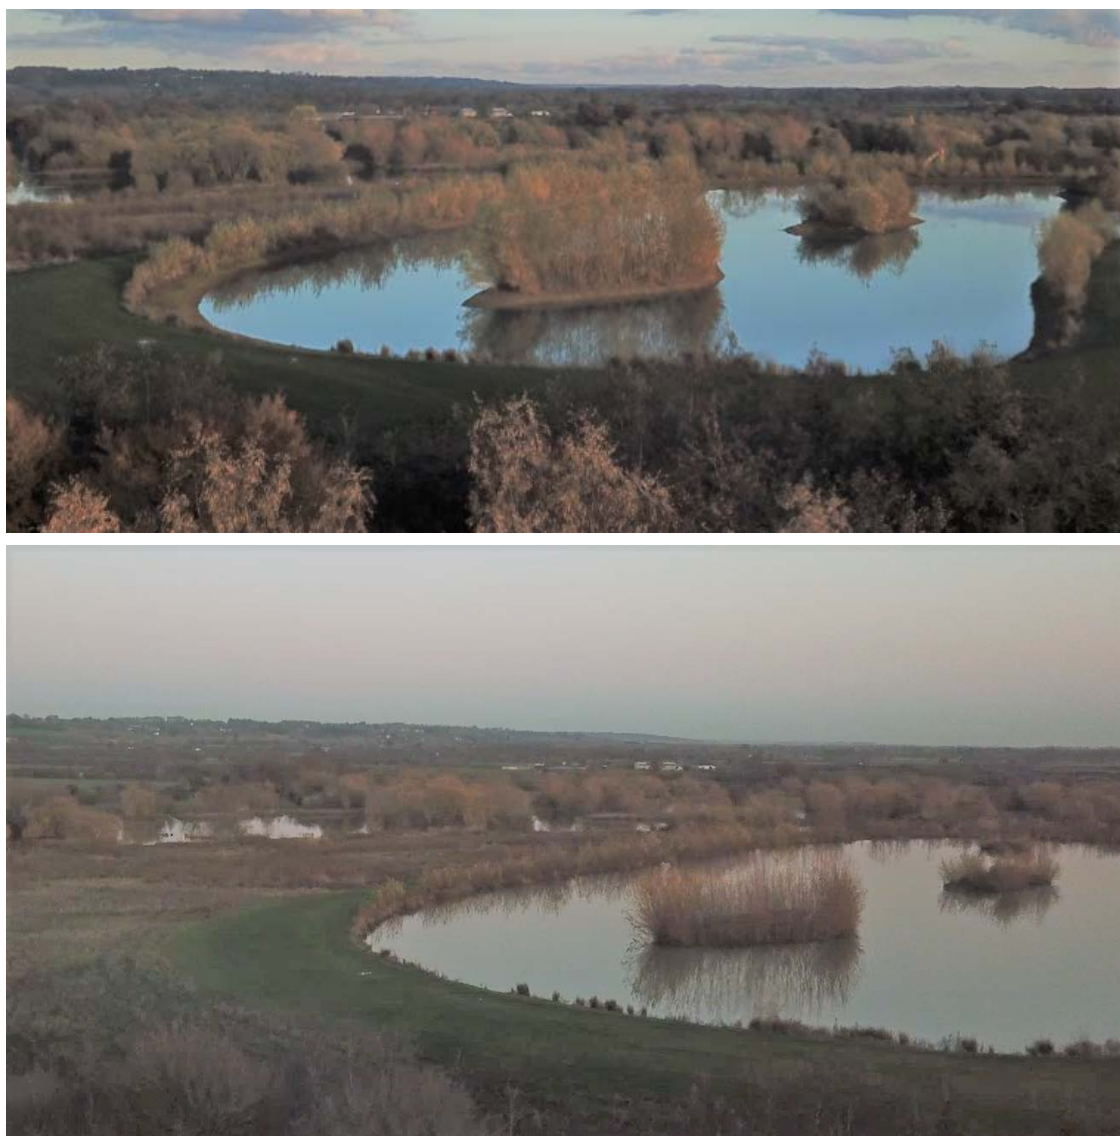
*Figure 3. View south of Hertsfield Barn to Lake 3 on a) 10/11/19 top b) 29/11/19 bottom, showing significant variation in water levels.*

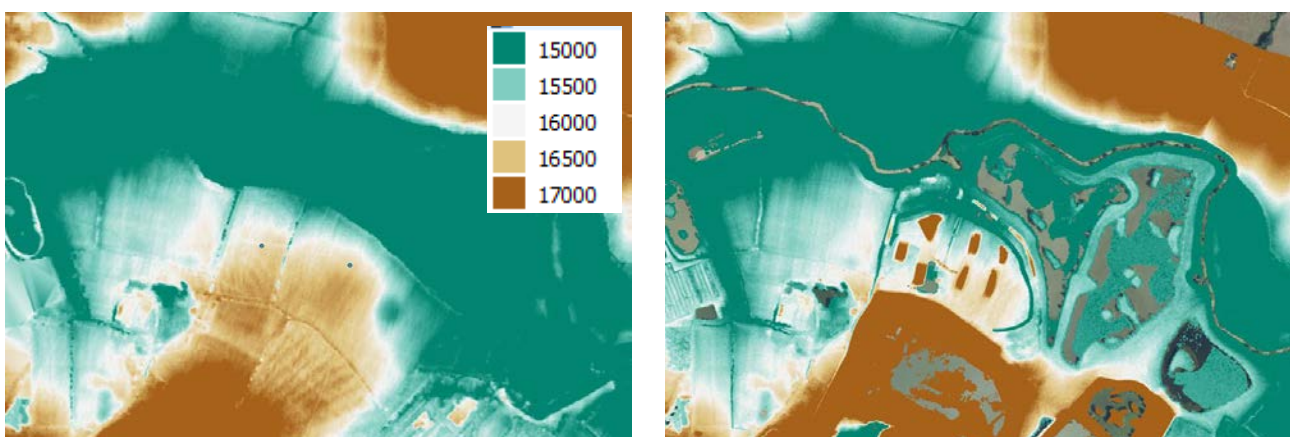
Hafrens findings (October 2019) indicate that the impact on flood plain storage is less than previously calculated, however, this has been done on the basis of a volumetric calculation using a flood level derived from previous work and topographic LIDAR data available from 2002. LIDAR data is also available from 2008 and shows ground levels to be significantly lower than the 2002 levels (Figure 4), presumably as a result of soil removal and other activities.

Figure 4 LiDAR data showing elevation in mm. Left 2002, Right 2008.

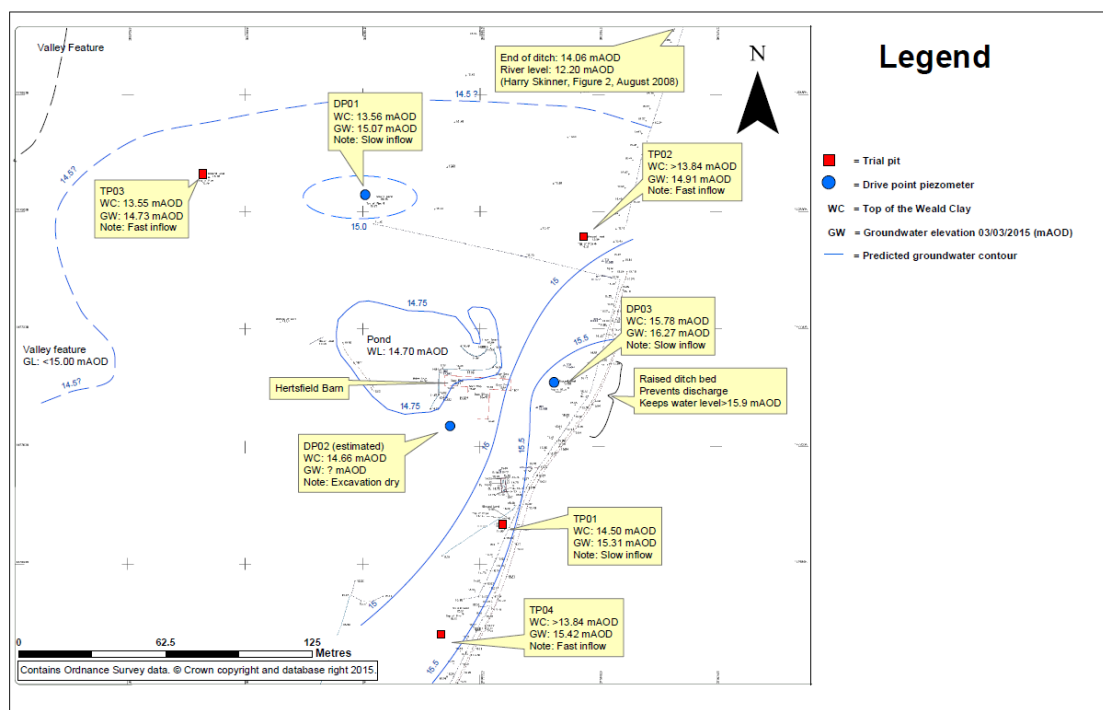
Figure 1 Estimated groundwater contours (from ESI,2015, Figure 8)

Groundwater contours should include the groundwater low around Hertsfield pond and make reference to the earlier trial pit and groundwater data presented in ESI 2015. As Taytime have not collected any data outside the Western Boundary then the information provided within the ESI report should be considered. If this information is disregarded, then the applicant should state the reasons for this and provide an alternative explanation for the high groundwater and flooding observed.

The groundwater level labelled on the revised contour plot for BH04 is incorrectly labelled as 15.66mAOD when in fact it should be 15.26mAOD, the level recorded on

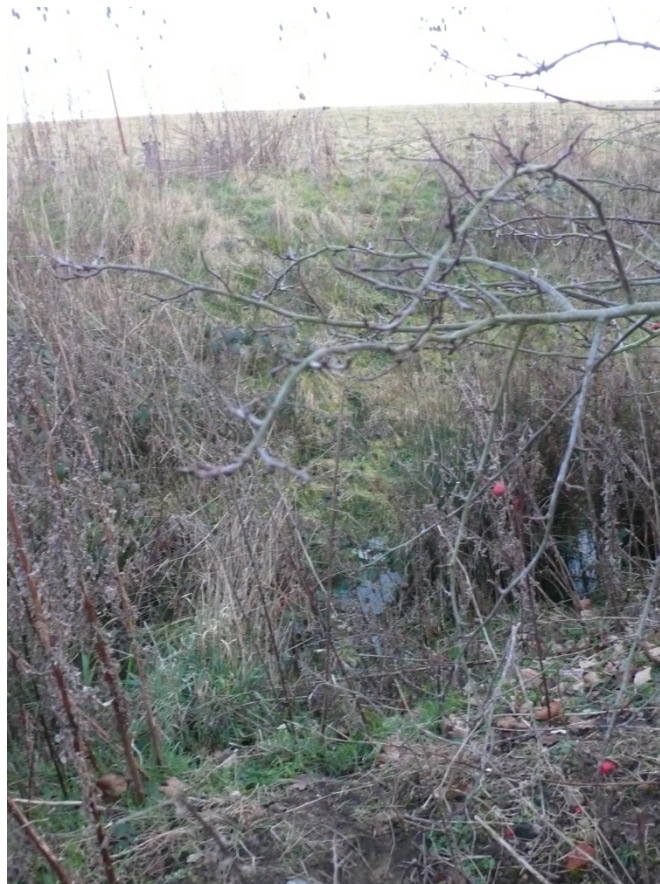
5. After rain, the water in the ditch sits – it doesn’t drain away immediately, it doesn’t run down the ditch channel - it sits in the ditch and then drains through the ground.

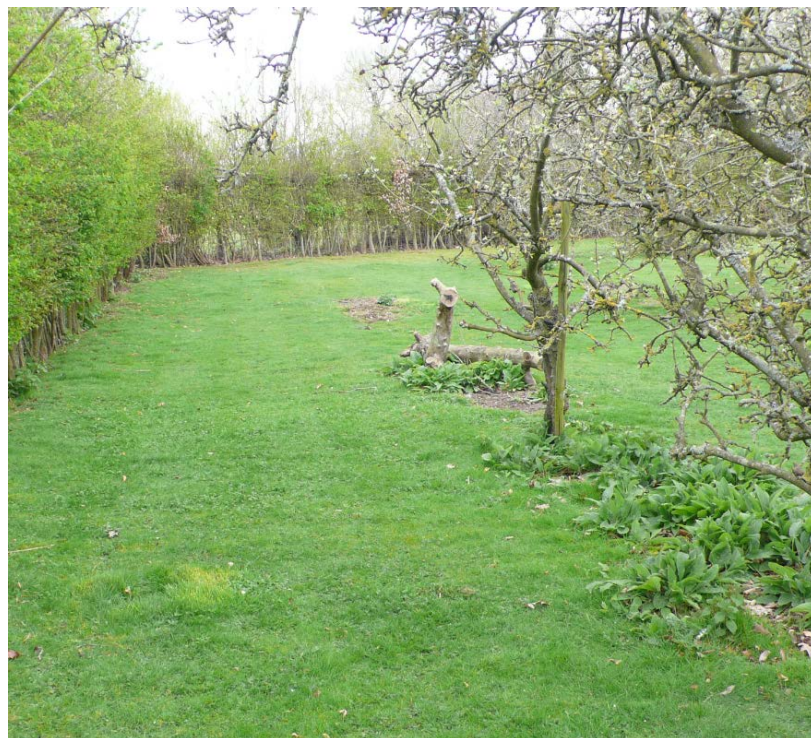
7. Numerous trees have died in the orchard now.

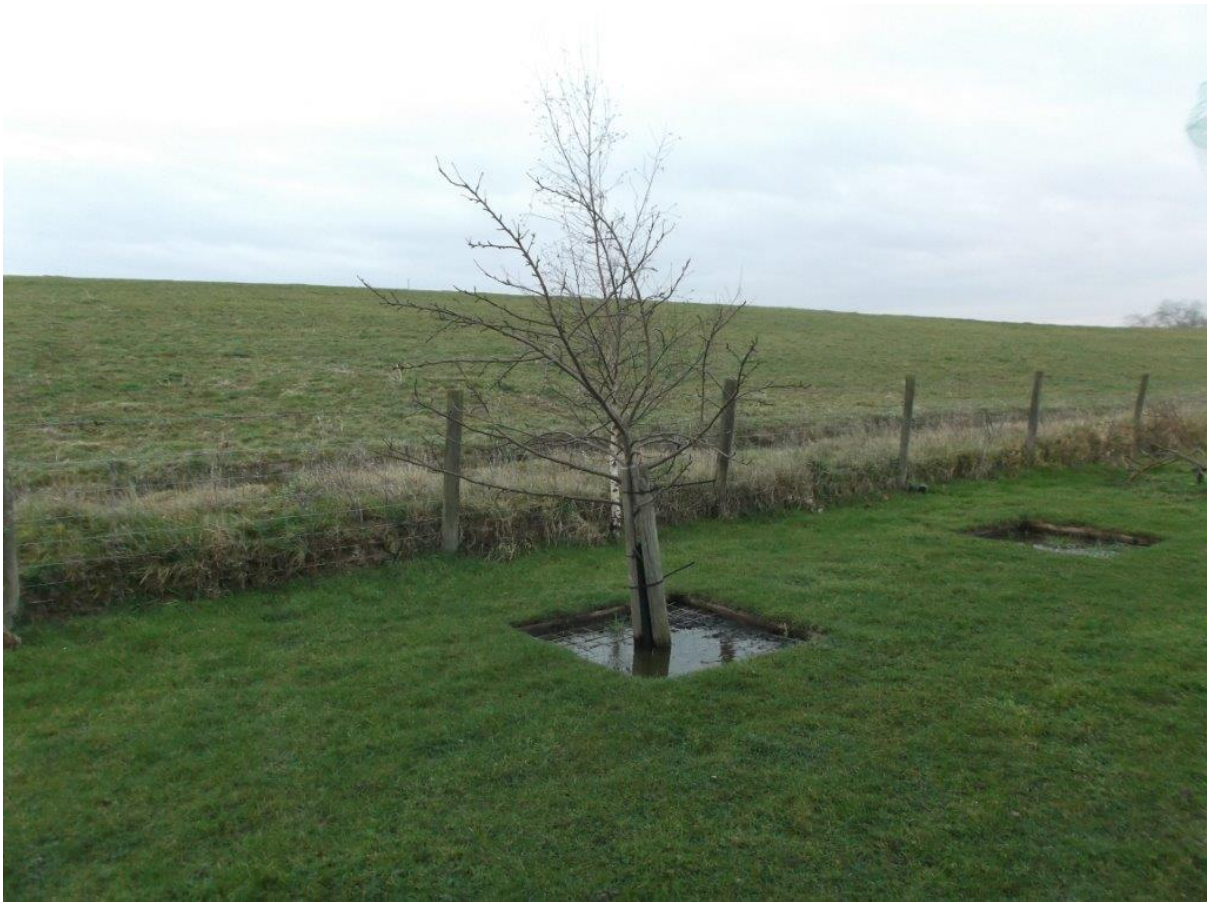
10. 12th February 2016 photograph from Alan Mathie, who is in the cottage next to Leigh Highwood and has lost 3 fruit trees. Shows the western ditch behind the fence.
