Monk Lakes Groundwater Assessment

November 2016

Maidstone Borough Council

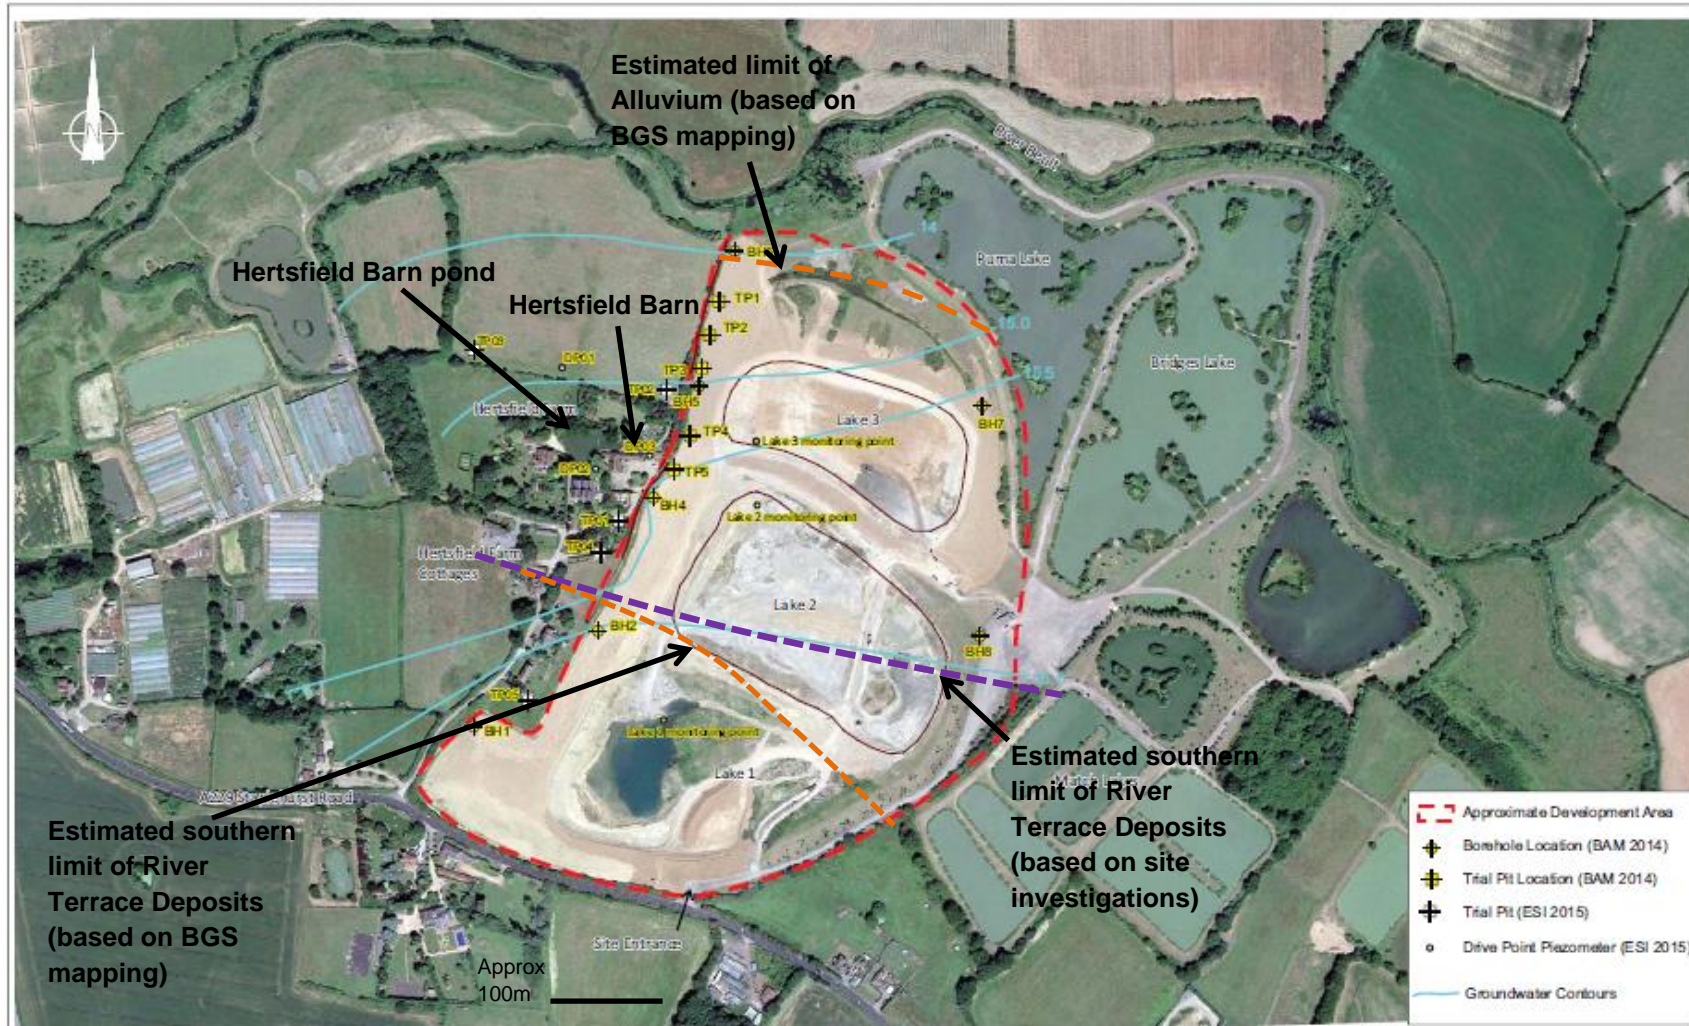
Figure 4.1: Monk Lakes site with southern limit of River Terrace Deposits

Without knowing the geology between BH2 and BH4, and also the geology around Hertsfield Barn where there is thought to be a natural depression feature, it is difficult to assess the likelihood that works in the development area will cause groundwater flooding to the west. It is considered to be possible for groundwater to flow from the site towards the west within the River Terrace Deposits. This is discussed further in Section 4.3.

1. At least one more trial pit/borehole should be dug on the western boundary between BH2 and BH4 in order to better constrain the southern limit of the River Terrace Deposits and corroborate the information from ESI (2015). Suggested locations for this borehole are shown on Figure 4.3.
2. The nature of the fill used to construct the lakes should be ascertained.
3. A geophysical survey could be carried out across the site, in an attempt to better define the extent of the River Terrace deposits. However, additional boreholes are likely to achieve this in addition to providing groundwater level information.
4. The statement in 4.3.2 of Peter Brett Associates (2015) that access permission was not granted on Mr Padden's land should be rephrased as, from available correspondence between the two parties, who refused access to whom appears to be contentious.

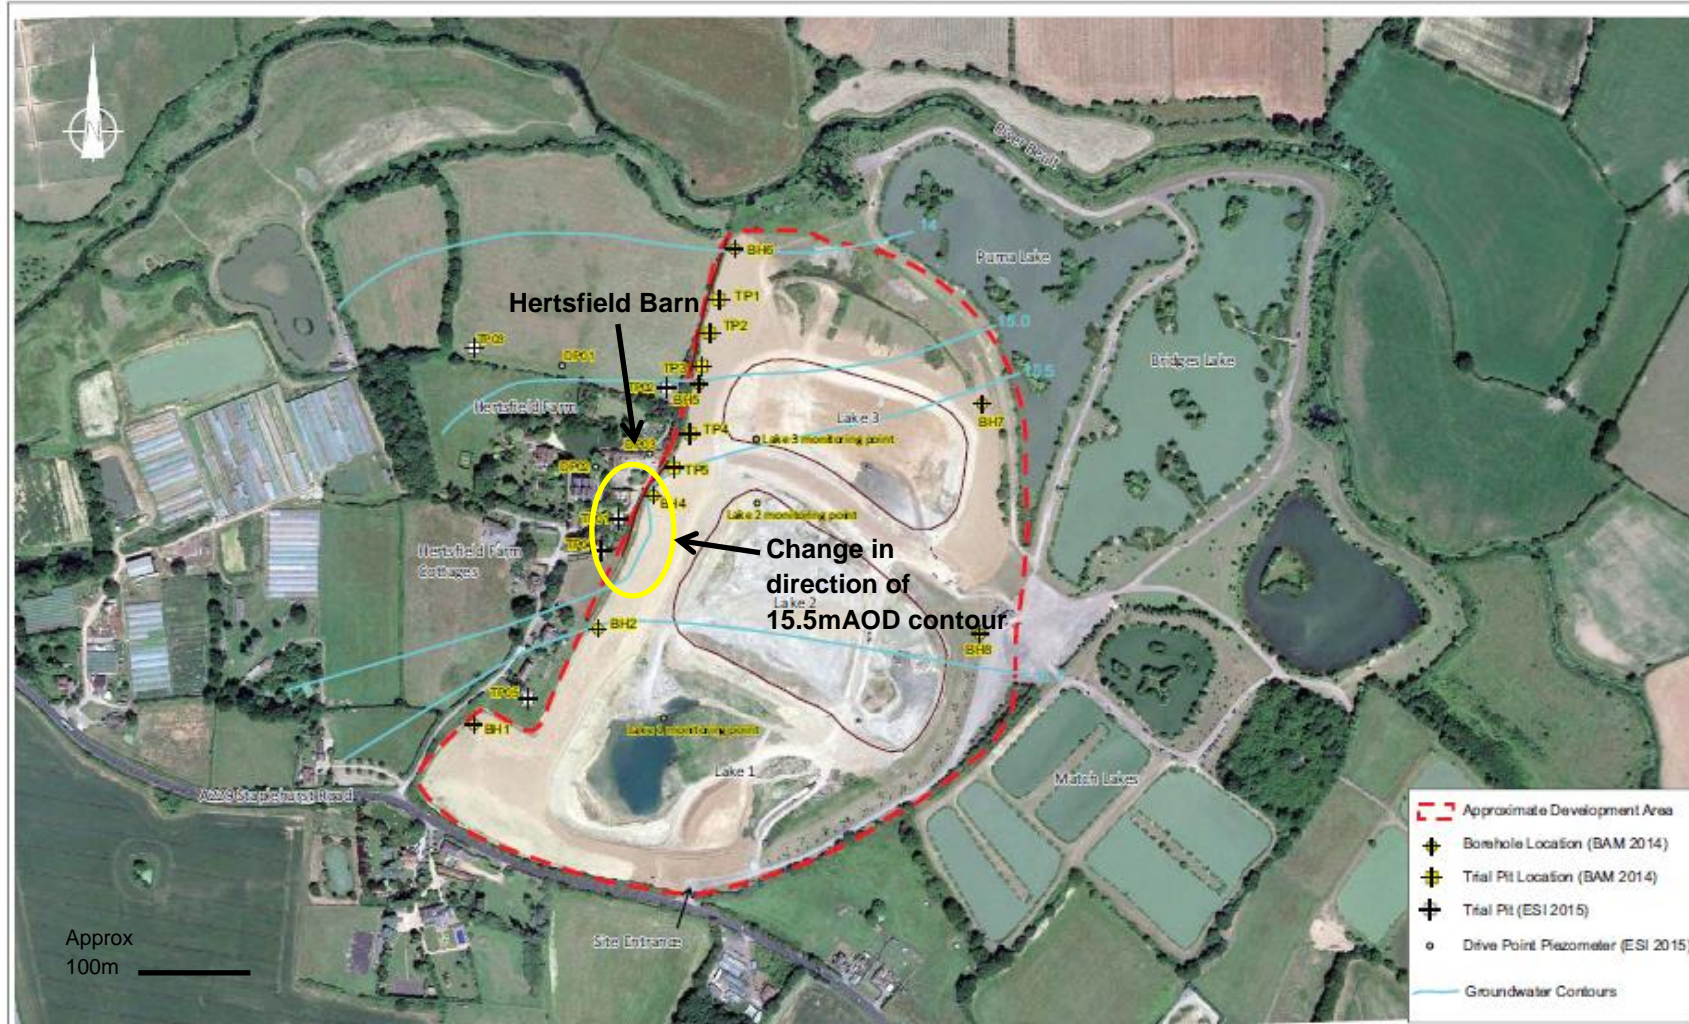
Figure 4.2: Monk Lakes site with groundwater contours

The unexpected contour shape in this area is not commented on, nor explained in PBA's report. If further work confirms the presence of this change in contour shape, possible causes that should be investigated include:

- Leakage from Lake 2.
- Infiltration of surface water into the Lake 2 embankment, and subsequent movement of this water through the embankment and River Terrace Deposits towards the ditch.
- The ditch acting as a linear source of groundwater recharge in that area.

4. The cause of the change in contours in this location, if corroborated by further borehole testing, should be investigated and explained. Possible causes that should be investigated include:

- a. Leakage from Lake 2
 - b. Infiltration of surface water into the Lake 2 embankment, and subsequent movement of this water through the embankment and River Terrace Deposits towards the ditch. However, if this were the case, it might be expected that groundwater movement was towards the west at Lake 3 too. This does not seem to be occurring.

8. The contours drawn by PBA in Figure 9 of their report extend through BH2, where there are no River Terrace Deposits present and no groundwater was found. It is recommended that the River Terrace Deposit geology is shown on this figure and that contours are either not interpolated outside of this geological area, or justification for them is presented.

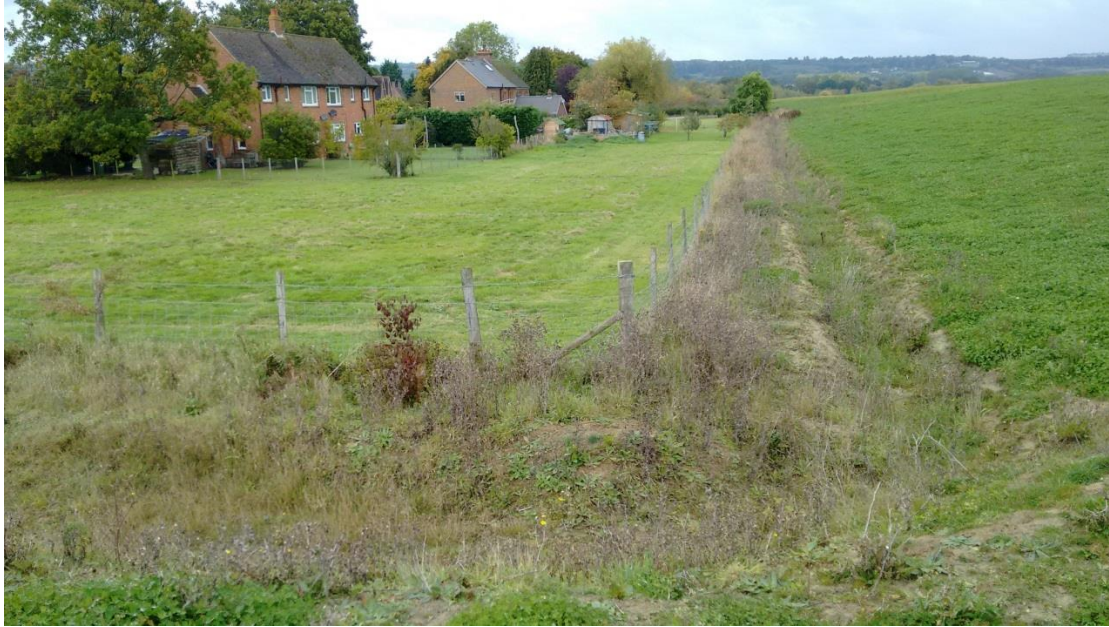
Figure A.4: Western boundary ditch looking NE from viewpoint 3

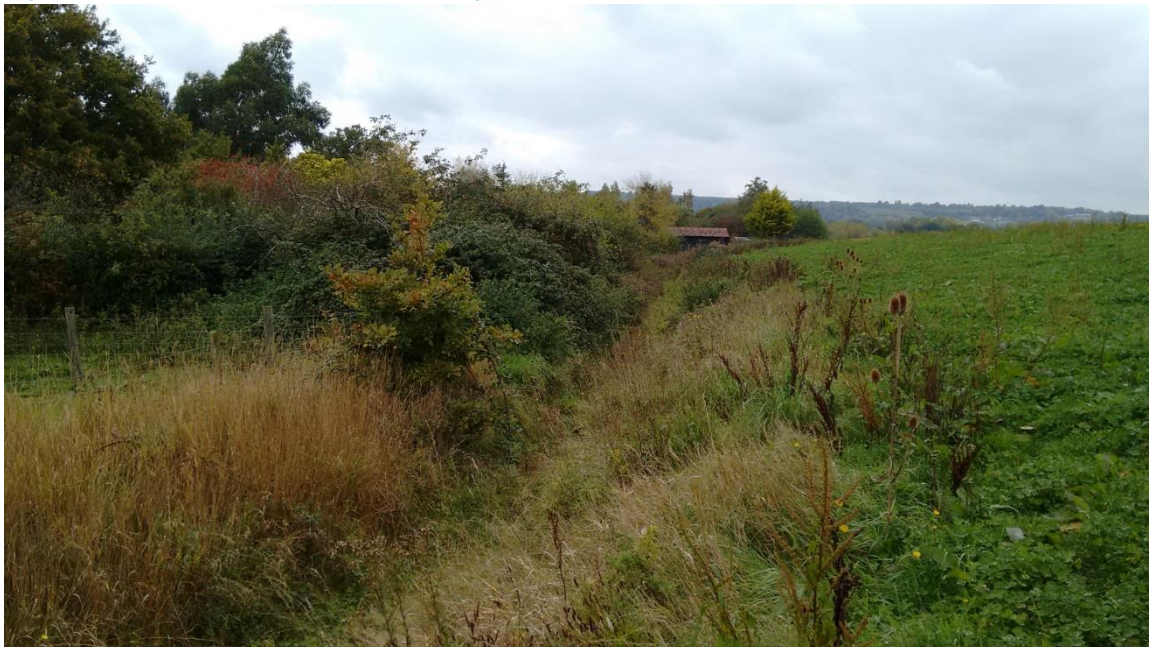
Figure A.5: Western boundary ditch looking NE from viewpoint 4 towards orchard

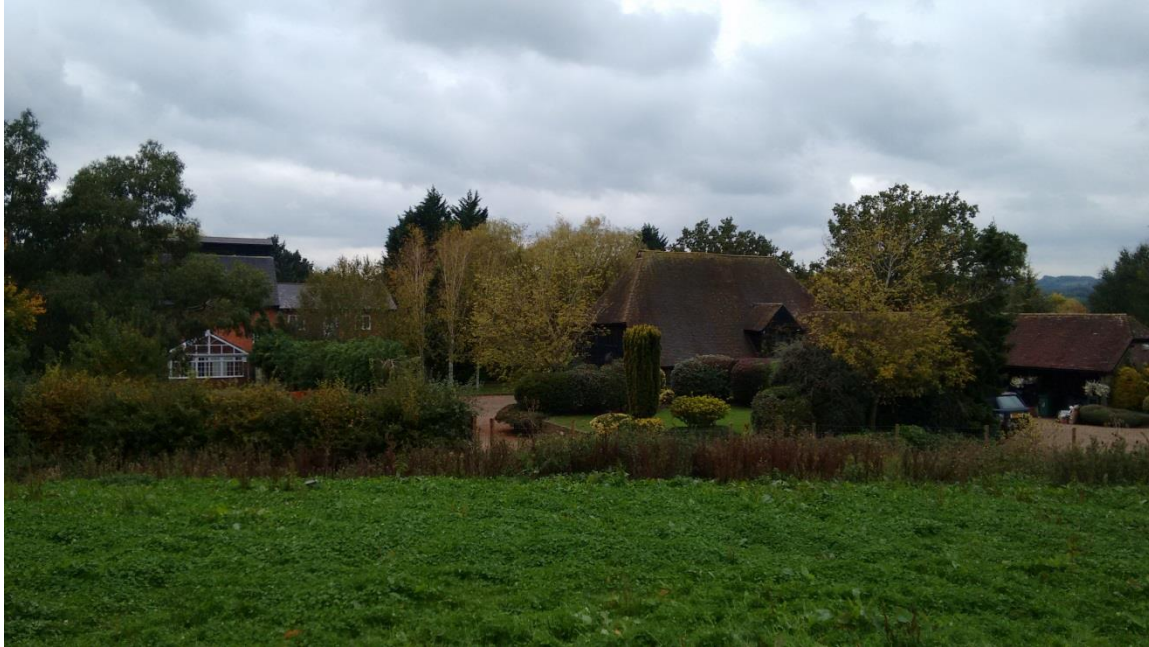
Figure A.6: View W of Hertsfield Barn and the western boundary ditch from viewpoint 5

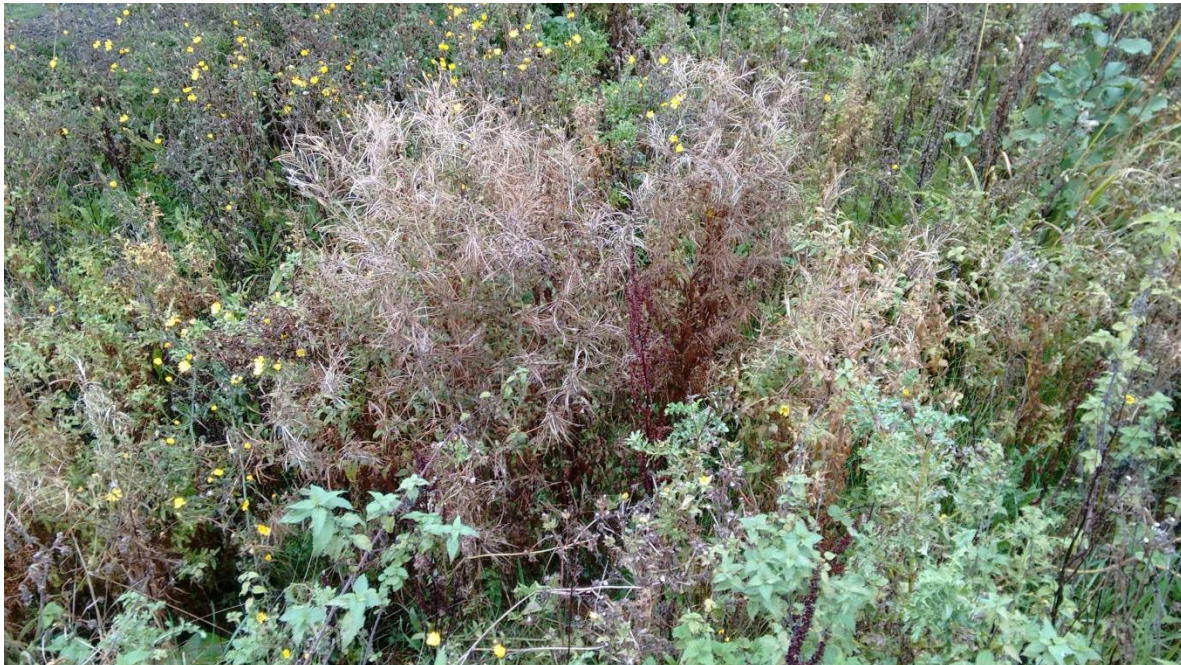
Infiltration of water from the ditch into the ground is considered to be possible where the ditch is constructed in the River Terrace Deposits. It is also considered likely that the drainage ditch is not draining due to inadequate falls and the fact that it intersects the water table in places. In addition, the ditch was observed to be very overgrown during the site visit on Thursday 15th October 2015.

Figure A.7: Overgrown western boundary ditch near TP4 with small volumes of standing water. Viewpoint 6.

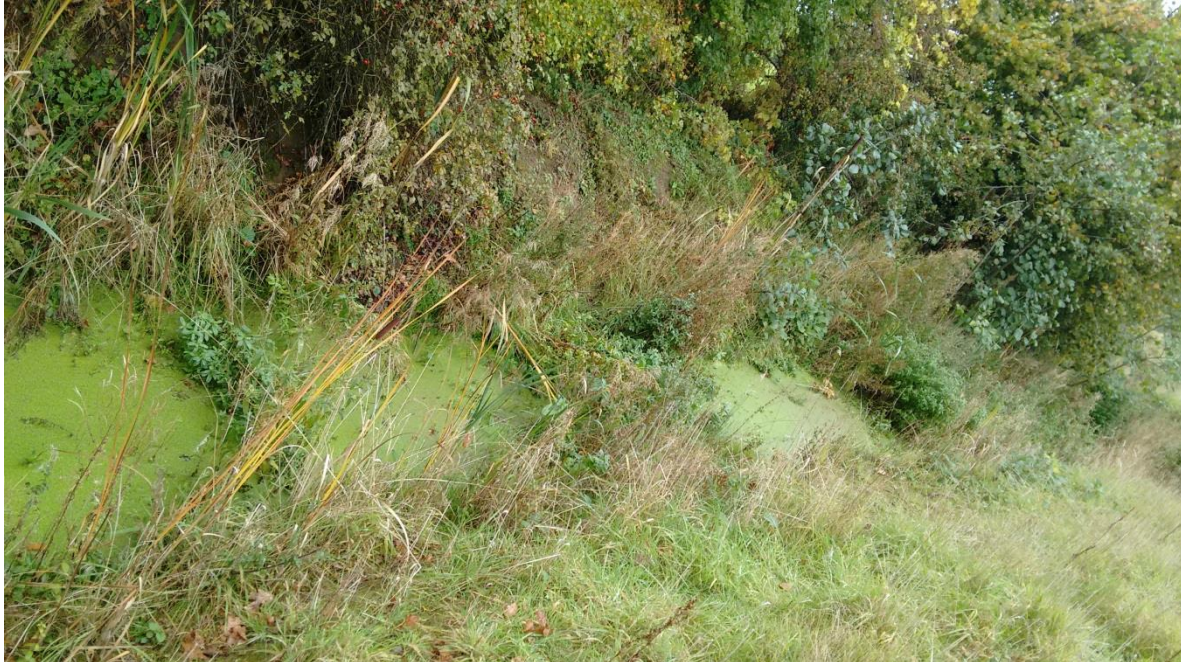
Figure A.8: Standing water in the western boundary ditch near TP1. Viewpoint 7.

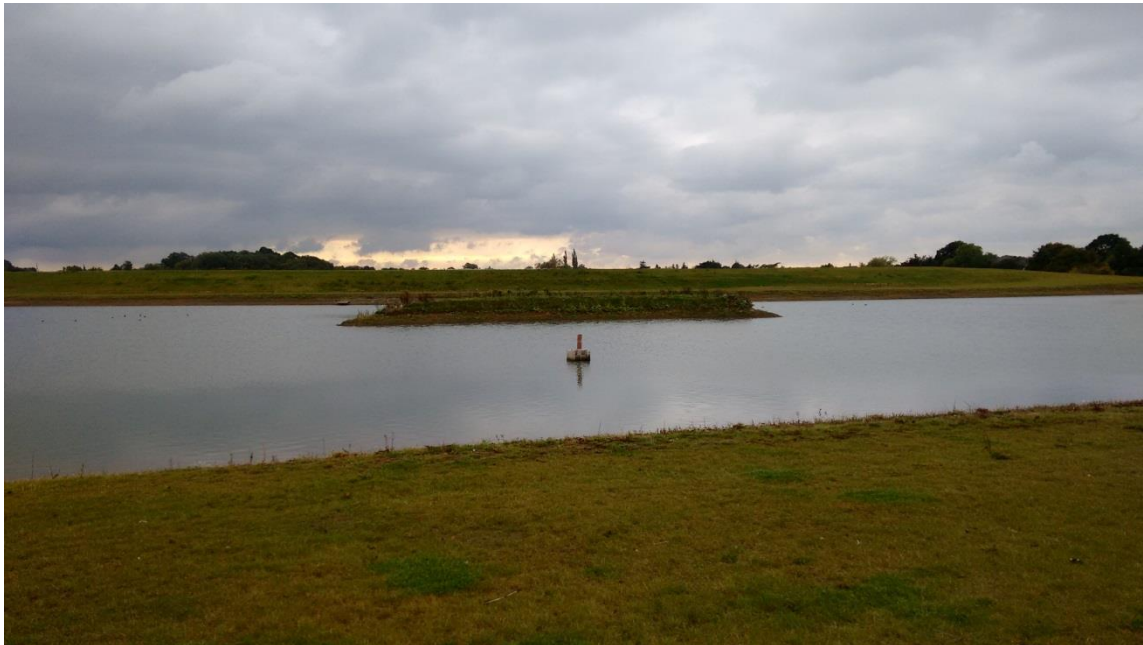
Figure A.9: View S over Lake 3, including outfall. Viewpoint 8.

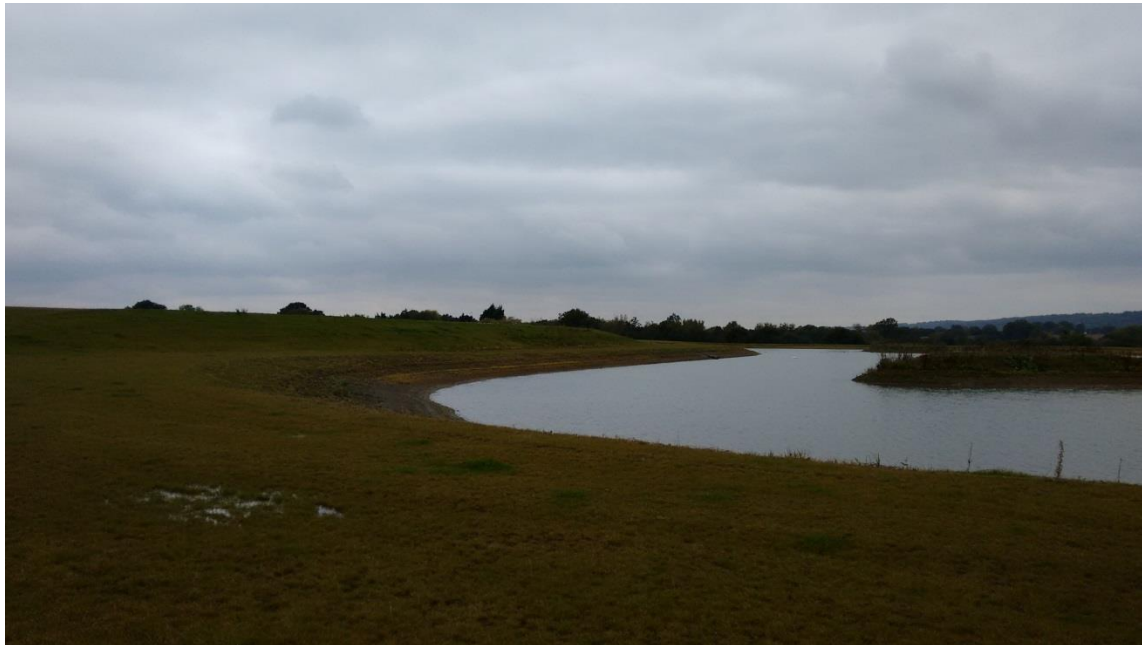
Figure A.10: Lake 3 (right) with crest of Lake 2 (left). Viewpoint 9.
