## **Proof of Evidence on Heritage – Appendices.**

Address Land at Moat Road, Headcorn

## **Appendix 4: Methodology for Repair and Reconstruction of the Granary**

THE GRANARY  
MOAT FARM  
HEADCORN

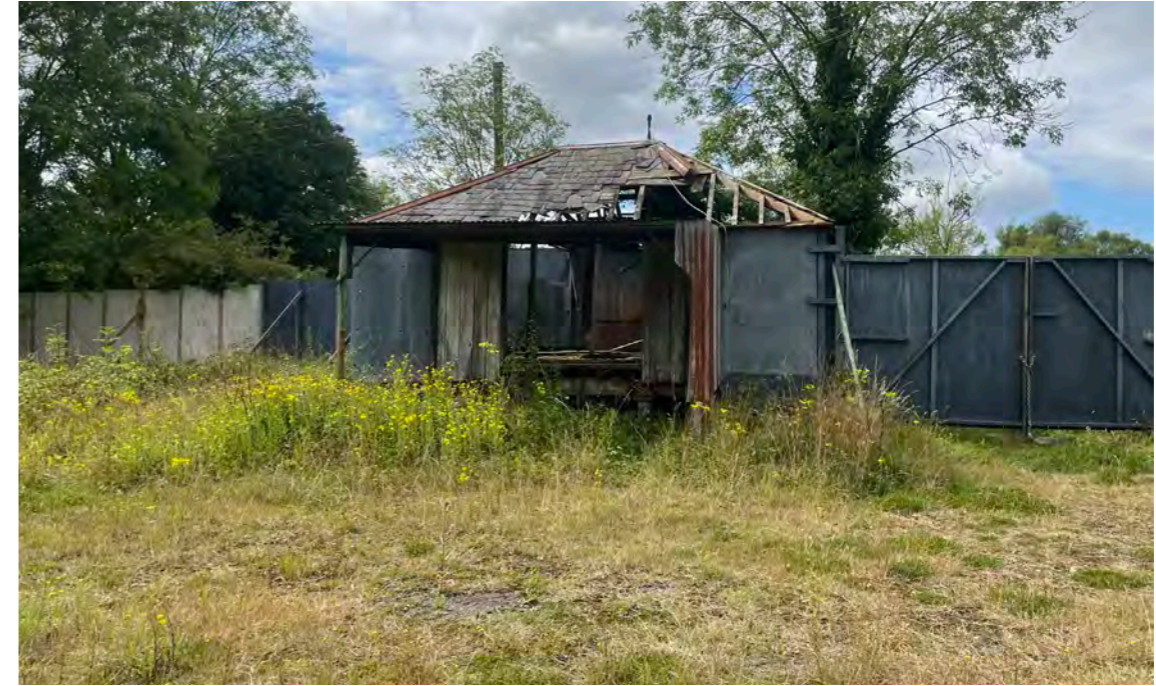
north elevation

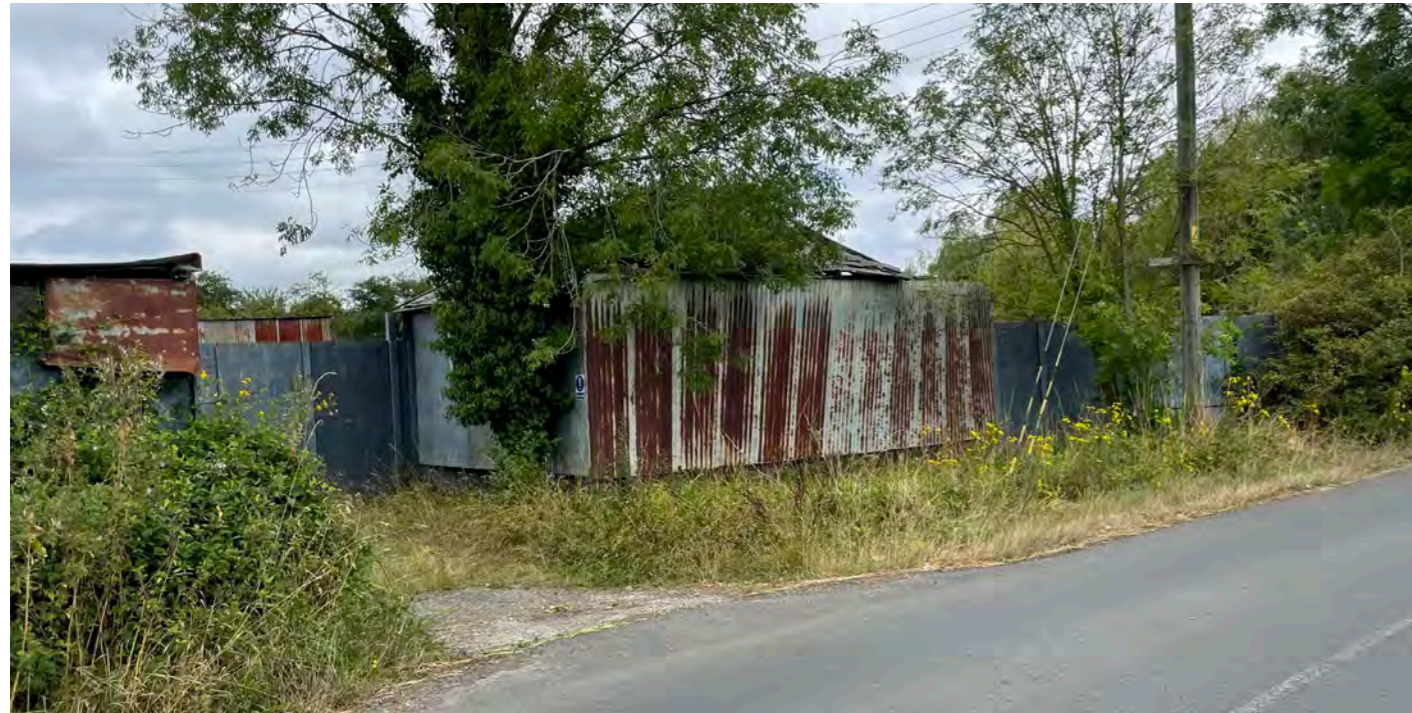
south elevation from road

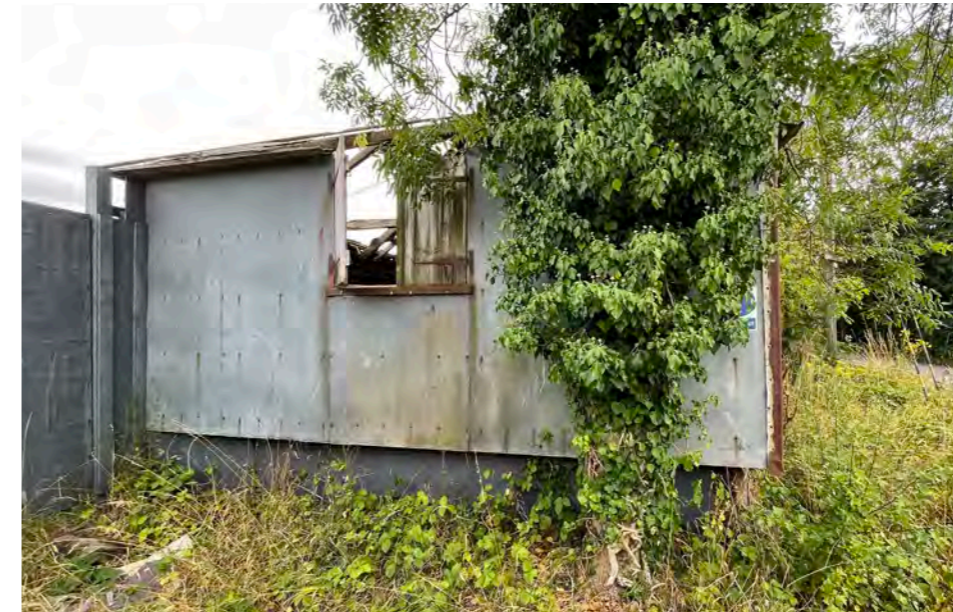
west elevation

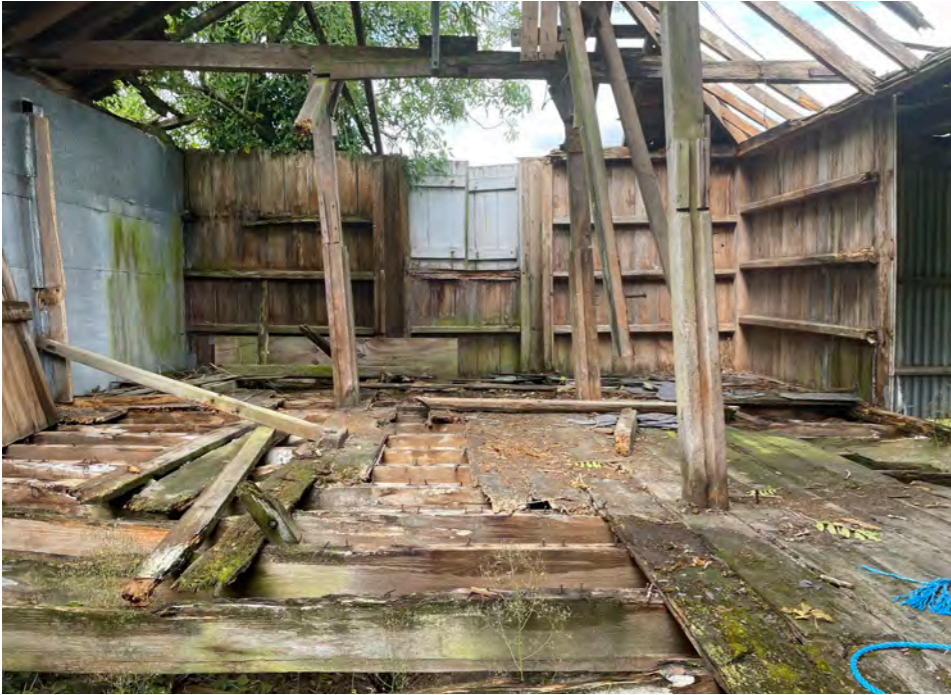
internal face of west elevation

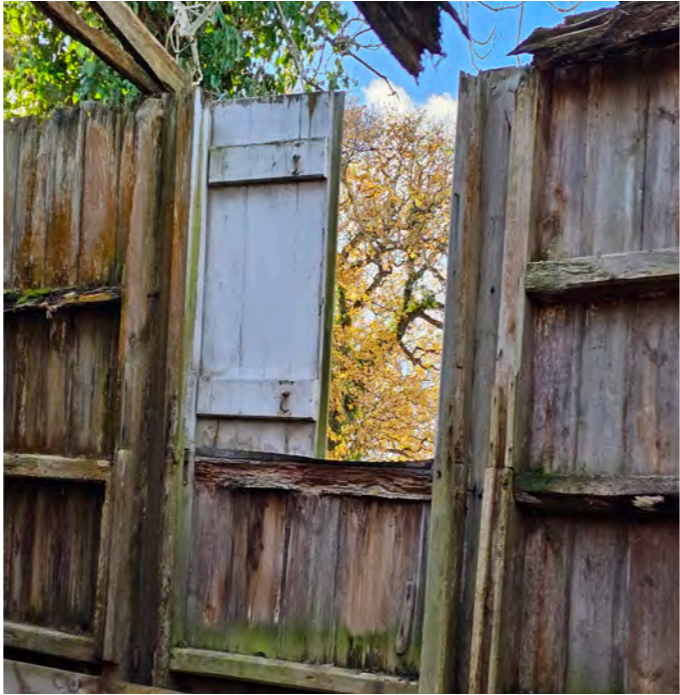
internal face of shutters to west elevation

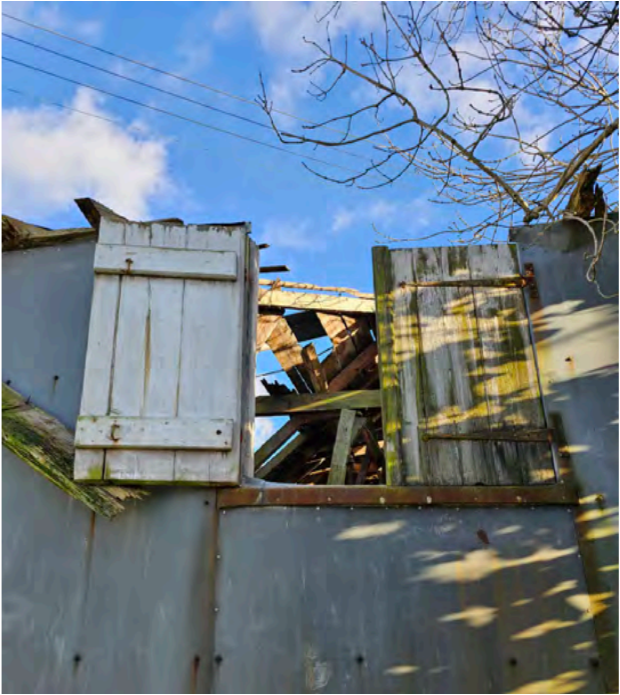
external face of shutters to west elevation

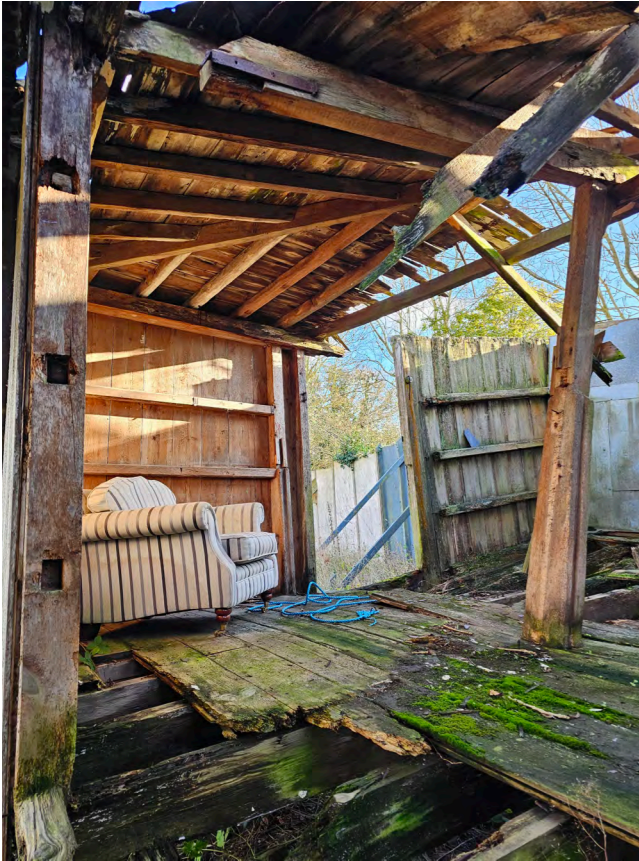
internal face of east elevation

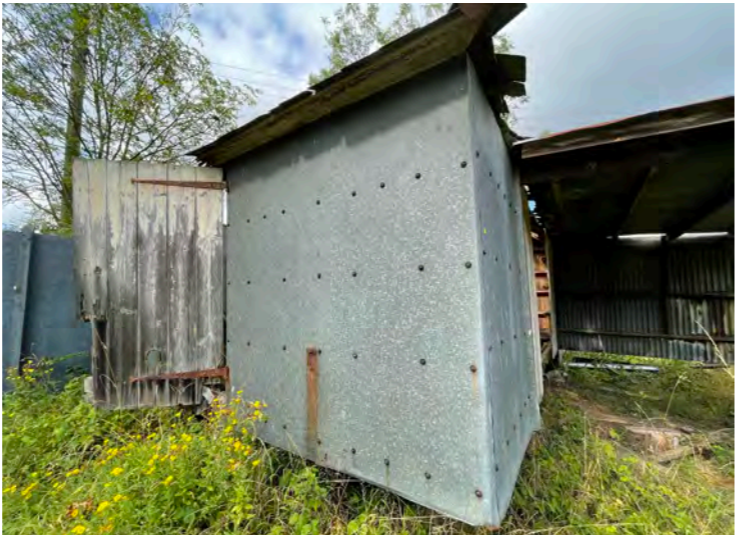
external face of door to east elevation

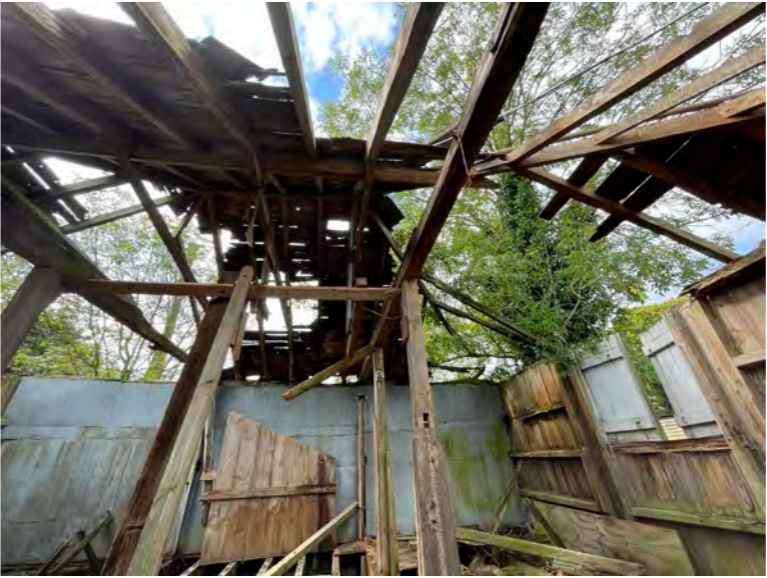
internal face of south elevation showing central posts

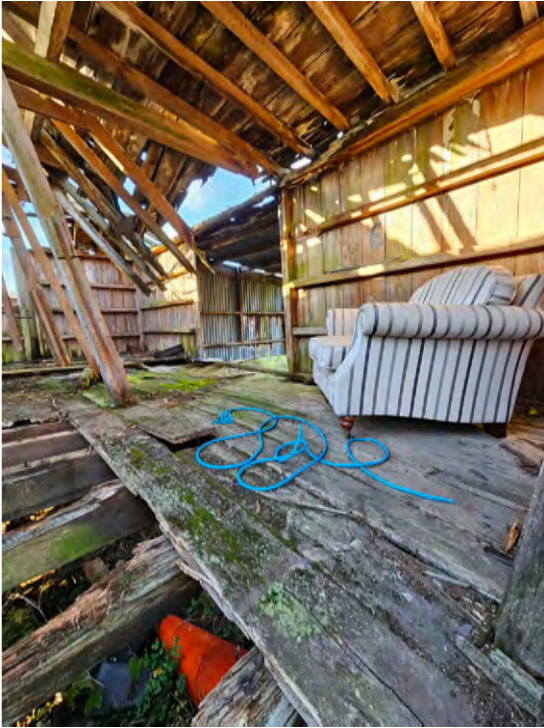
internal face of north elevation showing opening

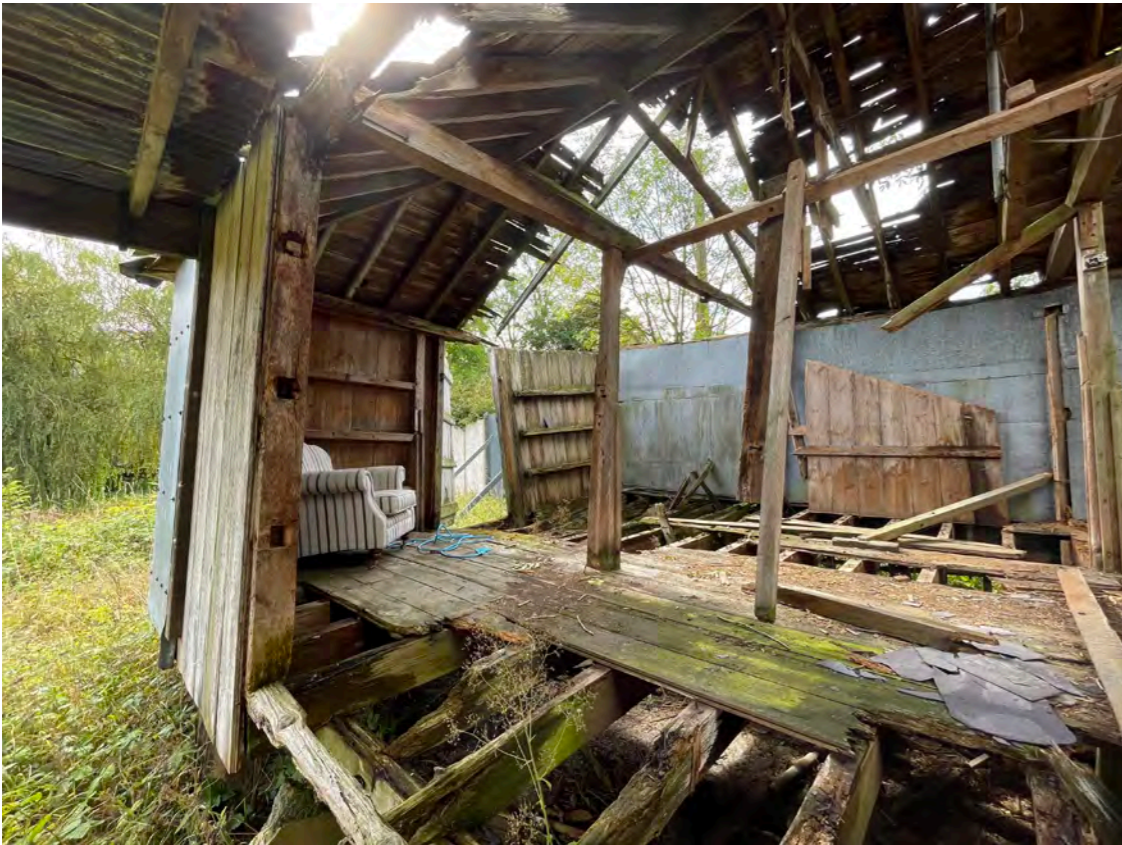
internal view of roof structure

8. The roof structure appears to have been extensively supplemented and replaced, and is now in a serious state of disrepair and decay with many components missing. The assembly appears to comprise paired common rafters birds-mouthed and skew nail fixed to the wallplate and skew nail fixed to a ridgeboard ( a feature and method of fixing common in the later 19th century). Alternative pairs of rafters are connected with collars supporting a trenched purlin with hip rafters and jack rafters to the hips. The collars appear to be morticed and pegged to the rafters rather than half lapped.

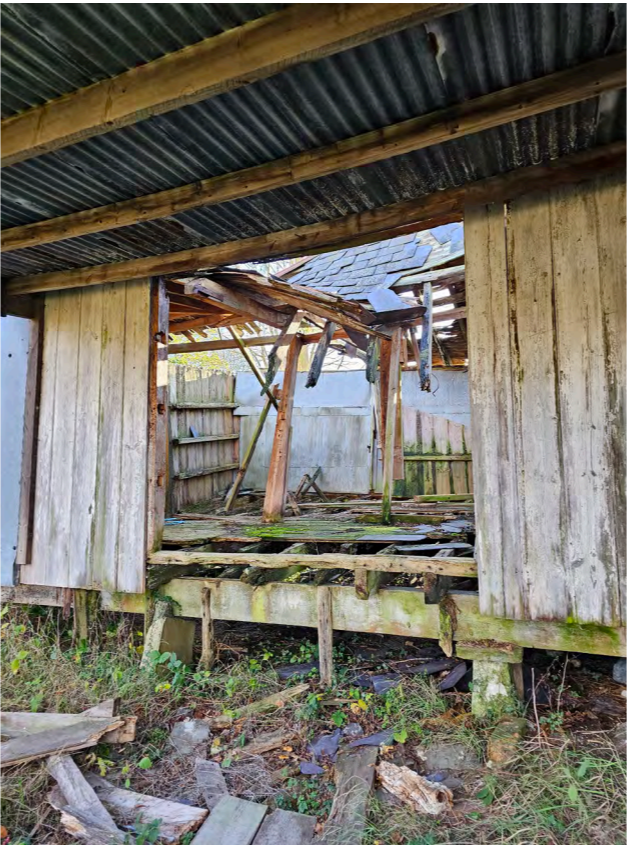
opening and original external cladding to north elevation

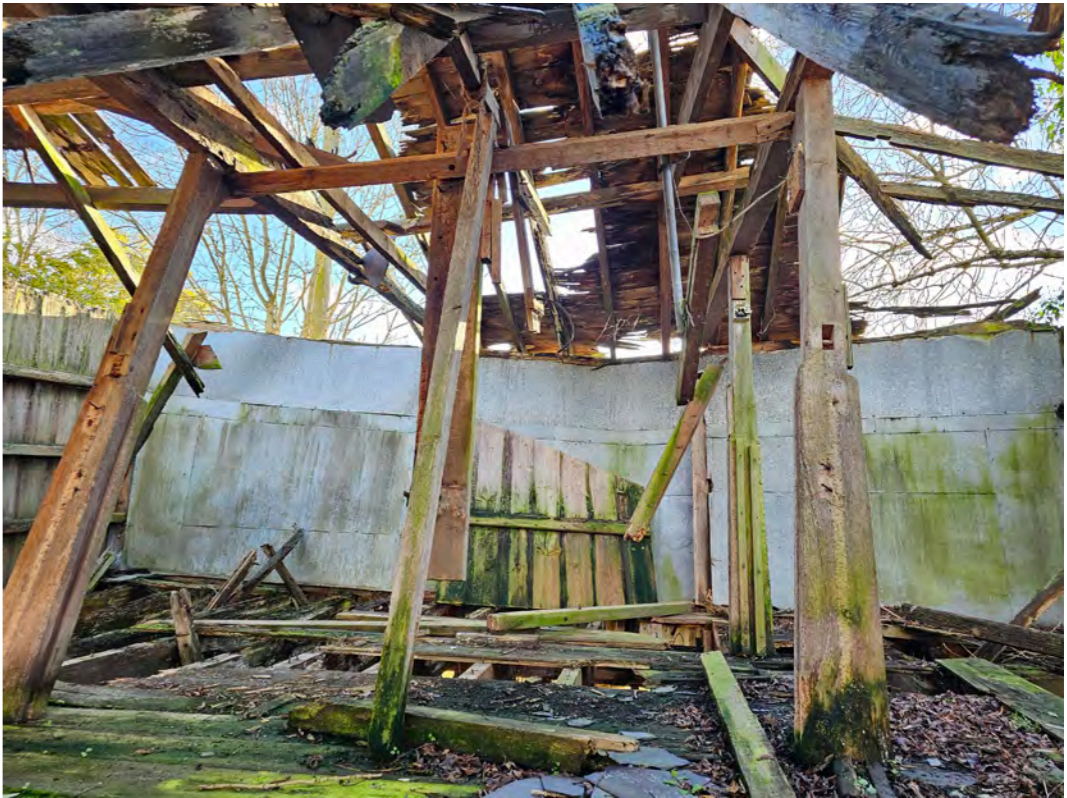
haunched central posts to grain bins. Note  
pegs and mortice to receive partitions (re-  
mant of partition propped on rear wall)

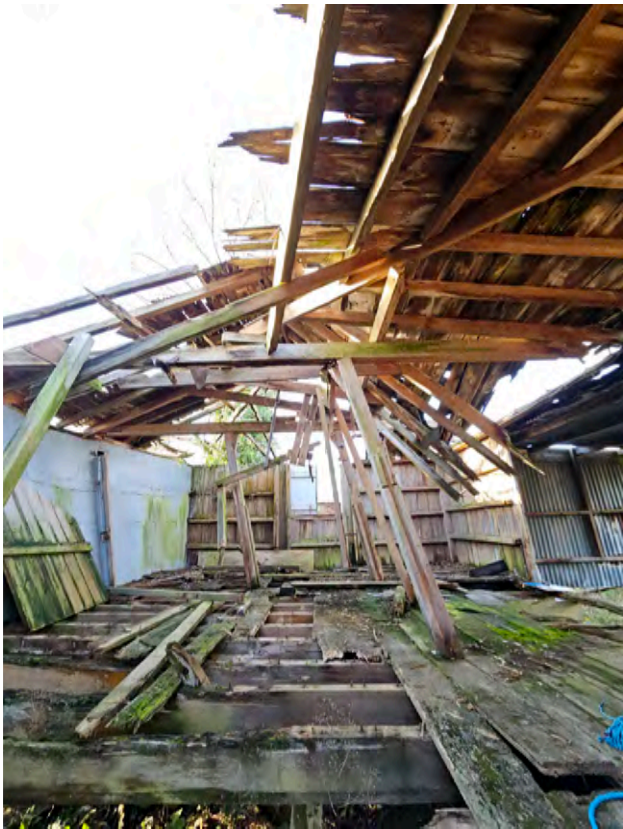
tie beam morticed and pegged to posts

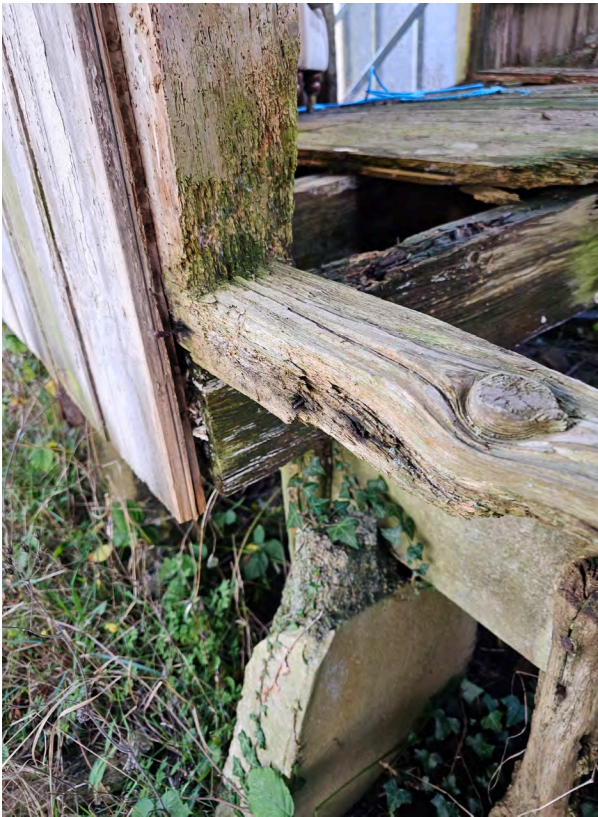
cill plate, door post, joists and cladding

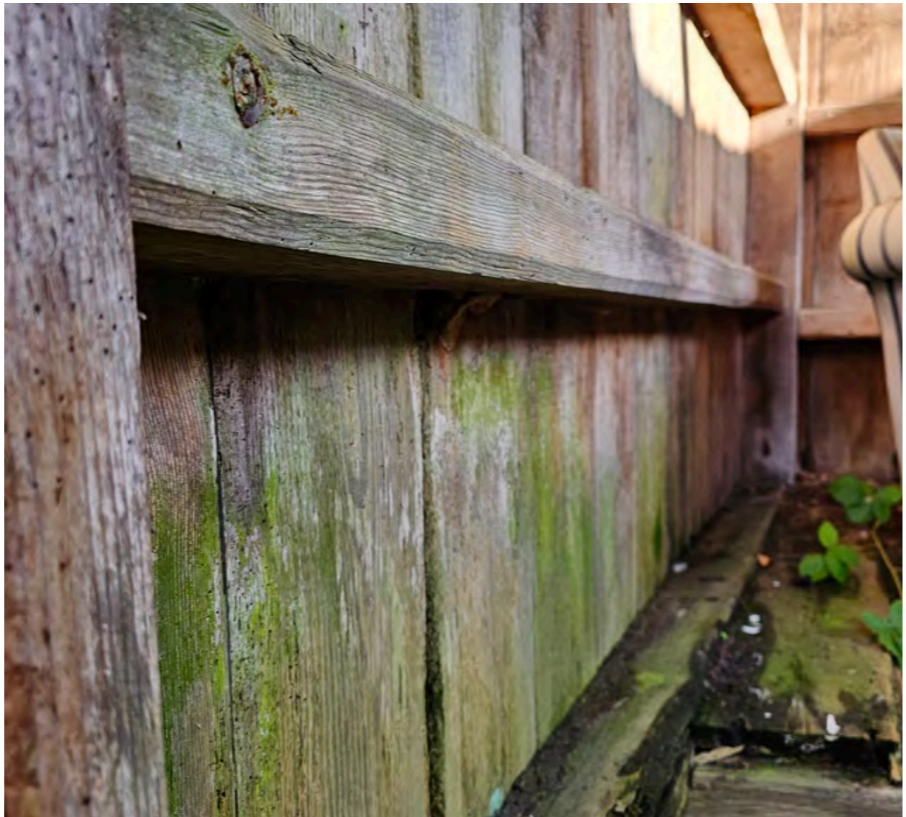
rail and cladding

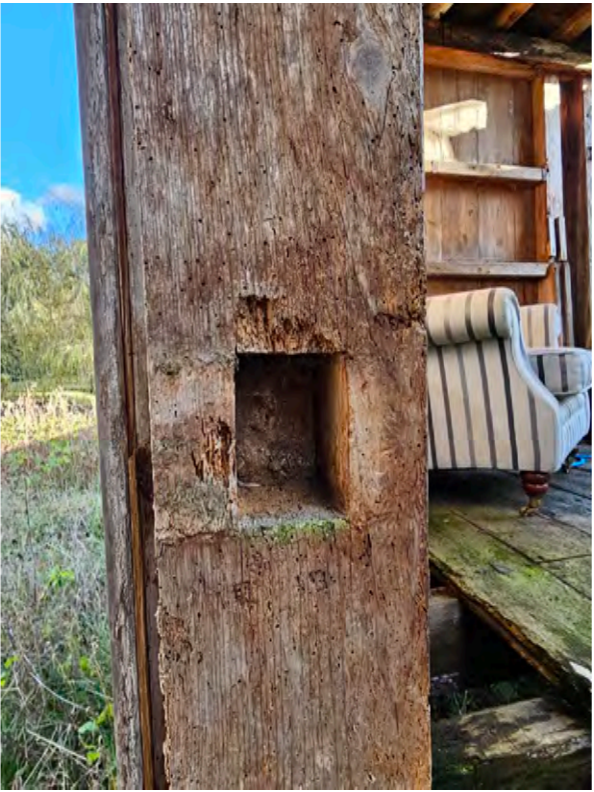
mortice in post to receive cladding rails

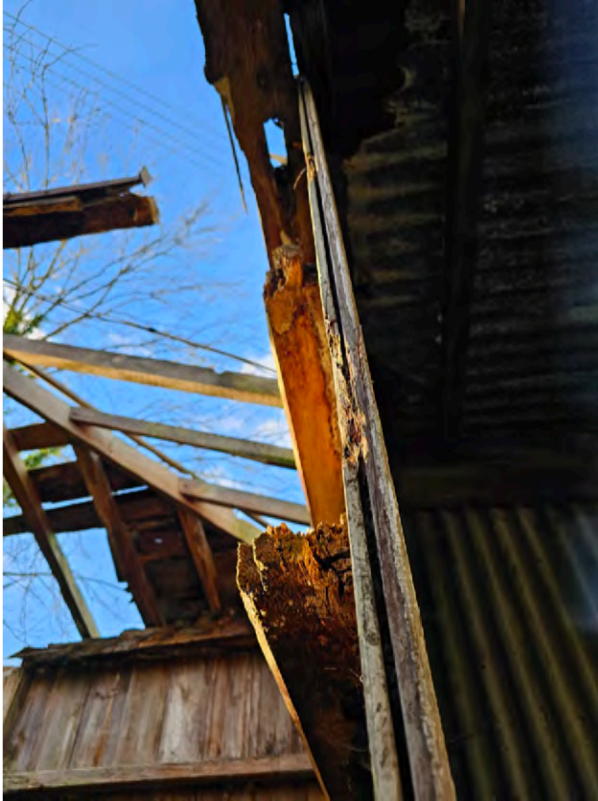
cladding rain and mortice to receive wall post to wall plate

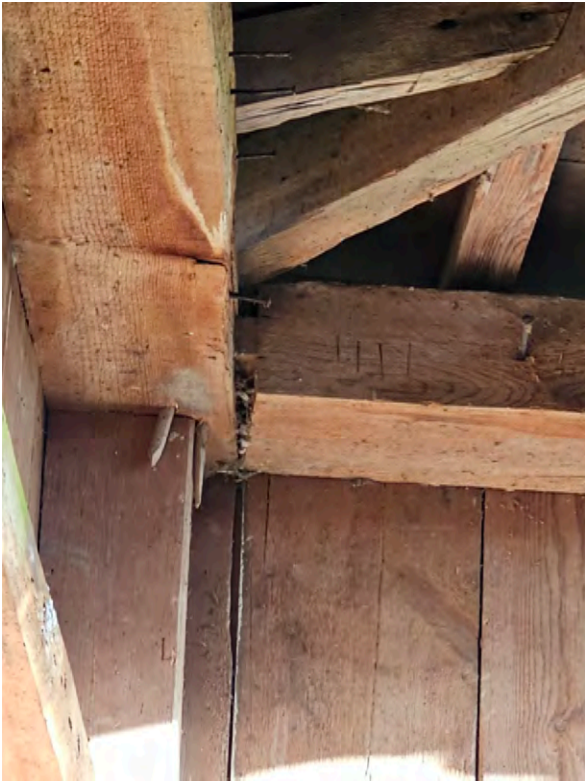
morticed and pegged wall plate and post

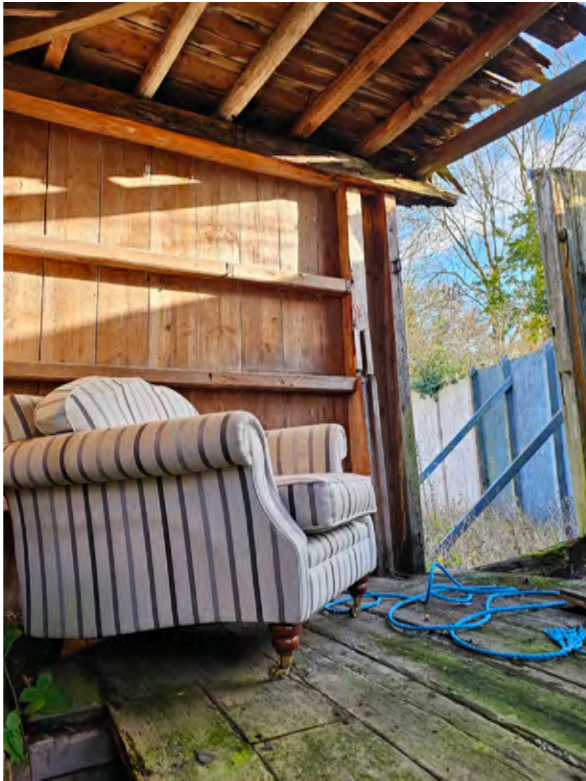
haunched and grooved grain bin post

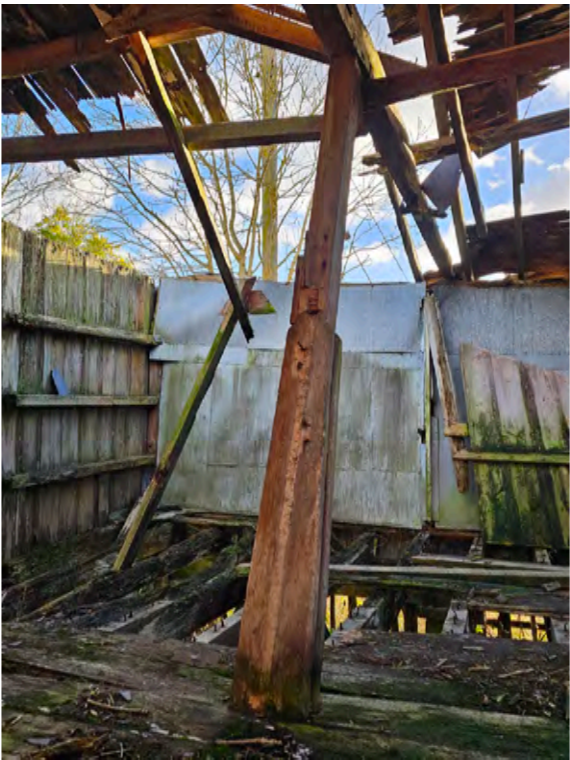
haunched and grooved central grain bin post supporting tie beam

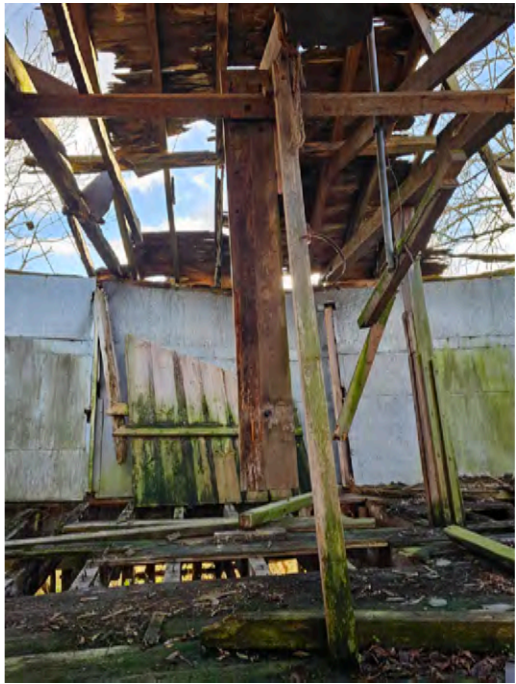
central grain bin prop supporting tie plate to be removed

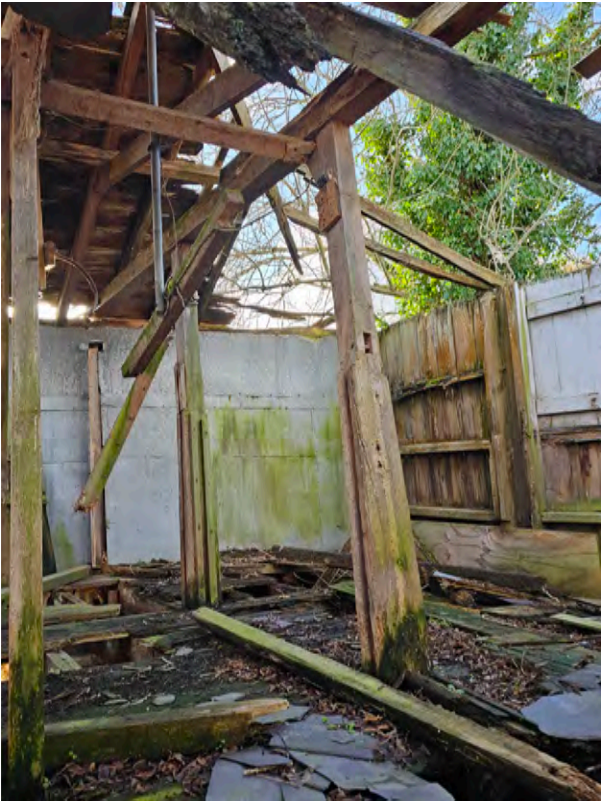
haunched and grooved central grain bin post supporting tie beam. NB brackets to be removed

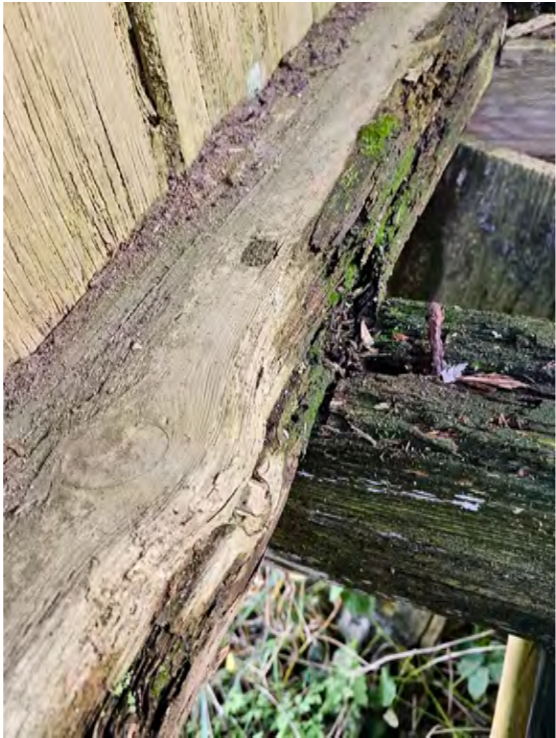
cill plate pegged (alternate) and lapped over joists

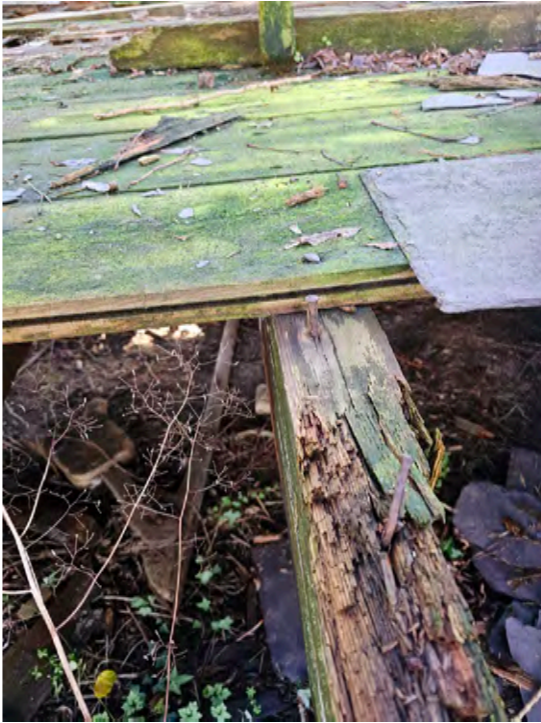
tongue and groove floorboards

5. The exposed timber frame comprises three substantive beams or girders with shaped ends each resting on three staddle stones or replacement props. The beams support floor joists set perpendicular and finished in thick tongue and groove floor boards nailed to the joists.

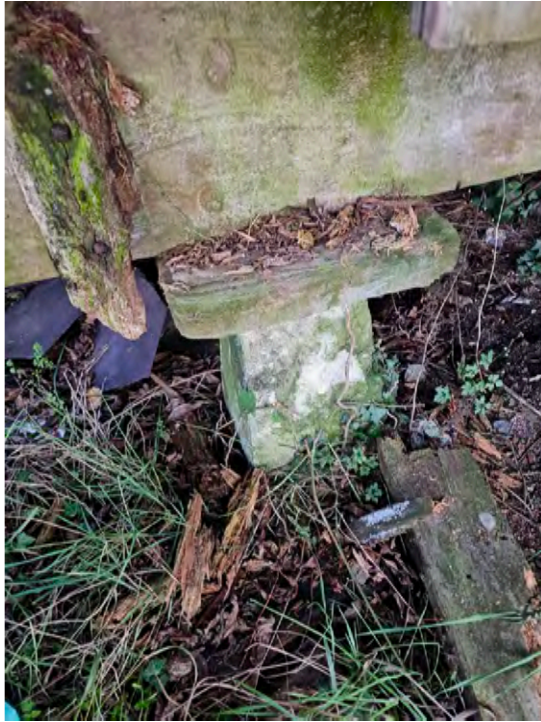
staddle stone supporting girder

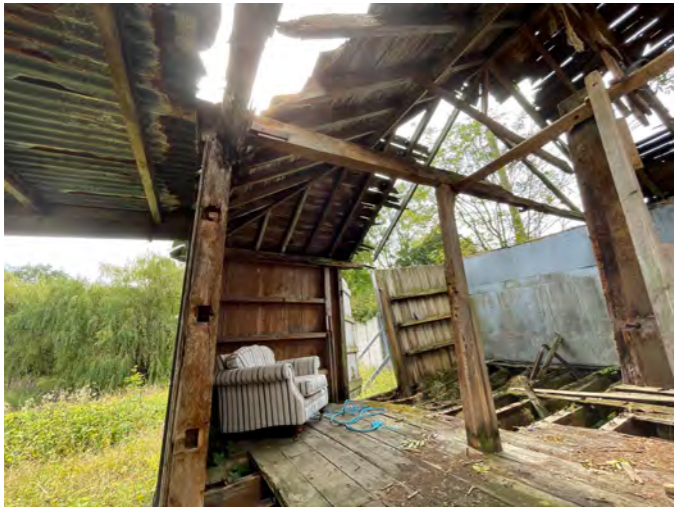
morticed and pegged wall plate and post

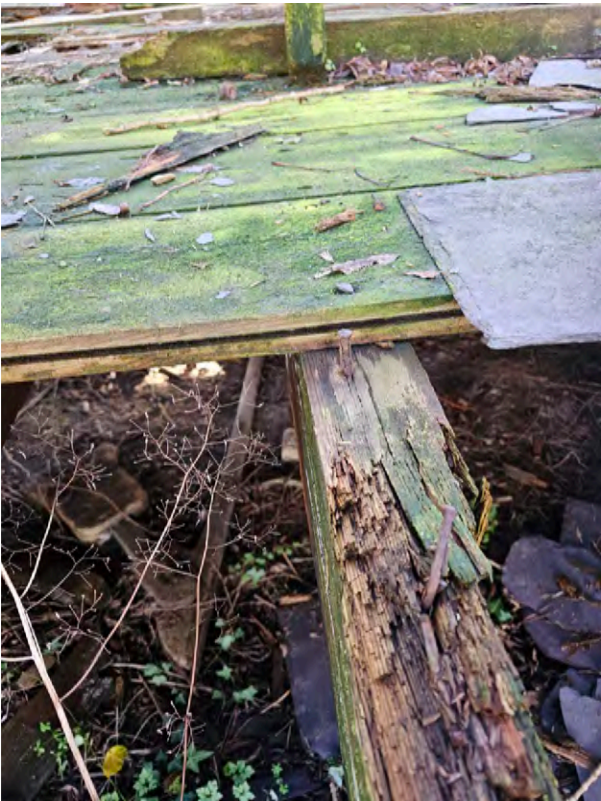
nailed tongue and grooved floor boards

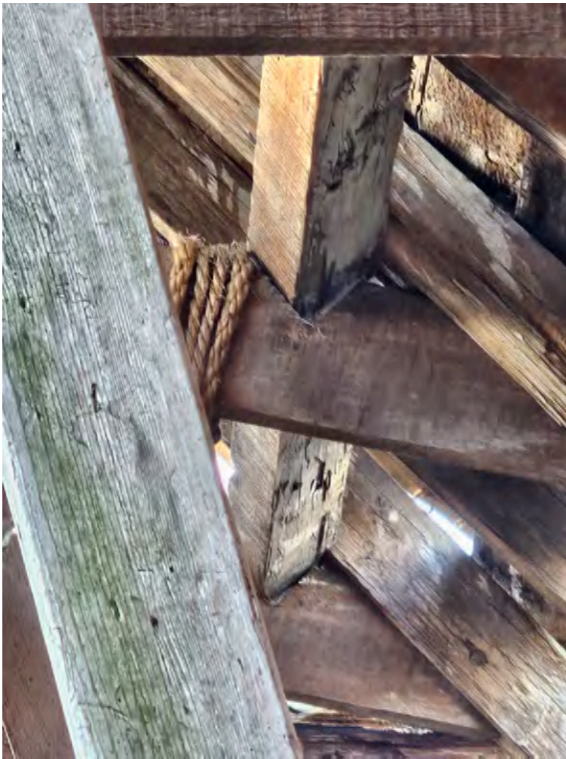
trenched purlin over collar (rafter appears lapped) Collar may be later

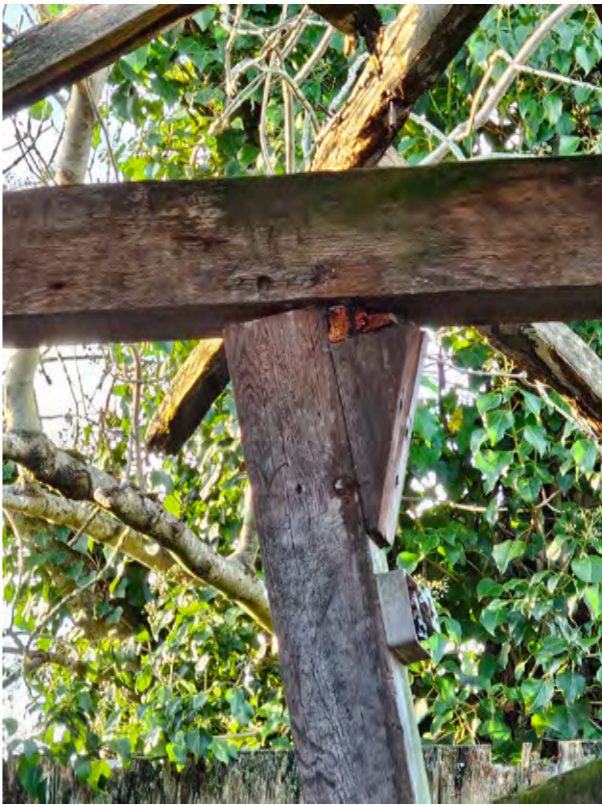
morticed and pegged post to tie beam

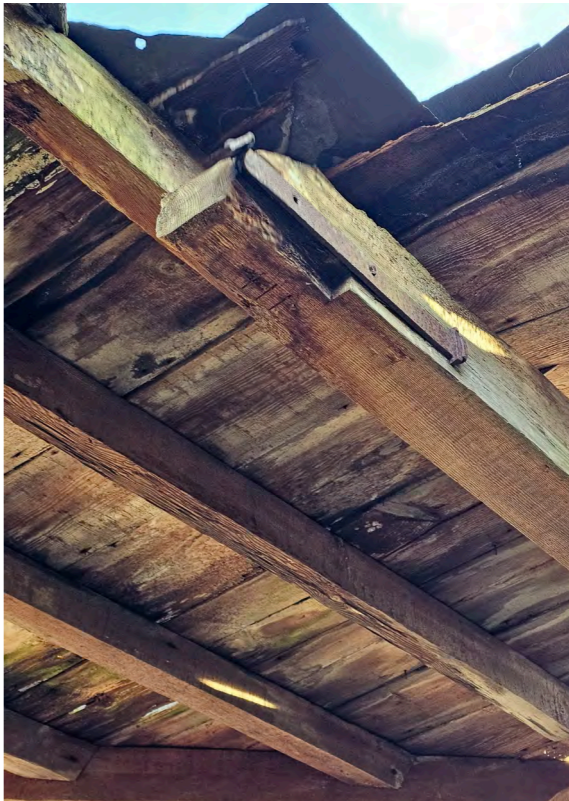
dovetail joint to tie beam to wall plate with twisted forged strap for restraint

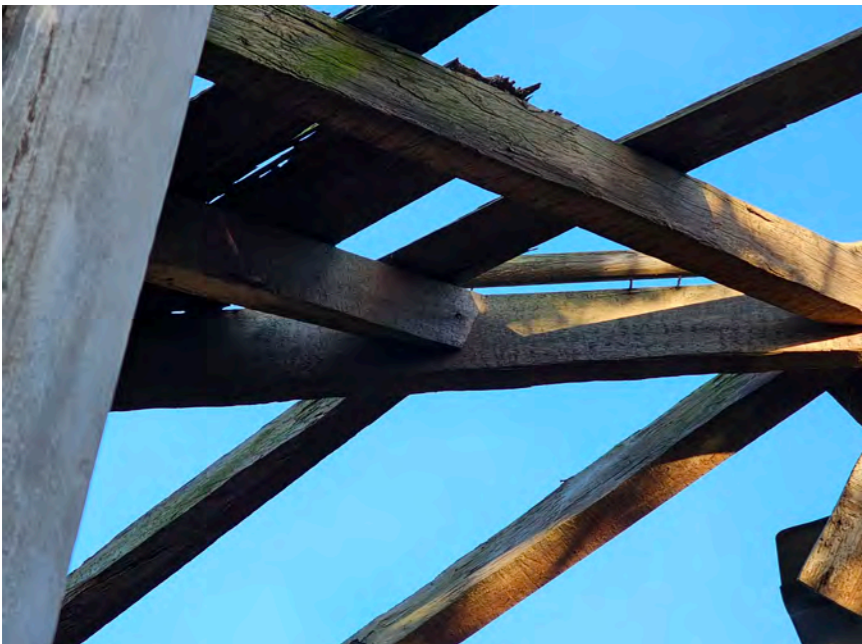
skew fixed nailed jack rafters to hip rafter

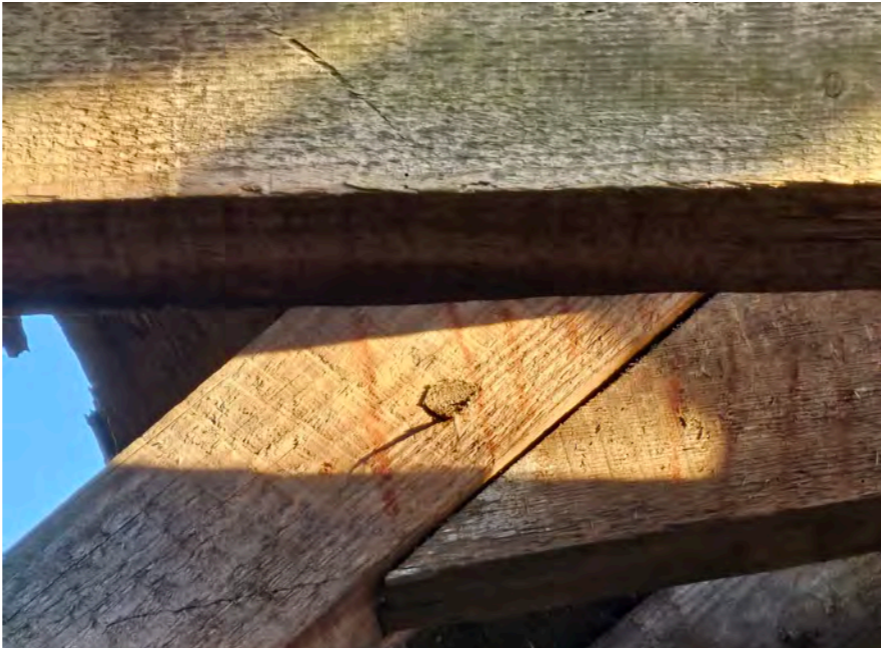
original pegged collar to rafter. Note red riddle pencil carpenter's marks rather than scribed with chisel suggestive of successive alteration to roof

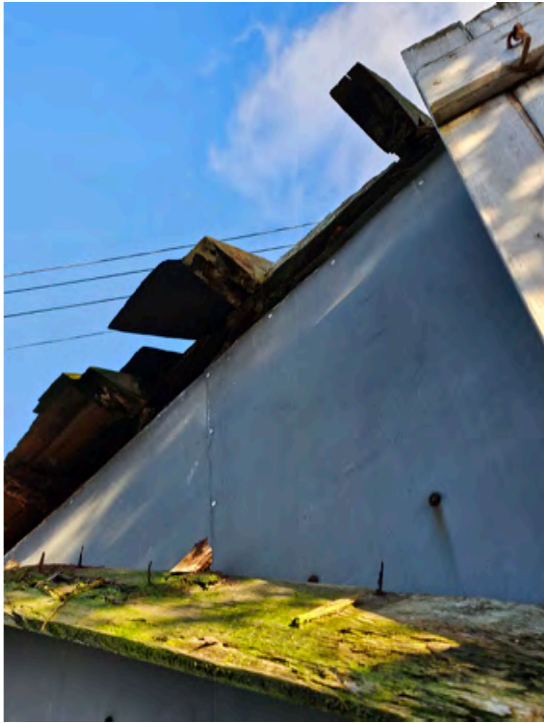
splayed rafter feet with nailed soffit board (displaced)
