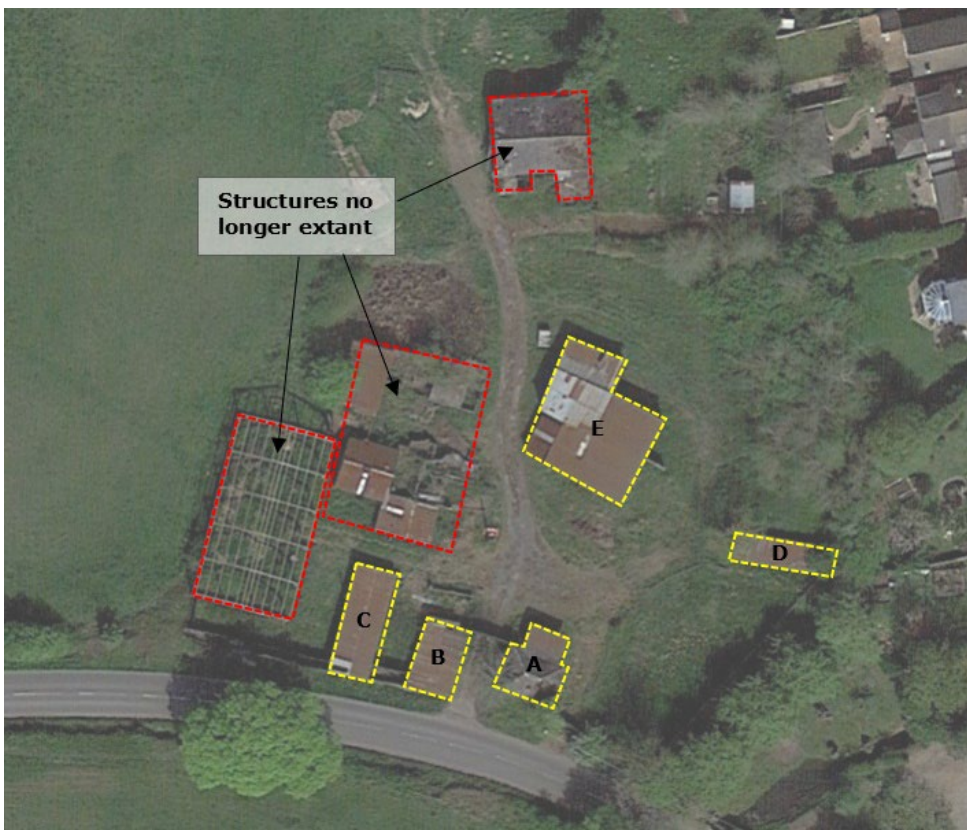
Plate 15: Plan of the former farm buildings associated with Moat Farm.

- 5.32. There are five former farm buildings within the south-eastern part of the Site (annotated A–E on Plate 15 below).
- 5.33. There were once several additional structures within the former farm complex; however, these were recently

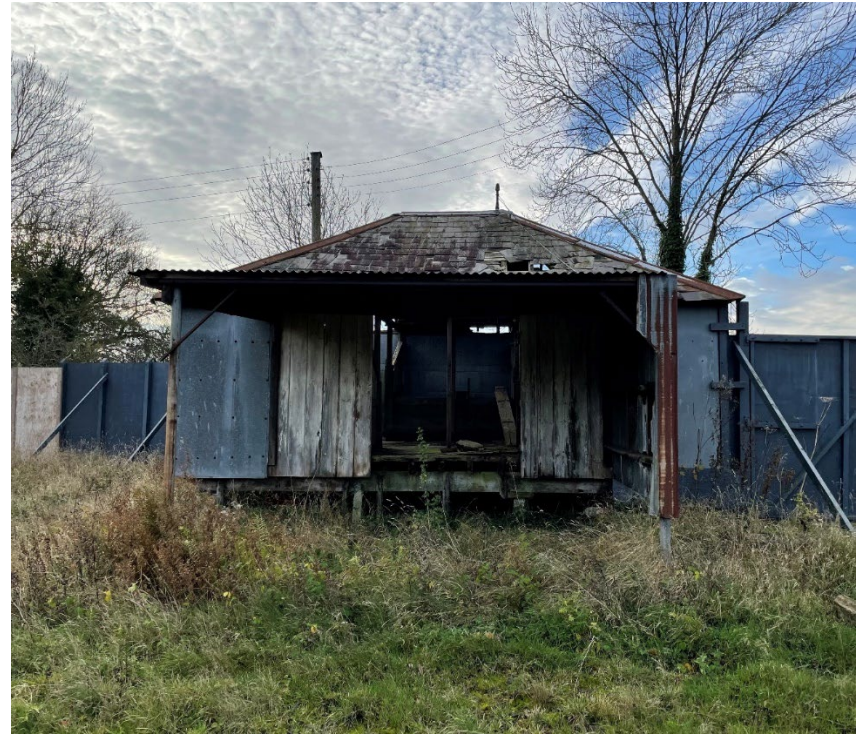
- 5.35. Structure A is predominantly of timber construction with a hipped slate roof (Plate 16). It is clad in timber boarding and sheet metal, with a corrugated metal awning off the north elevation. The entire structure is raised off the ground by staddle stones, lumps of concrete and stakes. Internally there are remnants of timber partitions and grain bins (Plate). Most timbers have modern, machine-sawn profiles. Beneath the rotten and missing floorboards there are some roughly cut timbers that may have been reused from an earlier structure; however, these are rotten and damaged and are of no special interest. The structure is severely dilapidated: the sarking boards are damaged and rotten and many of the slates are missing, thus enabling substantial water ingress (Plate 18).

- 5.36. Although a structure appears to be recorded in this location on the tithe map, the surviving fabric suggests that it was substantially or entirely rebuilt at a later date and has evidently been remodelled since. Structure A is considered to possess minimal heritage significance overall. It may be considered to be curtilage Listed, due to its association with the Grade II Listed Moat Farmhouse.

Plate 16: Structure A, general view of north elevation.

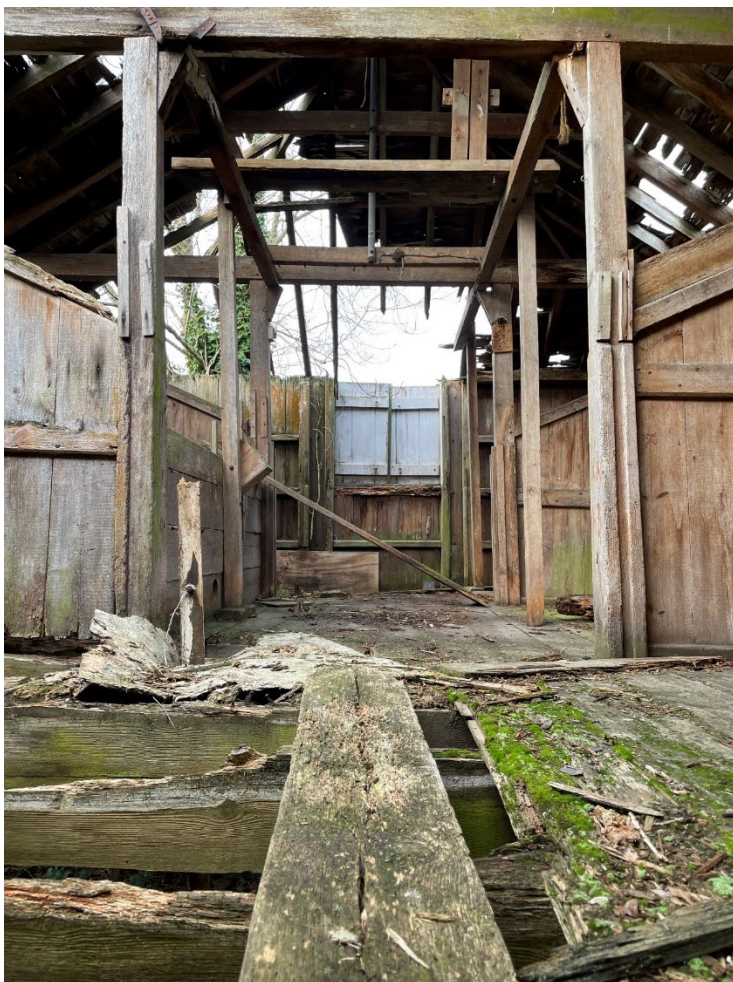
Plate 17: Structure A, detail of interior including missing and rotten floorboards and floor joists.

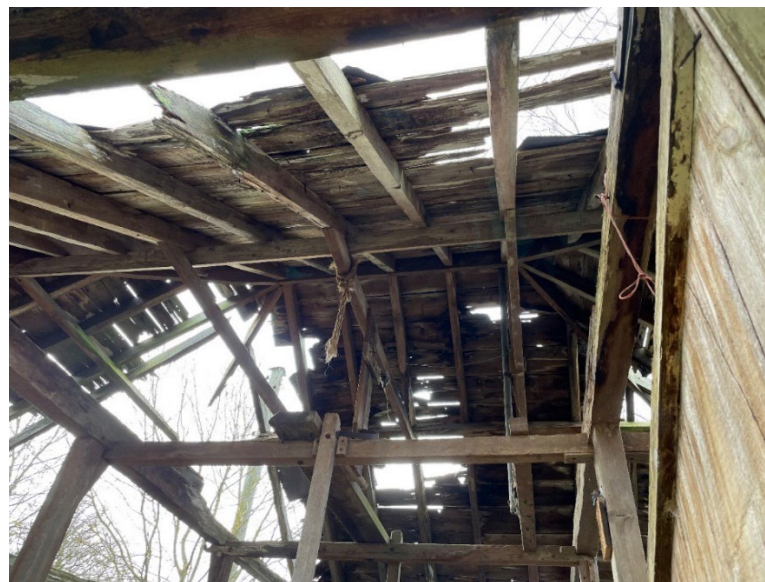
Plate 18: Structure A, detail of roof structure.

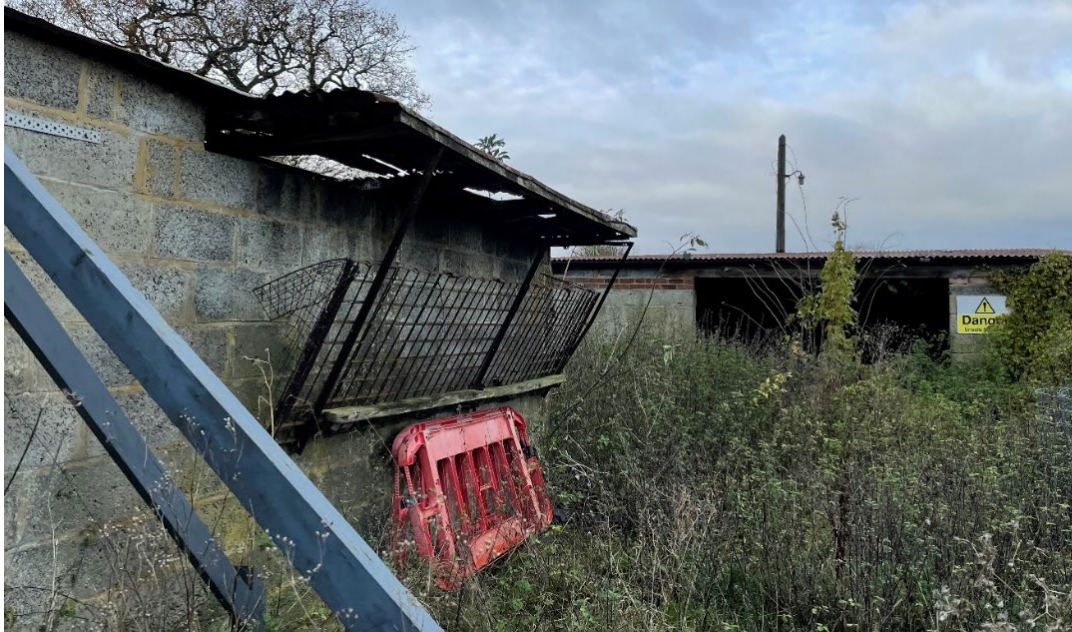
- 5.37. Structures B, C and D are all modern, single-storey agricultural shelters of predominantly concrete block and corrugated metal construction (Plate 19 & Plate 20). They possess no heritage significance and are not considered to be curtilage Listed.

Plate 19: General view of Structures B and C looking south-west from adjacent to the north elevation of Structure B.

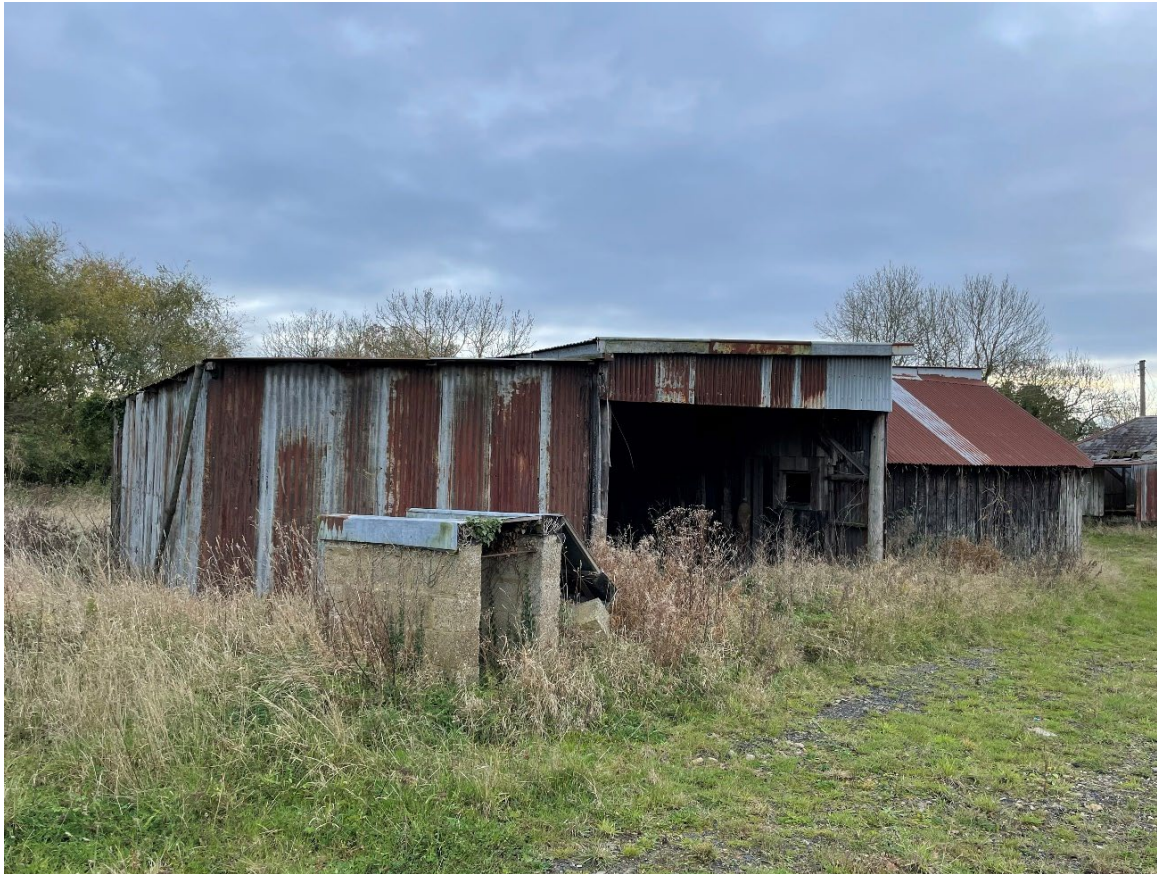
- 5.38. Structure E, located at the centre of the former farm complex, is a large barn building of timber frame construction that is roofed and clad in corrugated metal sheeting (Plate 21). The general form and shallow pitched roofs are indicative of a modern structure, although it appears to integrate some earlier, hand cut timbers fixed with mortises, tenons and pegs. The latter are roughly cut, have been heavily remodelled, and are severely fire

damaged, such that they appear to be giving little to no structural integrity to the building (Plate 2). For these reasons, Structure E is considered to possess minimal heritage significance overall. There is no evidence to suggest it was constructed prior to 1948, and it is not considered to be curtilage Listed.

Plate 21: Structure E, general view of west elevation.

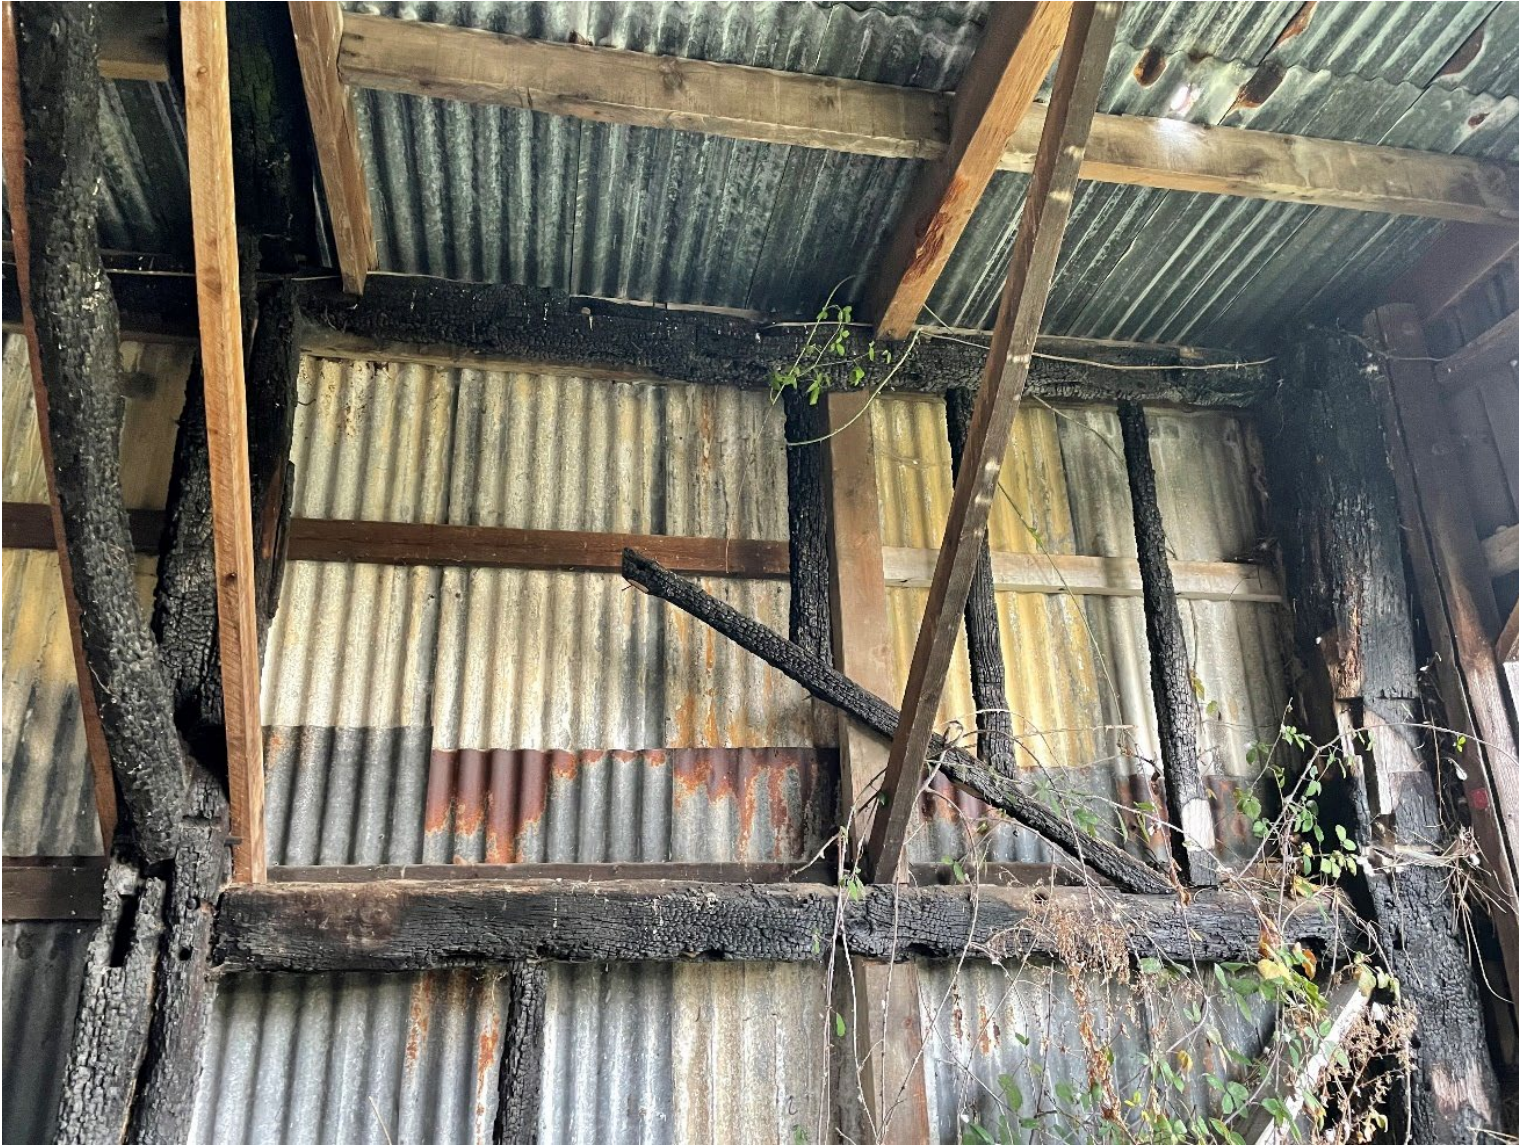
Plate 22: Structure E, detail of interior.

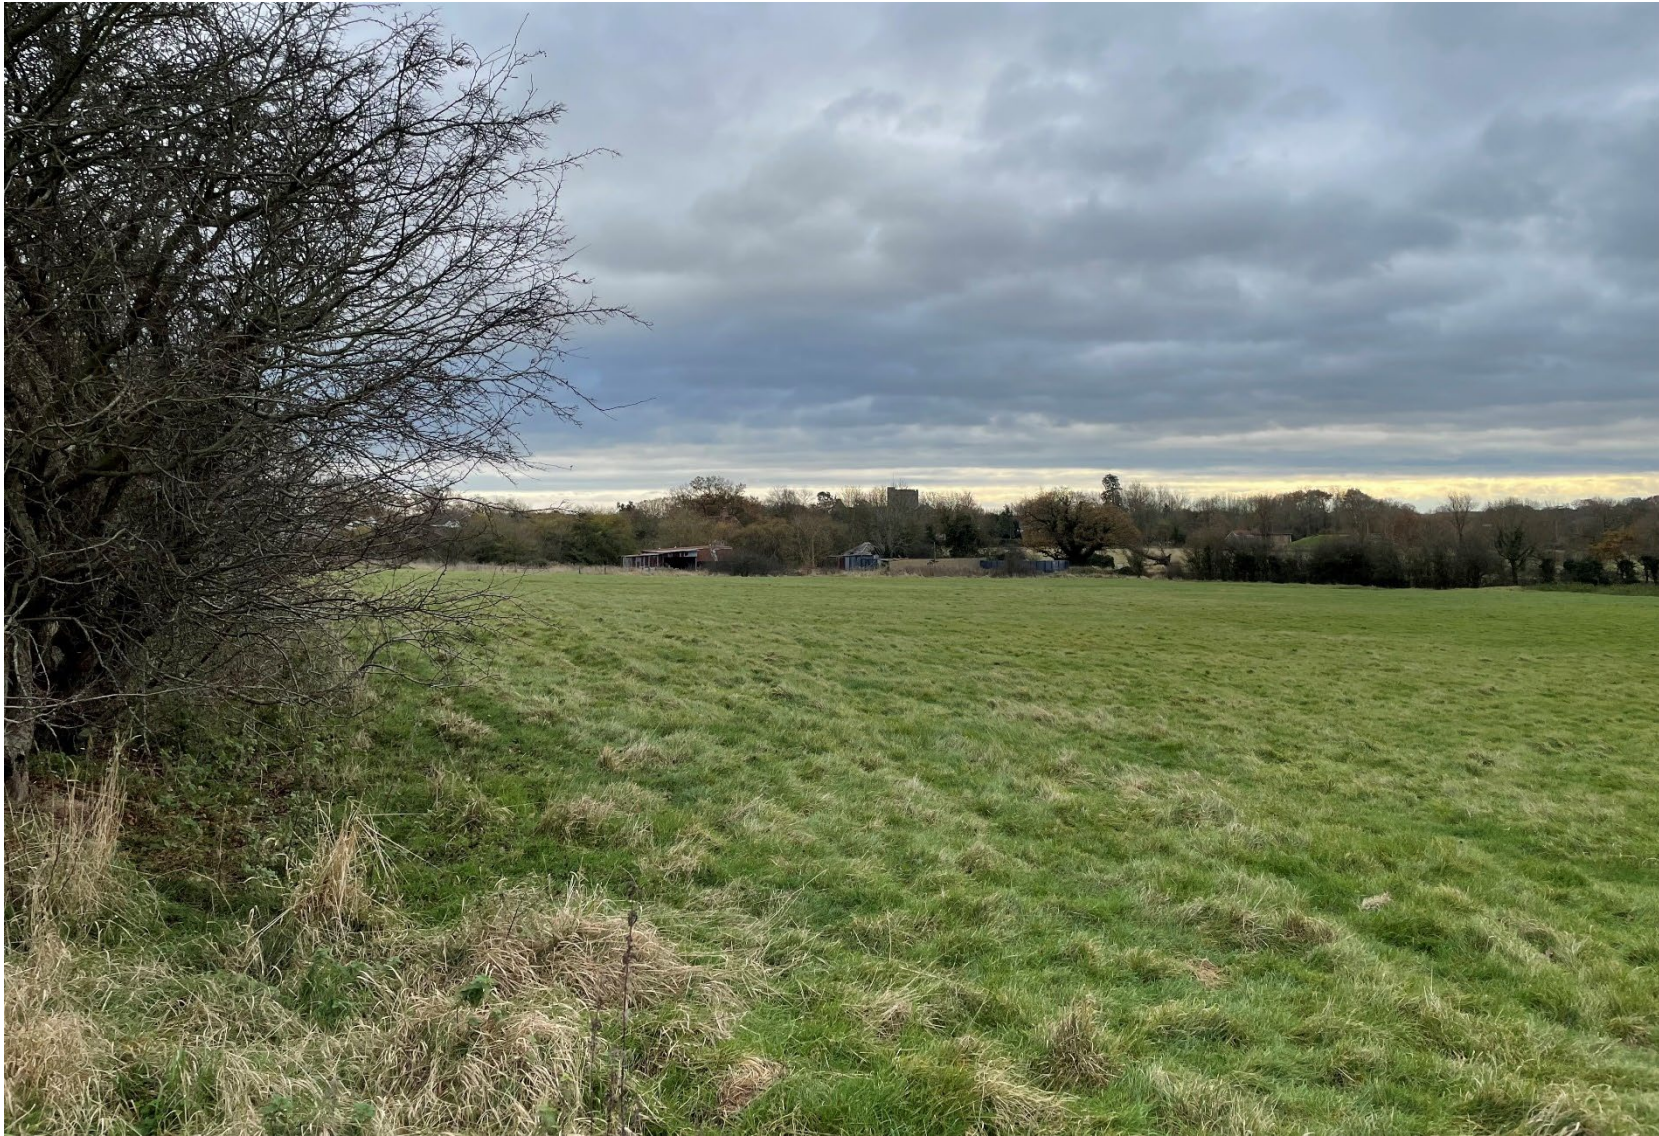
Plate 14: South-east-facing view towards the tower from the public right of way at the north-west corner of the southern parcel of the site.

- 6.10. The experience of the church tower from within the site during the winter months (when intervening vegetation is not fully in leaf) comprises incidental, heavily filtered glimpses of the uppermost part of the tower. Vantage points include from the public right of way that runs parallel with the western edge of the southern parcel of the site (Plate 14) and from private land elsewhere within the site (for example, Plate 15). The intervening vegetation has further matured since these photographs were taken and it is anticipated that the tower will be more heavily filtered (and even completely screened) from view during the summer months.

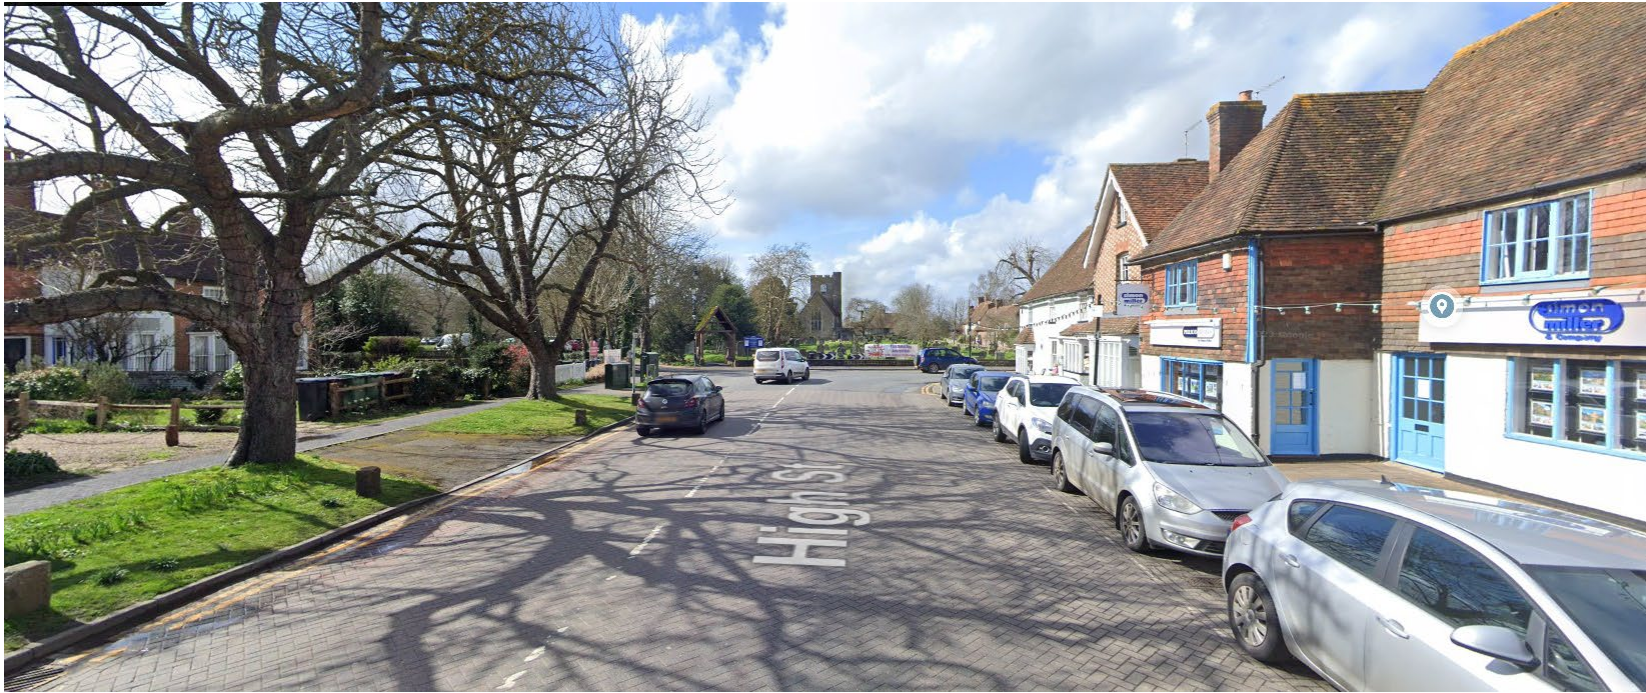
Plate 16: 2023 Google Street View image showing the important viewshed towards the church along the High Street.

- 6.13. The incidental, heavily filtered glimpses from within the site do not equate to important designed or associative views.
- 6.14. A Court of Appeal judgement is also relevant in this respect since the glimpses of the tower from within the site are remote and ephemeral and they do not contribute to the significance of the asset by way of better illustrating the experience of the church within its surrounding landscape or townscape.²⁶
- 6.15. In relation to the last point, and by way of contrast with the incidental and ephemeral views experienced from within the site, there are important views of the church from the historic settlement core of Headcorn, especially the west-facing viewshed along the High Street where the church is the focal point due to the alignment of the road and the flanking historic buildings (Plate 16).

The site is not visible.

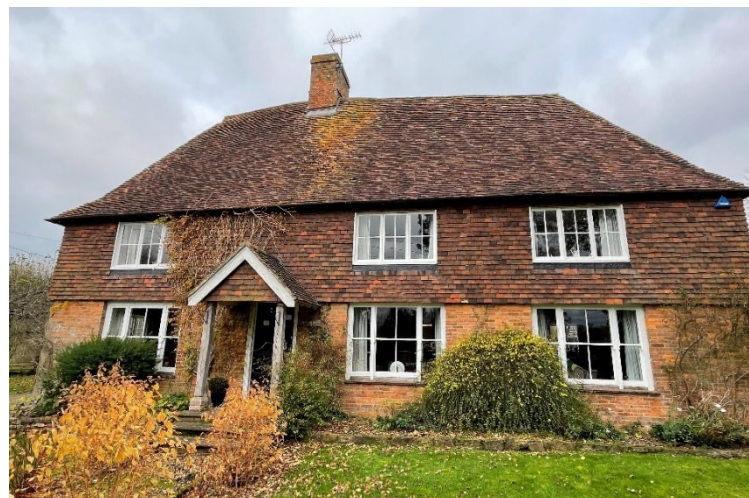
Plate 23: The Moat, Grade II Listed Building.

- 6.22. A full copy of the List Entry is included at **Appendix 7**.
- 6.23. The building is a former farmhouse which is thought to date from the early or mid-16th century. It has a timber frame core which has since been concealed externally by brickwork and hung tiles.
- 6.24. The 1841 tithe map for the parish of Headcorn illustrates that the farmhouse was formerly located at the centre of a moated complex which lay beyond the Site. The wider farm complex included a collection of unspecified buildings, yards, a saw pit, and a pond (these extended into the south-east corner of the Site). All were in common ownership and functional use with The Moat, being owned and occupied by the master and fellows of St John's College, Cambridge (Plate 24).

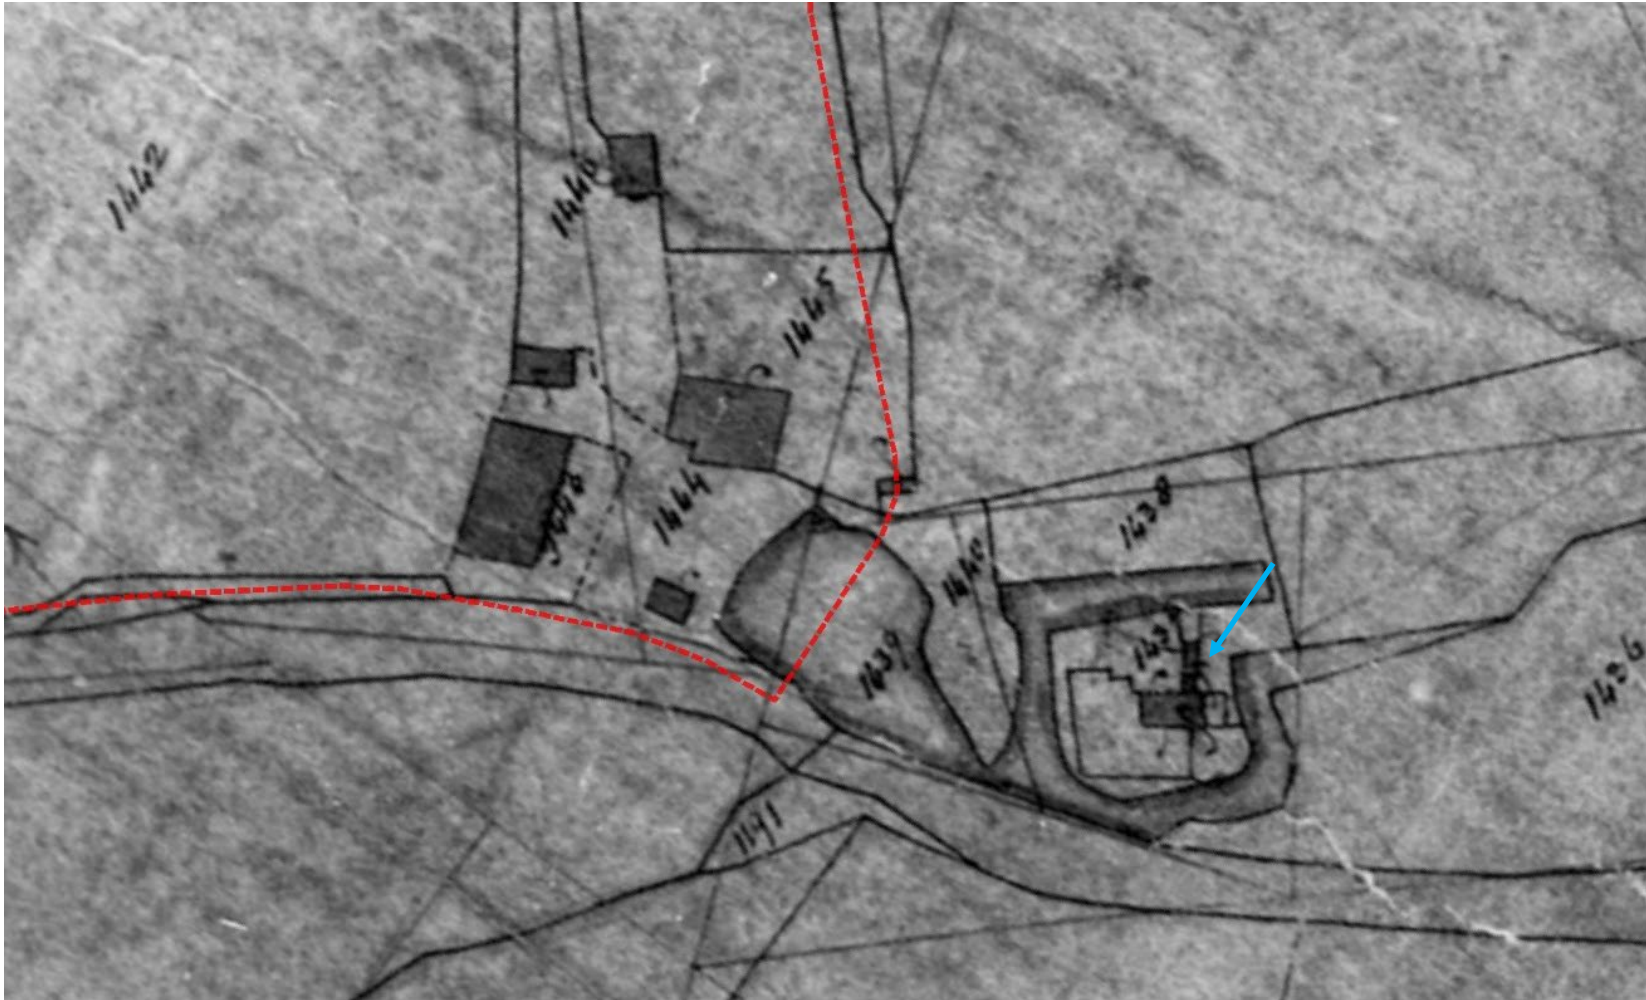
Plate 24: Extract of the 1841 tithe map for the parish of Headcorn.

The Site (partially shown) is outlined in red. The Moat is marked with a blue arrow.

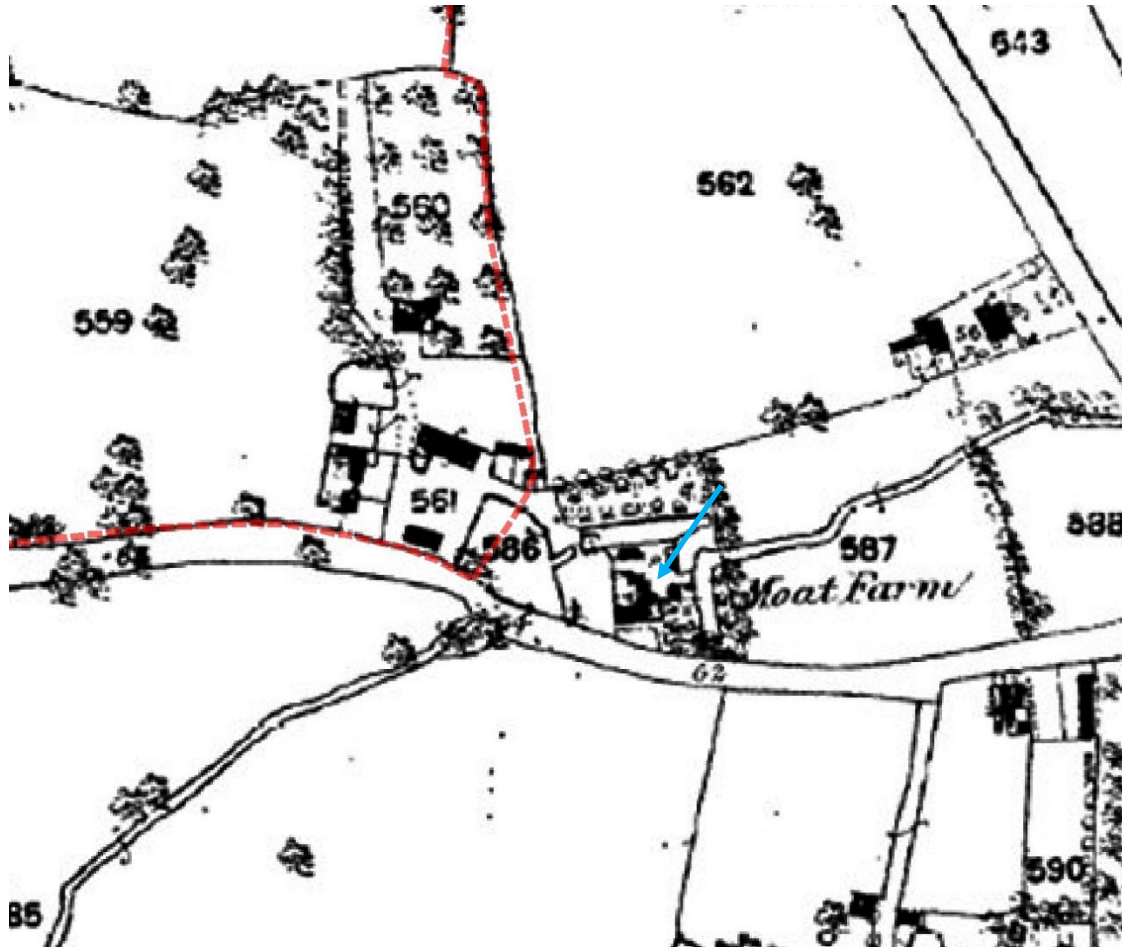
Plate 25: First Edition (1897–98) Ordnance Survey map.

- 6.25. The late 19th-century First Edition Ordnance Survey map records the moated farmhouse and structures to the north-west as 'Moat Farm' (Plate 25). The moat surrounding the farmhouse had been substantially eroded or drained, especially on the south and west sides. The earlier buildings located within the south-east corner of the site (as recorded on the tithe map) had apparently been remodelled or replaced, especially as the two largest structures illustrated on the 1841 map are recorded with much reduced footprints on the late 19th-century map. These buildings were presumably in agricultural use.

The Site (partially shown) is outlined in red. The Moat is marked with a blue arrow.

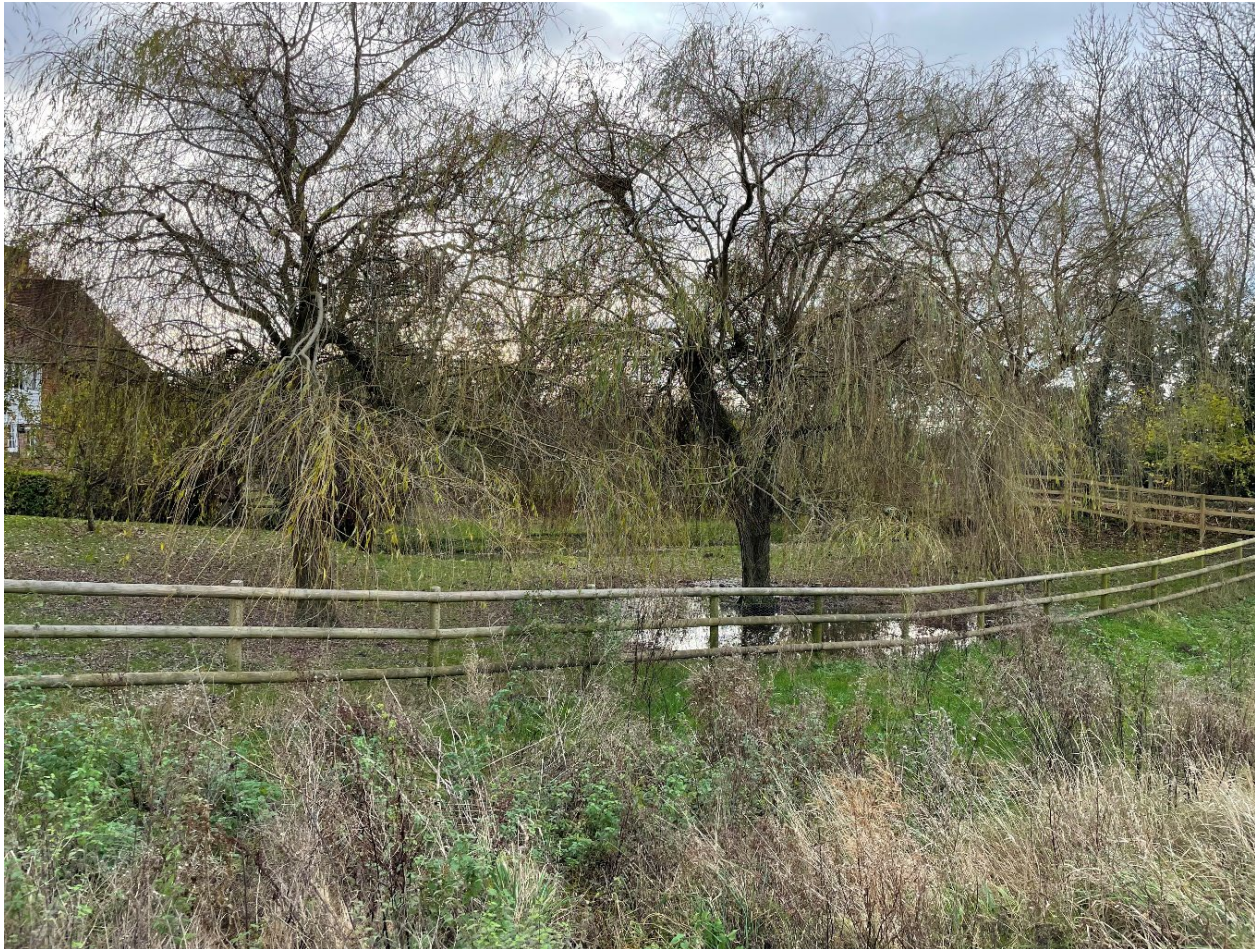
- 6.29. The historic pond (located at the south-eastern edge of the Site) which formerly separated the farm complex from The Moat is legible as a slight depression; however, this has largely drained away (Plate 27).

Plate 27: South-east-facing view to the location of the former pond from the south-east edge of the site.

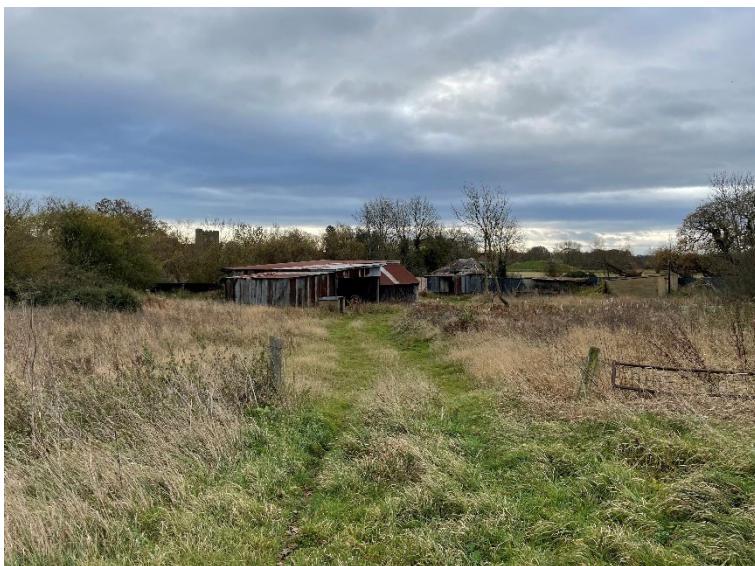
Plate 28: Views South Towards the Farm Buildings from the Site.

6.30. Intervisibility between the land to the west and the Listed building is very largely screened by intervening vegetation (Plate 28), although the land and building can be experienced in dynamic views travelling along Moat Road.

6.35. The Moat is visually separated from the remaining farm buildings within the site by intervening vegetation (Plate 28). There is some limited visibility from the grounds of

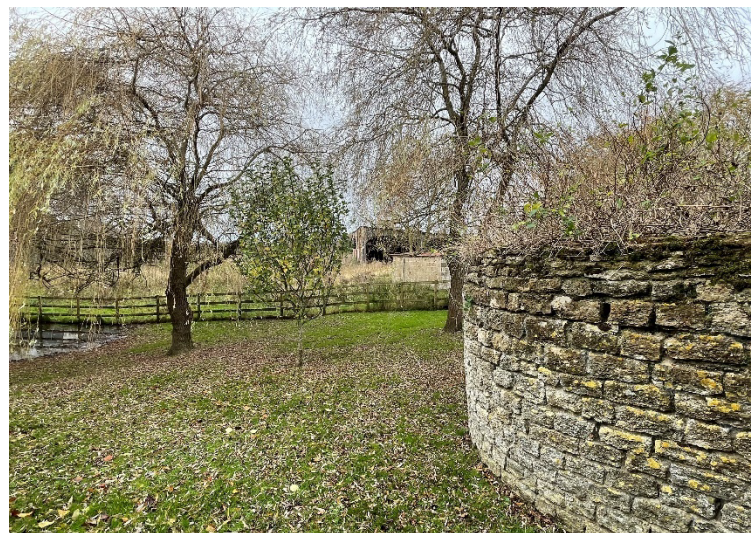
Plate 29: View from The Moat Grounds towards Farm Buildings.

the asset of Buildings D and E (Plate 29) from within the western area of the grounds, and visibility of the group as a whole from the boundary (Plate 30).

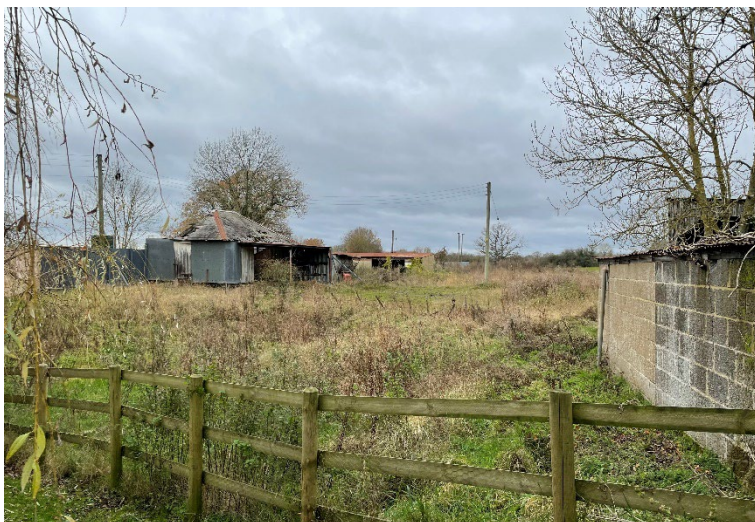
Plate 30: Views from The Moat Boundary towards Farm Building.

- 6.36. The dilapidated farm buildings detract from the visual approach to The Moat from the west and are not the focus of any intentional or important historic illustrative views for The Moat outwards.
- 6.37. The buildings and farmland within the site are considered to make only a minor contribution to the heritage significance of The Moat through setting, through historic illustrative values.
