Land north of Moat Road, Headcorn Kent

Proposed Site Access and
Associated Highway Works

Road Safety Audit Response Report 2

Road Safety Audit: Stage 1

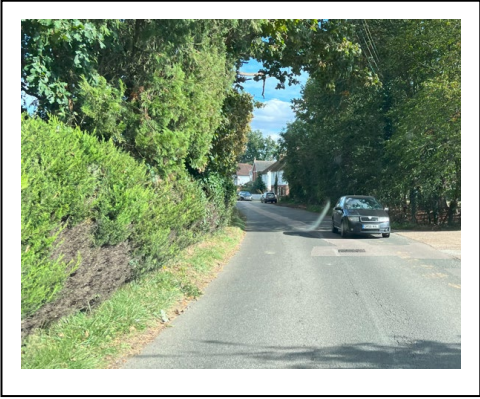
PROBLEM		1-3
Location:	Moat Road uncontrolled crossing.	
Summary:	A lack of suitable pedestrian-vehicle visibility splays can increase the risk of pedestrian-vehicle collisions.	
<p>As part of the scheme there will be a new uncontrolled crossing of Moat Road details of the intervisibility between pedestrians and vehicles are not shown on the drawing. The Audit Team were concerned that pedestrians crossing Moat Road (especially from the north) could have their visibility to vehicles approaching eastbound on Moat Road obstructed (Photo).</p> <p>Based on current standards and a speed limit of 30mph DMRB CD109 Table 2.10 shows that the visibility required is 1.5m x 40m (MfS 30mph).</p> <p>A lack of suitable visibility between pedestrians and vehicles can increase the risk of collisions.</p>

RECOMMENDATION		
Ensure that intervisibility is provided that meets the required standards.

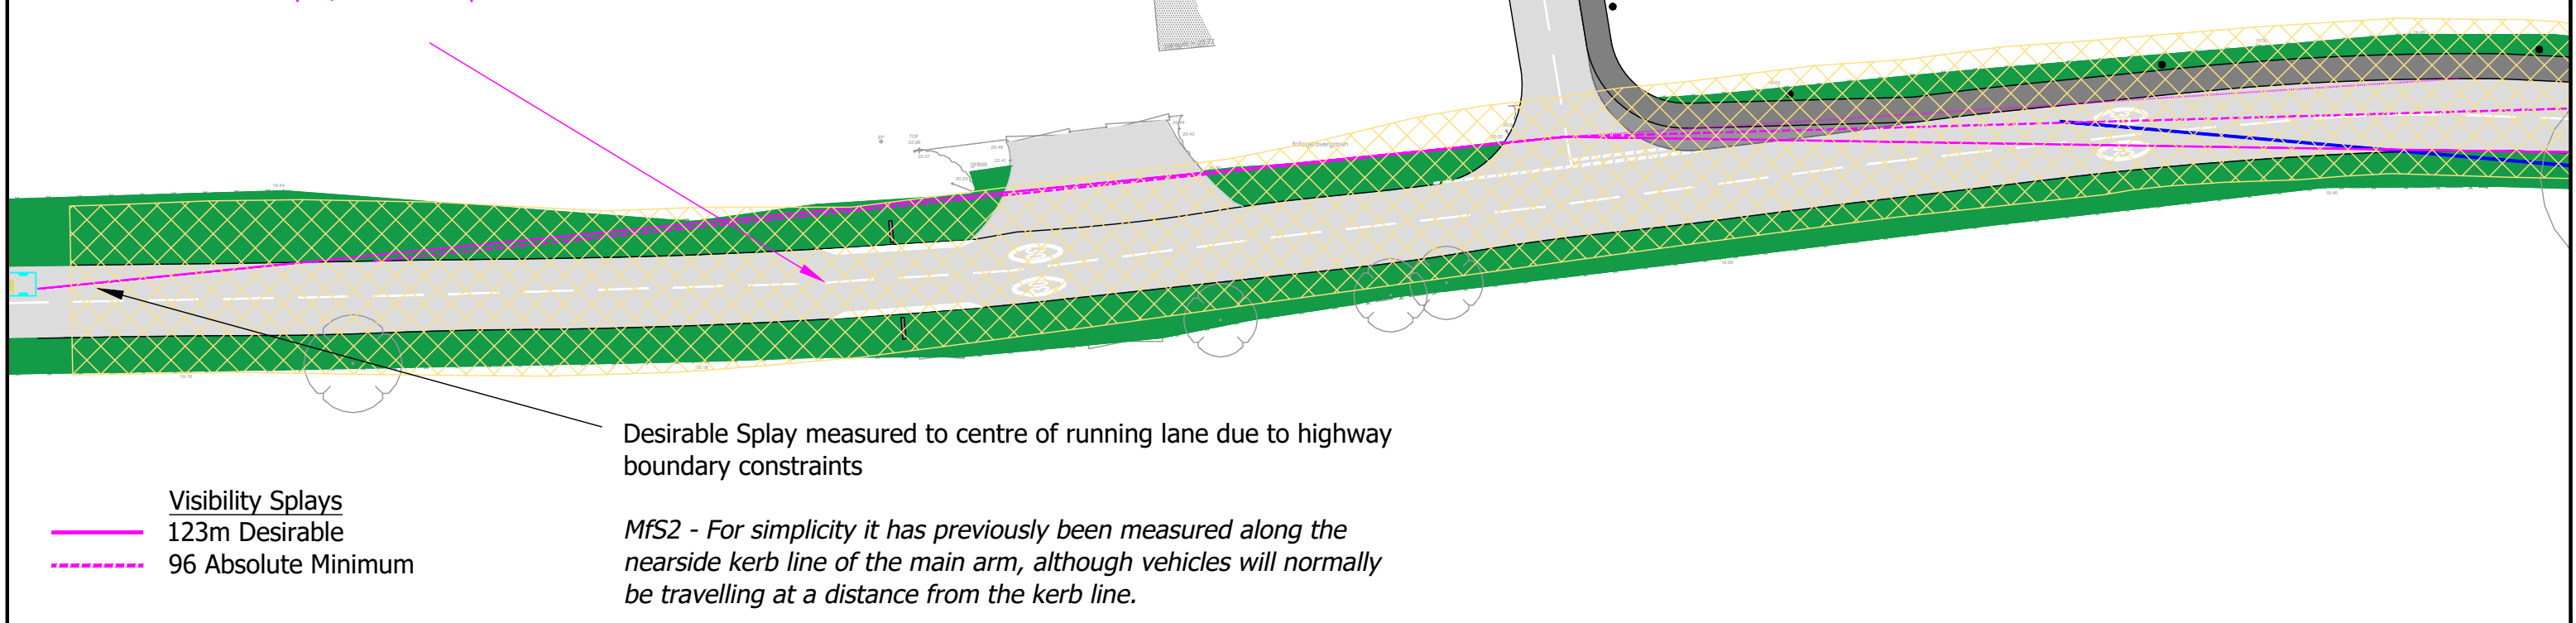
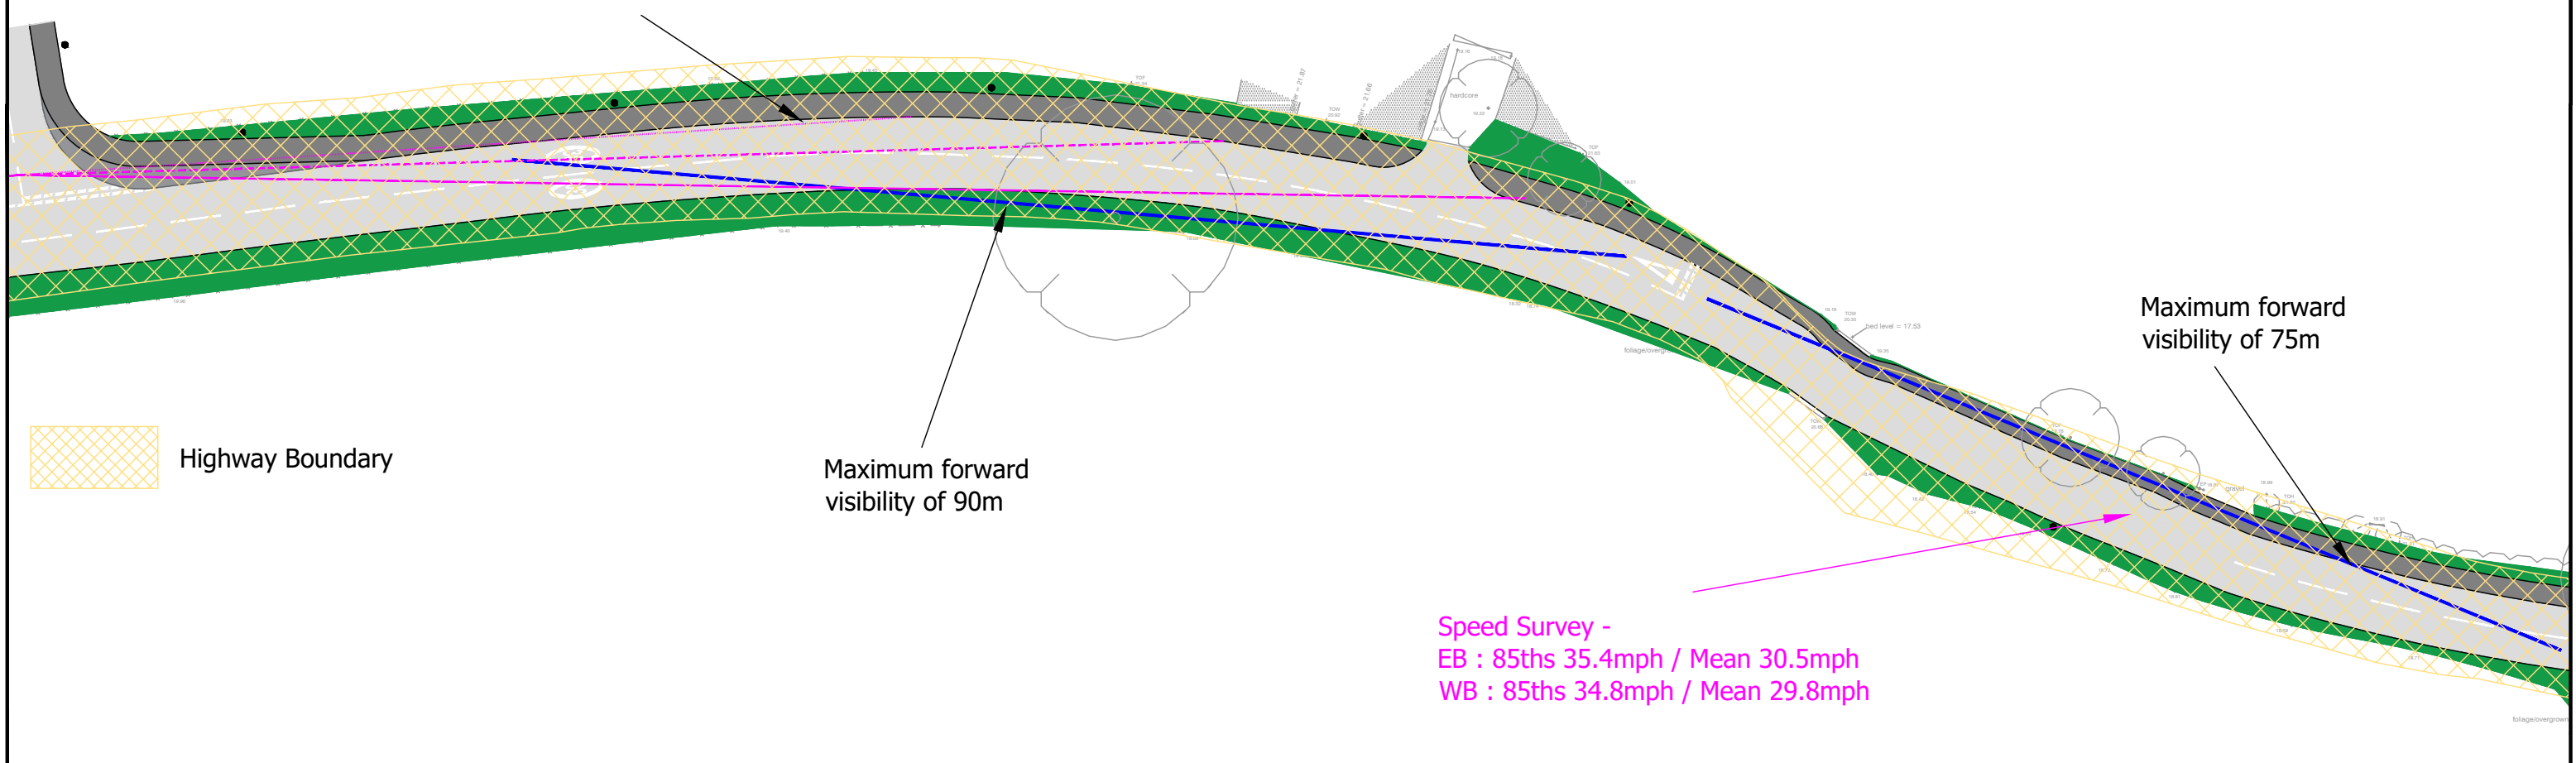
JOB TITLE	Moat Road, Headcorn	CLIENT	Catesby Estates PLC
DRAWING TITLE	Visibility Splays (with Highway Boundary Overlay)		
SCALE	1:500@A3	DRAWN BY	DN
DATE	Nov 2019	DRAWING No	20472-03-3
REVISION	A

Speed Survey -
 EB : 85ths 45.2mph / Mean 39.2mph
 WB : 85ths 45.2mph / Mean 39mph

Visibility Splays

123m Desirable

96 Absolute Minimum

Maximum forward visibility of 90m

Maximum forward visibility of 75m

Speed Survey -
 EB : 85ths 35.4mph / Mean 30.5mph
 WB : 85ths 34.8mph / Mean 29.8mph

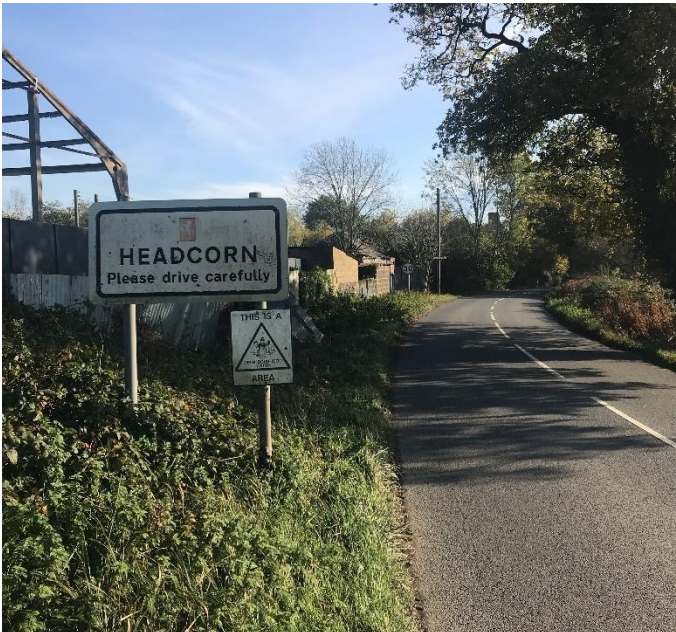
Figure 1: Street furniture items in northern verge of Moat Road.

Should street furniture items be located within the proposed footway, this may reduce the effective width and cause an obstruction to pedestrians, particularly mobility impaired or those with buggies. Where obstructions cause them to walk in the carriageway this increases the risk of them being struck by passing vehicles.

The recommendation is accepted. All existing signs/ street furniture that are affected by the proposed footway will be either be relocated to the verge behind the footway where possible or to alternative locations.

It is recommended that all street furniture items are reviewed and, where located in the proposed footway, are relocated accordingly.

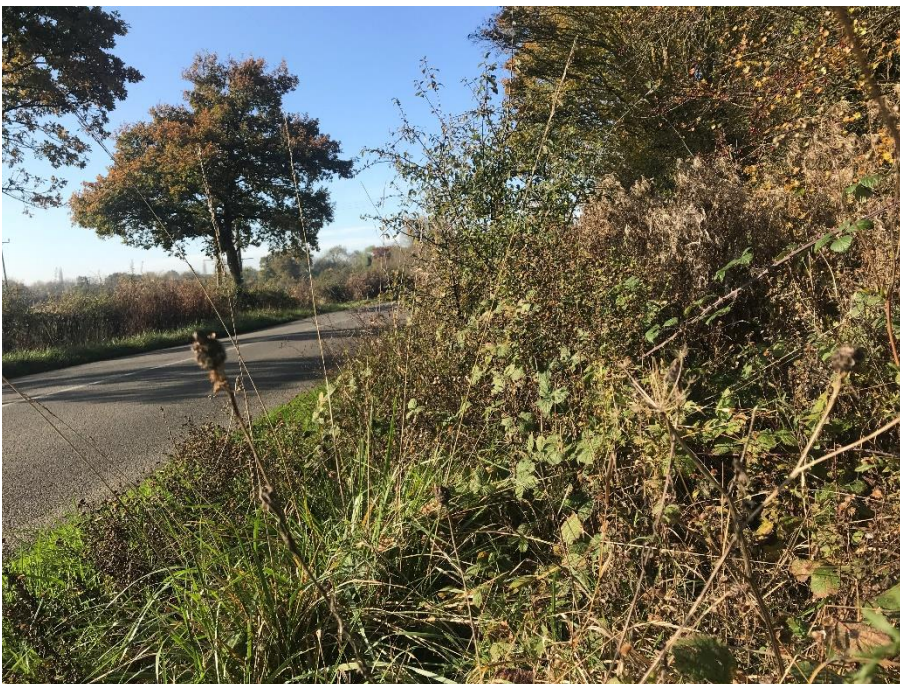
Figure 2: Existing vegetation to the west of the proposed site access

The proposed site access is to be located approximately 20m east of the electrical sub-station. The visibility splay for the junction is shown on drawing 20472-03a-2. It shows a desirable splay of 123m can be accommodated to the centre of the carriageway to west with a 96m absolute minimum splay to the edge of carriageway. Both however, extend through the existing verge which is currently established vegetation. **Figure 2** below shows the view to west from the proposed site access.

It is not clear from the proposals what the extent of vegetation clearance will be and therefore the viability of the visibility splays proposed. Should vegetation remain within the visibility splay, this increases the risk of inappropriate turning movements and collisions.

*The recommendation is accepted. The visibility splays are wholly contained within either land under the control of the developer or public highway. This is shown on **Drawing 20472-03a-3**. Therefore, any vegetation interfering with the visibility splay will be removed. There are no trees that would be affected.*

It is recommended that the vegetation within the visibility splay is removed and a maintenance plan provided to ensure the growth of vegetation within the visibility splay is managed.

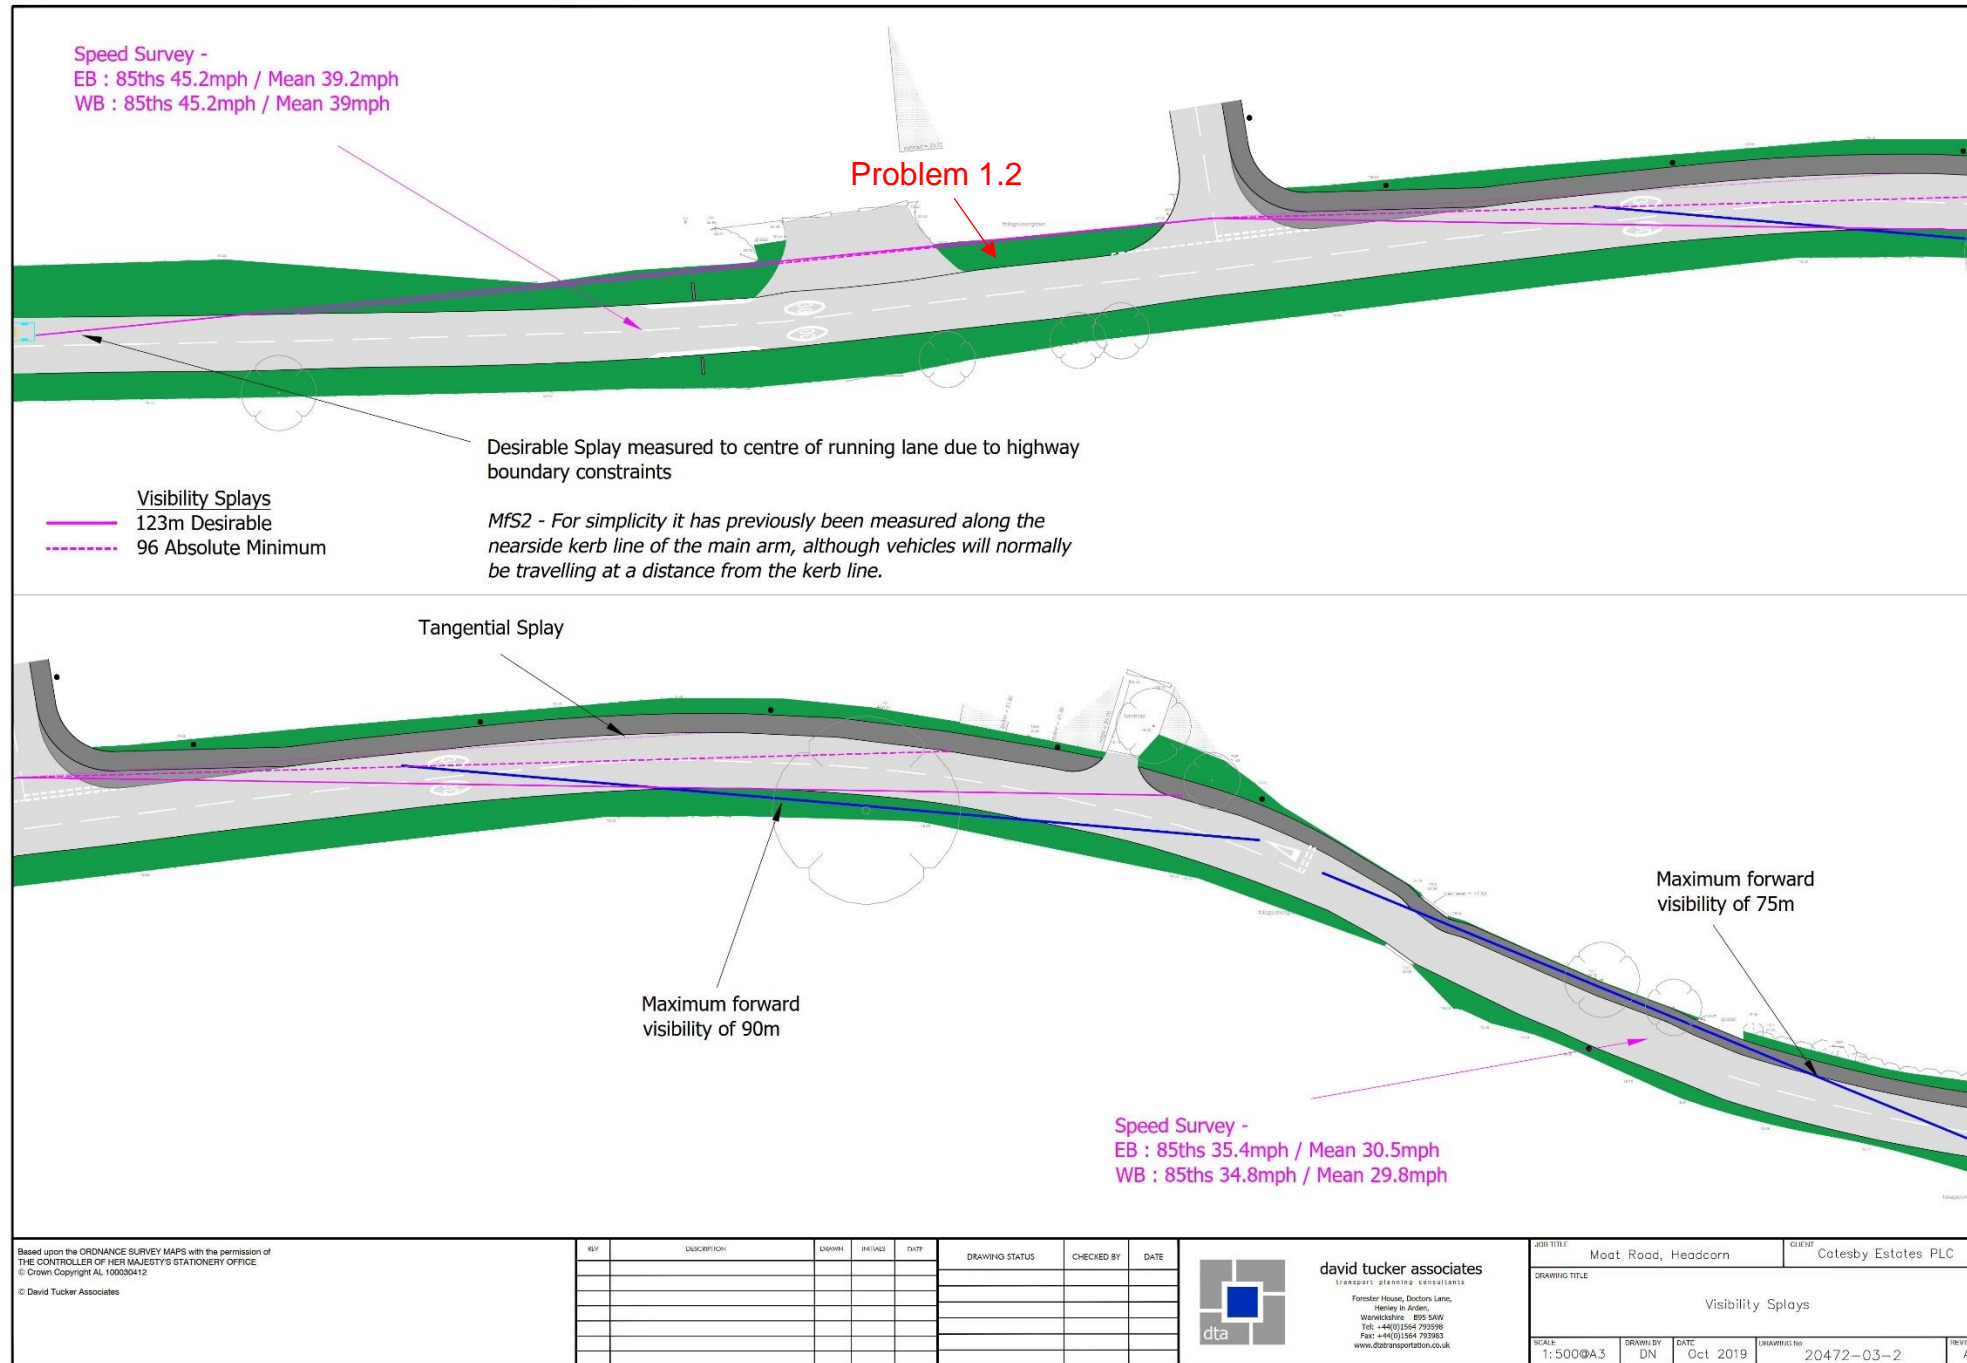
Key Plan B – Moat Road, Headcorn Visibility Splays

2.3 Location: Key Plan B: Proposed site access on Moat Road

The proposed site access is to be located approximately 20m east of the electrical sub-station. The visibility splay for the junction is shown on drawing 20472-03a-2. It shows a desirable splay of 123m can be accommodated to the centre of the carriageway to west with a 96m absolute minimum splay to the edge of carriageway. Both however, extend through the existing verge which is currently established vegetation.
