Technical Note

Project: Land North of Moat Road, Headcorn

Planning Ref: 23/504471/OUT

Bat Emergence Surveys: Building B4

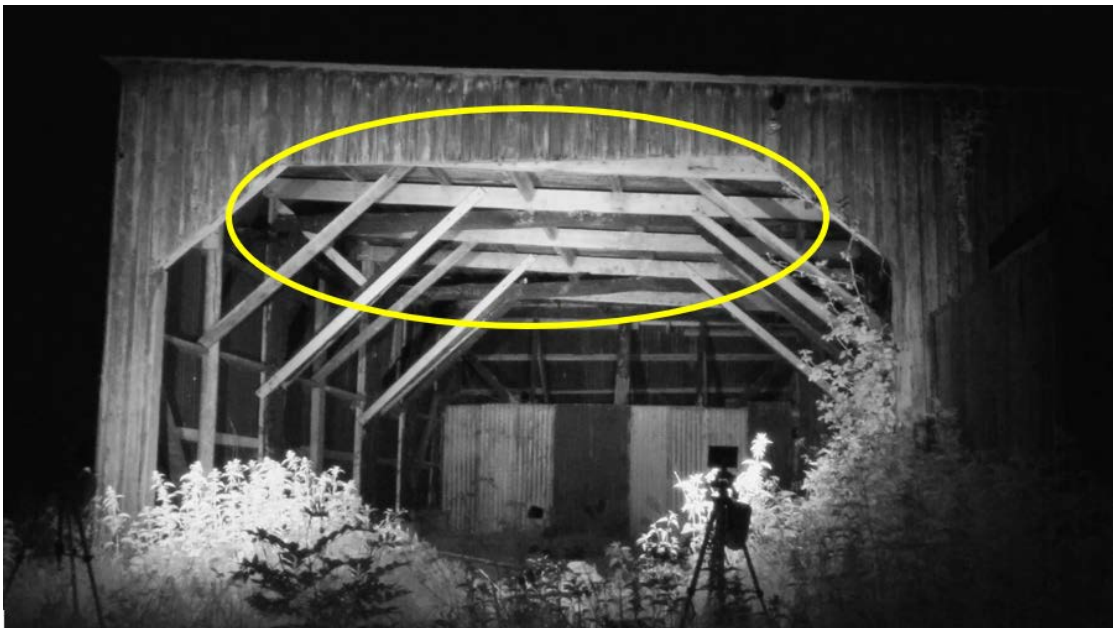
Figure 1 - Locations of bat perching behaviour

- 4.1.1 No bats were recorded emerging from potential roost features.
- 4.1.2 Repeated feeding perch behaviour was recorded by Pipistrelle bats (possibly both Common and Soprano Pipistrelle). While no calls were recorded of these bats at the exact time of the noted incidences of feeding perch behaviour occurring, both species were recorded flying in and around the building, including behind the corrugated wall and the hole in the roof. IR camera footage shows bats occasionally perching momentarily on beams in the northern section of the building (shown within the yellow-circled area in Figure 1 below).

- 5.1.1 Low numbers of Bats were shown by IR camera footage to fly and forage within the building. Pipistrelle bats were occasionally observed briefly perching on beams within the northern side of the structure when foraging within the building.

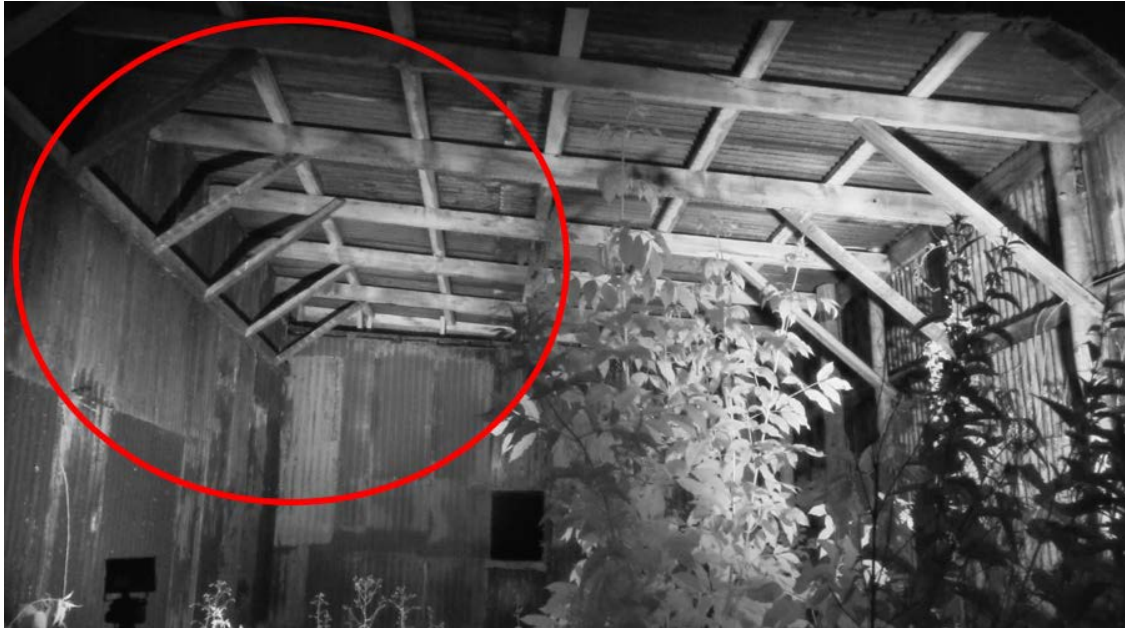
Figure 2 - Beams around which bats were observed exploring/foraging

- 4.2.1 No bats were recorded emerging from potential roost features.
- 4.2.2 IR camera footage showed low numbers of Pipistrelle bats occasionally exploring or foraging around some of the beams within the southern section of the building (circled red in Figure 2 below). The particular species concerned were not able to be identified as no associated calls were recorded at those precise times, however it is most likely that these are both Common Pipistrelle and Soprano Pipistrelle as calls of both these species were recorded at times close to and around these observations.
- 4.2.3 Repeated feeding perch behaviour was again recorded in the northern section of the building by Pipistrelle bats (likely both Common and Soprano Pipistrelle).
