Hertsfield Barn, Marden, Kent, TN12 9BW

STATEMENT OF

Dr Paul Ellis, BSc, PhD, CGeol

Subject Matter: The potential for groundwater flooding resulting from the unauthorised development at the neighbouring property known as Monk Lakes.

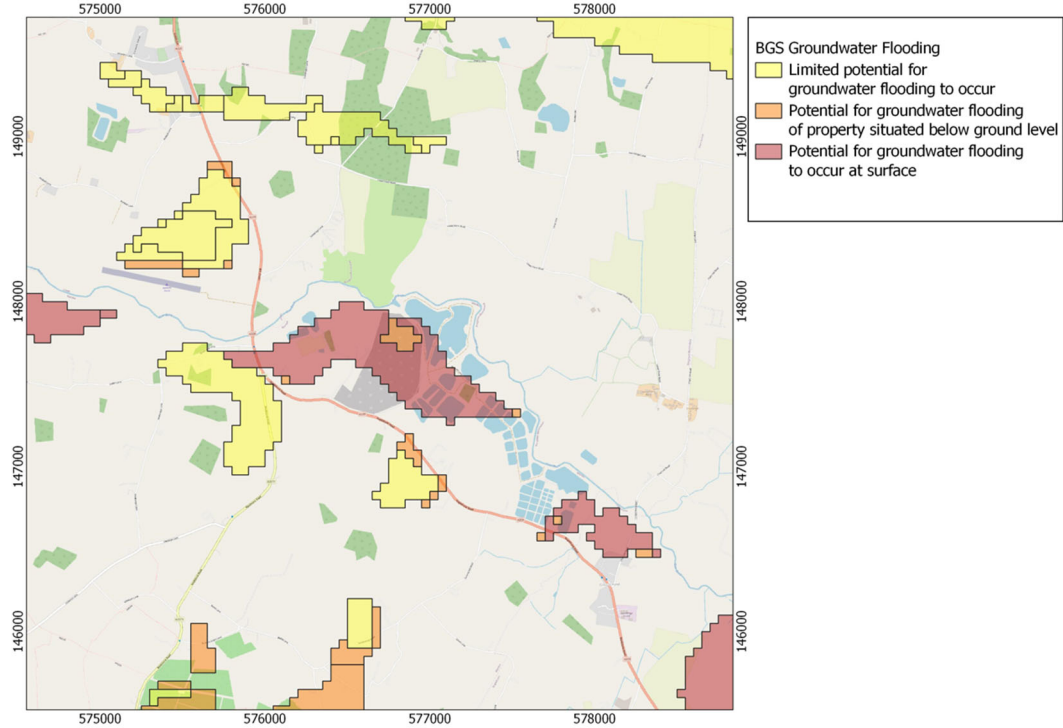
Figure 4 Susceptibility to groundwater flooding map, version 6.1, British Geological Survey.

- 4.3.9 Groundwater flooding is not considered a significant risk by the appellant, despite the published data to the contrary presented in Figures 4 and 5, and the long history at the site surrounding the investigation of groundwater flooding, including a previous judicial review. The applicant's boreholes have proved the existence of a shallow groundwater table and BGS mapping supported by site investigation data from Mr Padden indicates the aquifer extends beneath Hertsfield Barn. As discussed in my previous report (Geosmart, 2019a – see Appendix A) groundwater contours indicate potential groundwater flow from Monk Lakes, towards Hertsfield Barn.

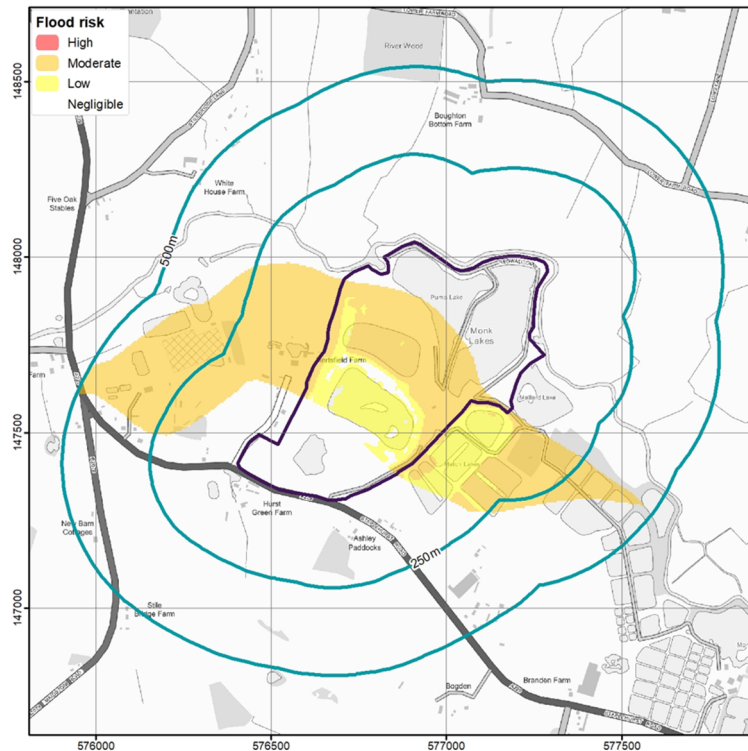
Figure 5 Groundwater Flood Risk Map GW5, Geosmart Information, National Map.

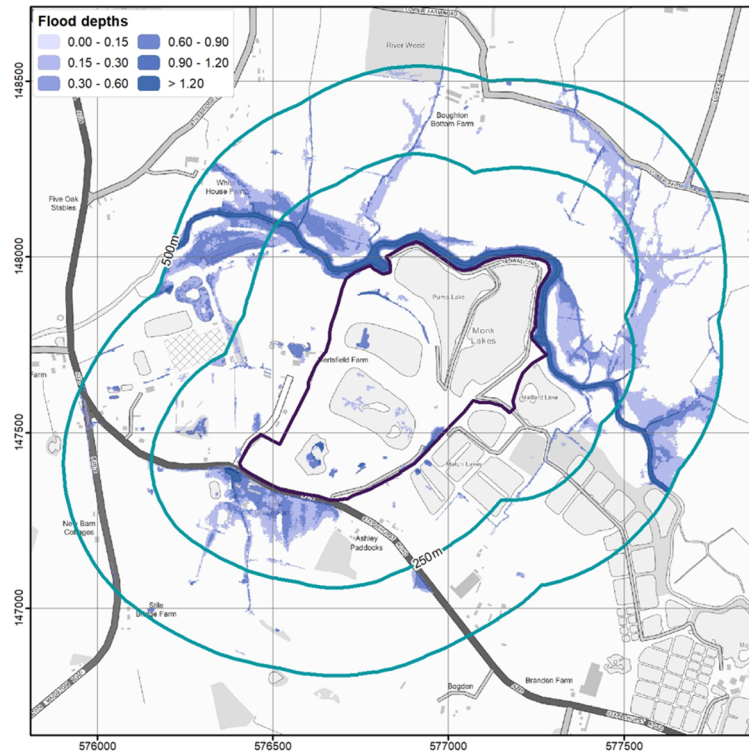
Figure 7 Environment Agency Surface Water flood depths for the 1 in 100 year event.

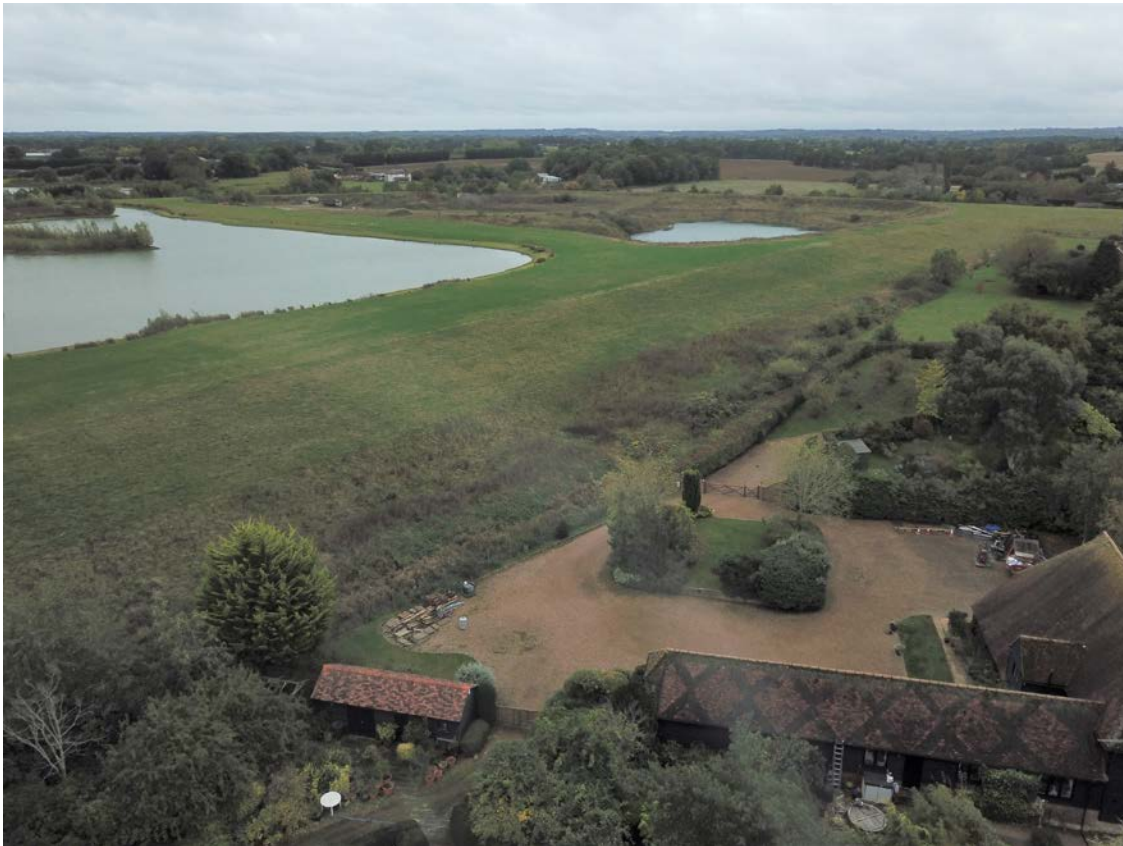
Figure 2. View looking south of Hertsfield Barn and Monk Lakes 1 and 2 (taken October 2019).

Mr Padden continues to report ongoing impacts on his property: a reported loss of trees in his orchard due to waterlogging; flooding of his pond and driveway; infiltration to his sewage treatment plant; and damp affecting his property. Similar impacts are also reported by other residents in the vicinity. Mr Padden estimates his pond to have been approximately 10cm higher this summer than previous years despite the dry weather. Recent Drone pictures provided by Mr Padden (Figure 3a) show levels in Lake 3 on the 10th of November 2019 to be low, exposing a significant section of the bank despite a very wet Autumn, which could be evidence of leakage from the Lake. Pumping was subsequently observed into Lake 3 resulting in a very significant rise in lake levels by 29th November 2019 (Figure 3b). It is assumed that the large volume of pumping was undertaken to replenish losses from the pond under the terms of the site abstraction licence, regulated by the Environment Agency.
