Monk Lake No 2

RESERVOIRS ACT 1975

CERTIFICATE OF EFFICIENT EXECUTION OF WORKS UNDER SECTION 7(6)

Report on the Inspection of Monk Lakes (Lake 2) Reservoir Under the Reservoirs Act 1975

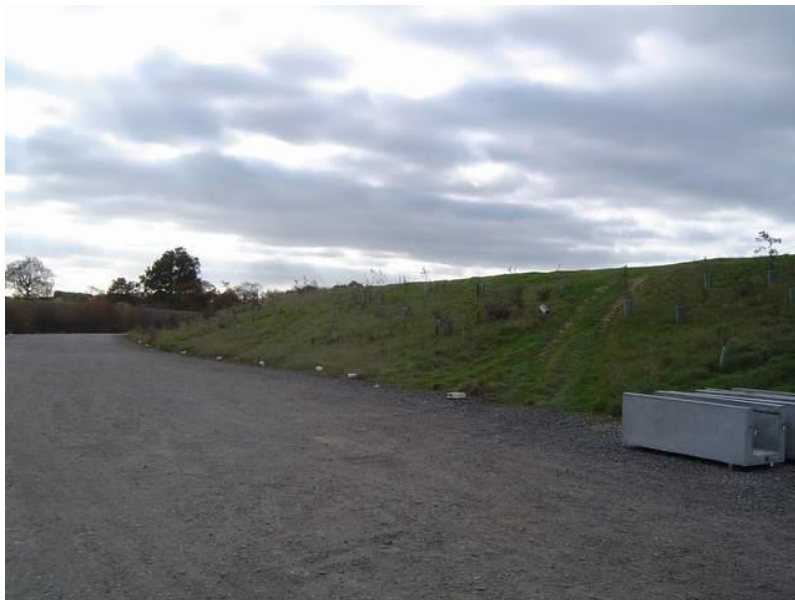
As noted above, the inspection was commenced at the eastern corner. The embankment at this point was constructed some time ago and has consolidated and been vegetated, as shown in the two photos below.

Eastern corner at the parking area looking south-westwards

All the embankments were tested with a hand-driven spike and found to be competent. The crest was very well compacted and the slopes less so, as would be expected. The material encountered during the probing was generally clayey, but some sand and gravel was evident in places. All the external slopes were noted to be stable.

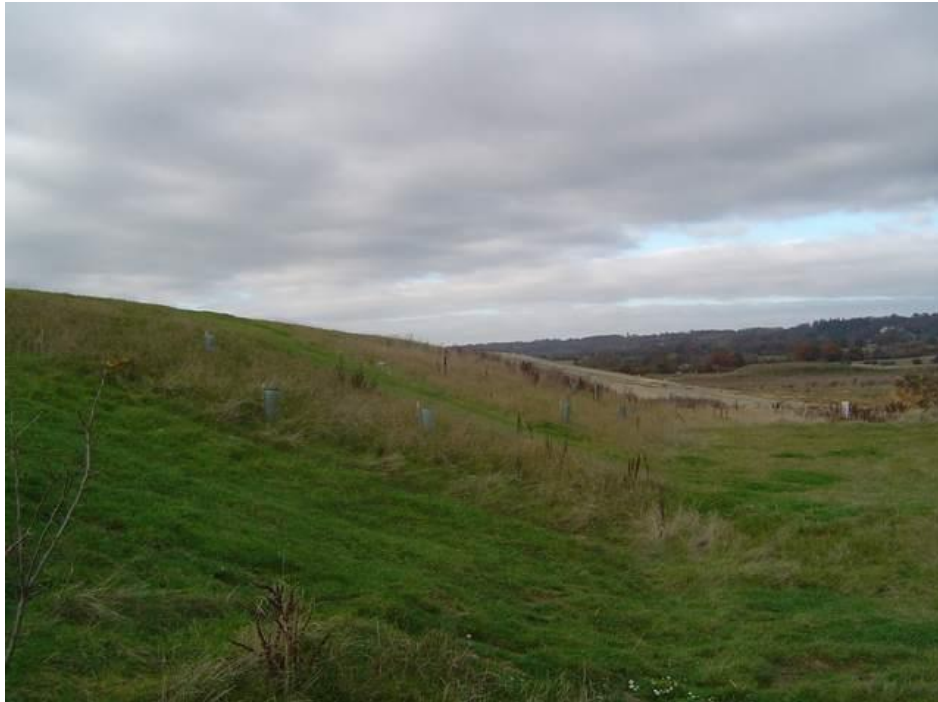
Eastern corner from the parking area looking north-westwards

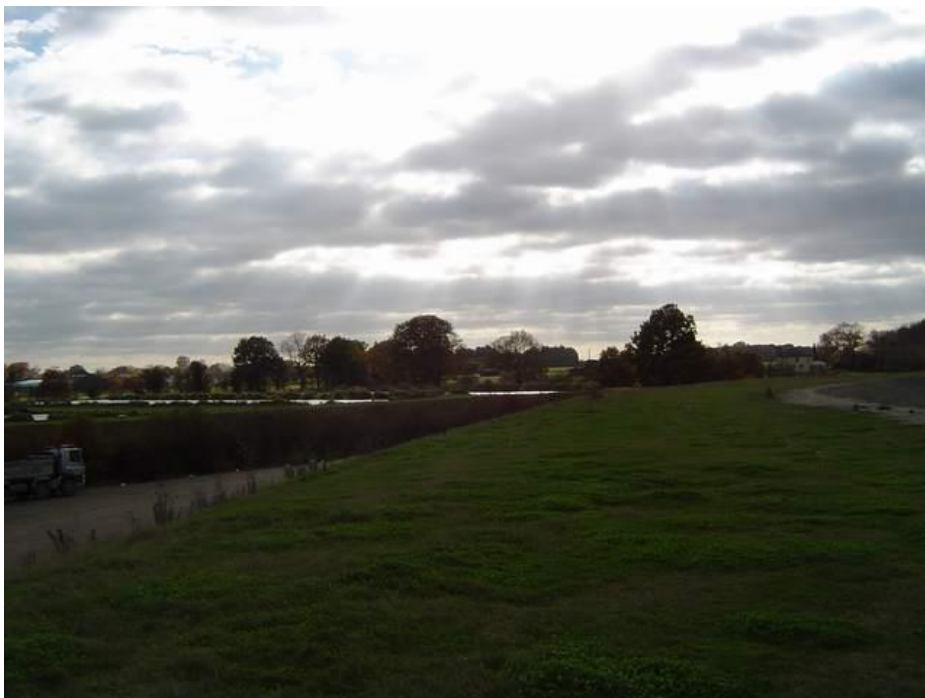
The crest is in good condition and is generally level, as seen in the two photographs below.

Crest near eastern corner looking south-westwards

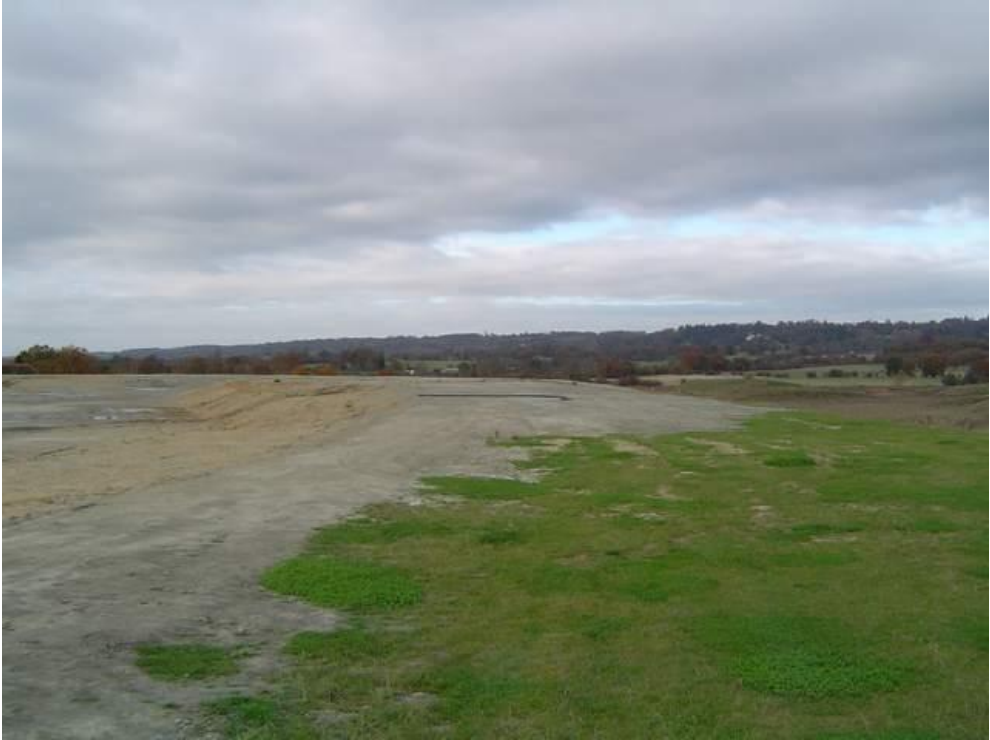
Crest near eastern corner looking north-westwards

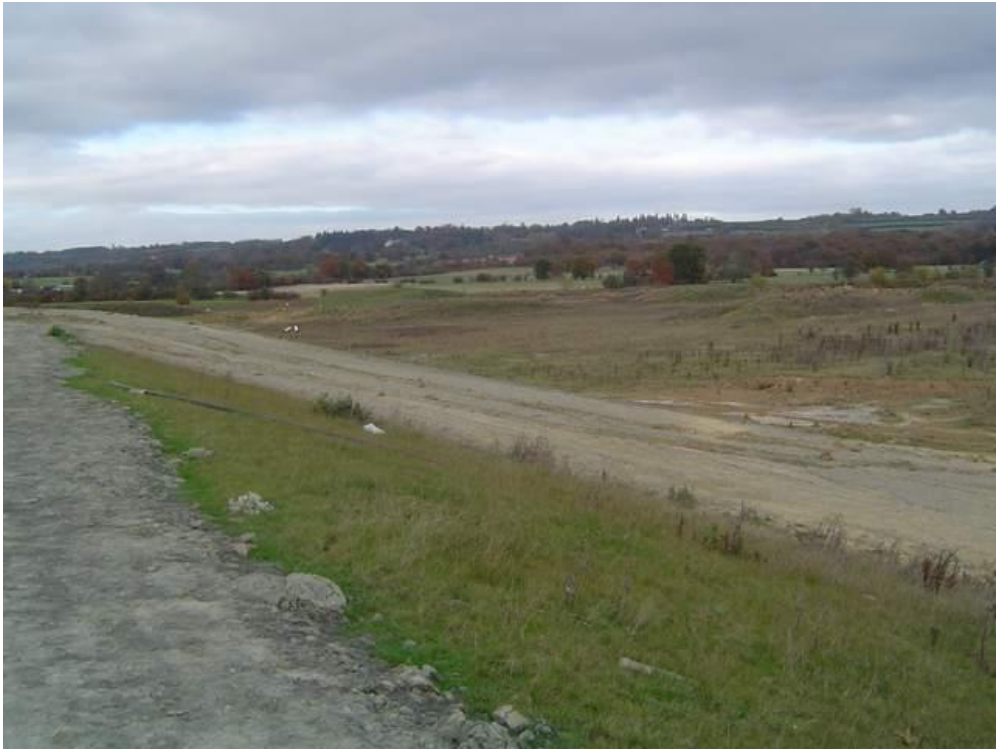
There is an access ramp to the crest approximately 100 m from the eastern corner, as shown below. It is assumed that this ramp will be retained when the three lakes are completed.

Access ramp

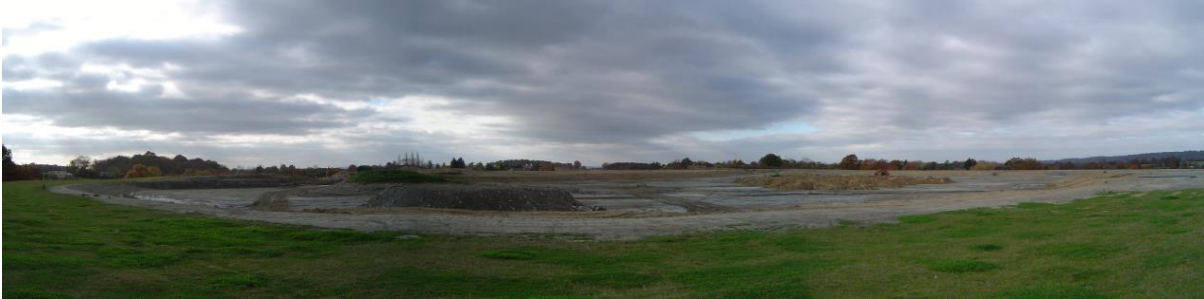
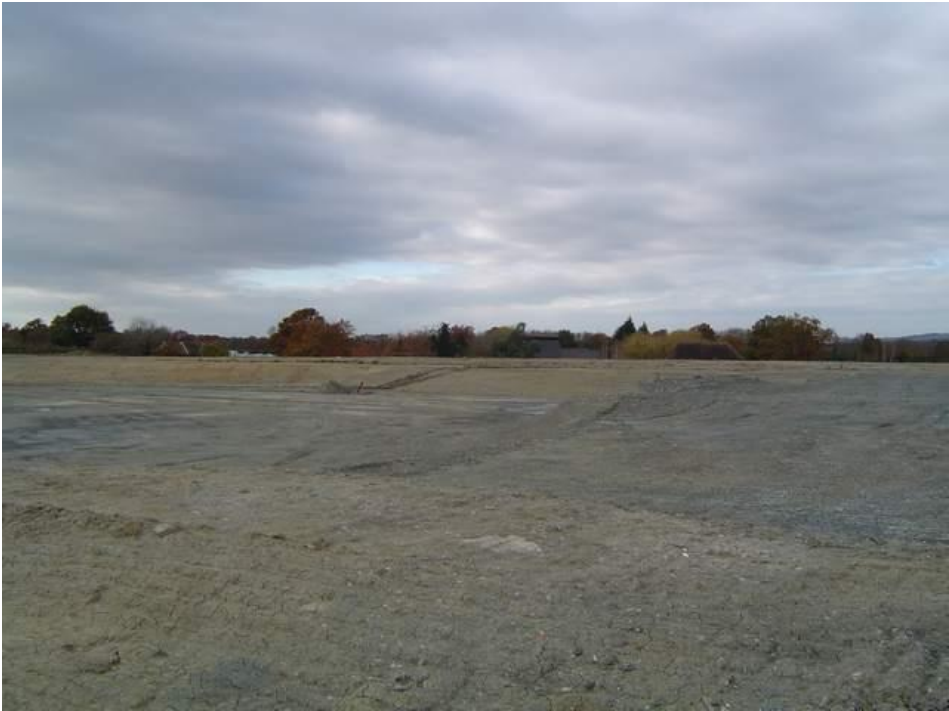
The reservoir basin has been largely completed as shown in the panorama below. Note the islands and the generally flat base of the reservoir.

Reservoir basin

In the above photo it should be noted that the clay on the floor of the basin is a little desiccated, due to a period of dry weather, and there is an outlet pipe visible in the centre of the photo. Nearby houses are also visible.

It is proposed that the water level is controlled by an outlet pipe shown above. Care will be needed to prevent blockage of the pipe, especially as reeds will be encouraged within parts of the reservoir. It is unclear why the pipe is at an angle, or where it exits. It is recommended that when the embankment is raised a short section, about 5 m wide, should be left 200 mm below the crest elevation to permit water to flow from Lake 1 → Lake 2 → Lake 3 in the event of overpumping and blockage of the outlet. Water would eventually be discharged from Lake 3 safely towards the River Beult.

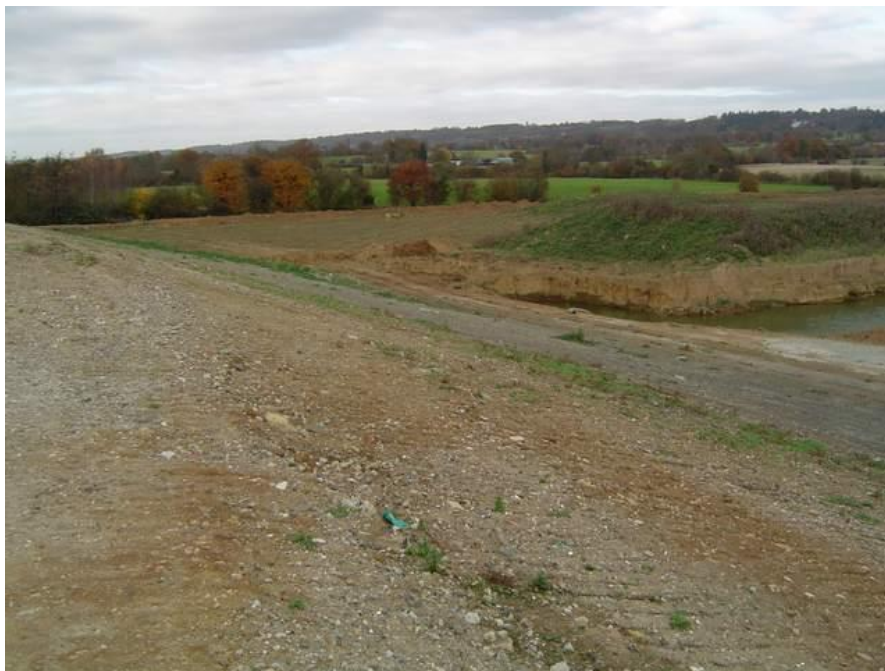
The external slope near the northern corner was noted to be in good condition, as shown below. It will eventually form the embankment between Lakes 2 and 3.

External slope at northern corner from embankment crest

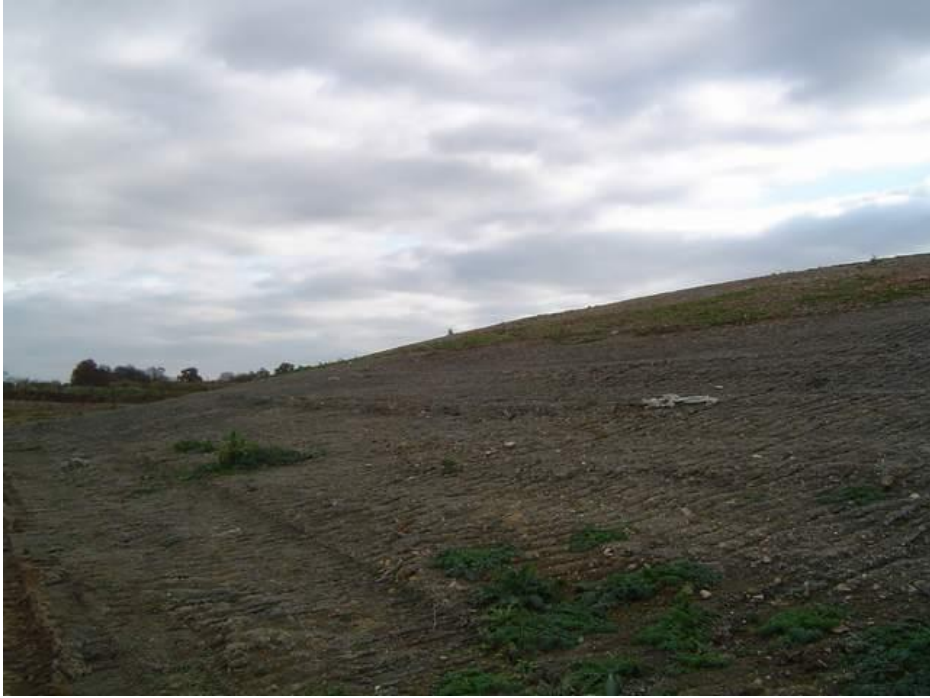
External slope at northern corner from embankment toe

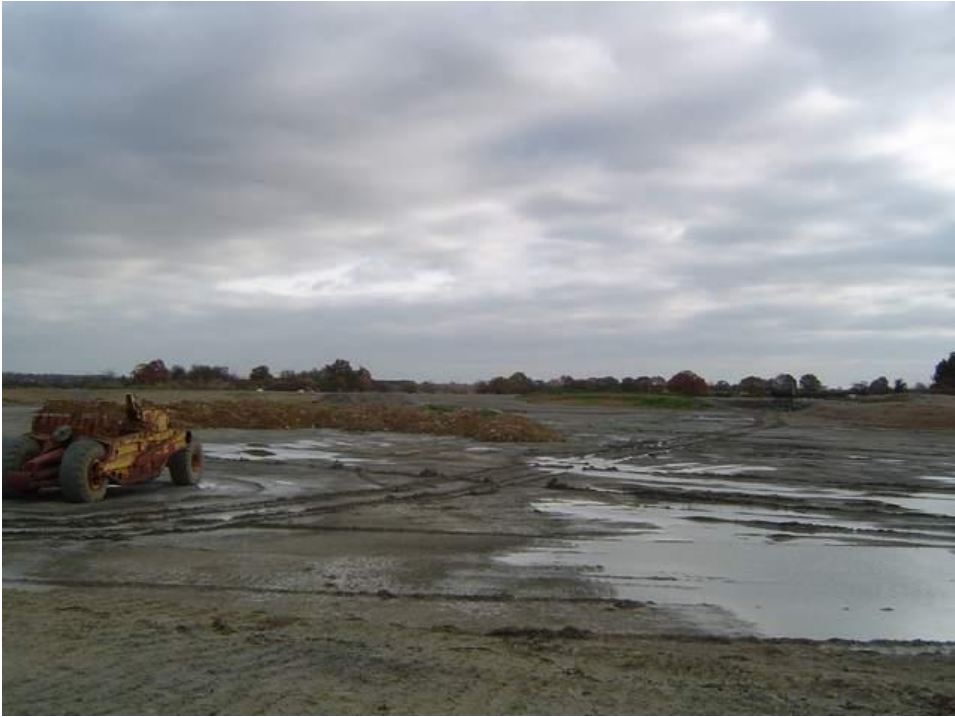
There was a small amount of water in this proposed wetland area, in a low spot, at the time of the inspection, as seen in the photo below.

Internal floor of reservoir basin in the wetland area

The above photo also shows earthfill material within the basin which will be reprofiled to form an island.

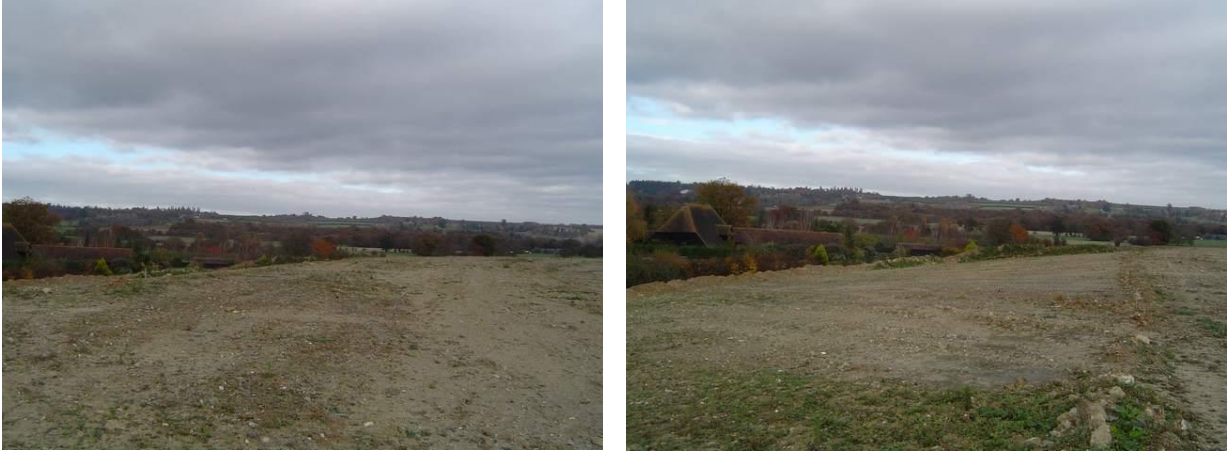
The external slope on the north-western side is close to existing housing and has been placed at a shallow slope, 1V:8H, to improve visual impact. Both the slope and crest have yet to be completed or vegetated, see photos below.

North-western slope and crest. Note houses close by

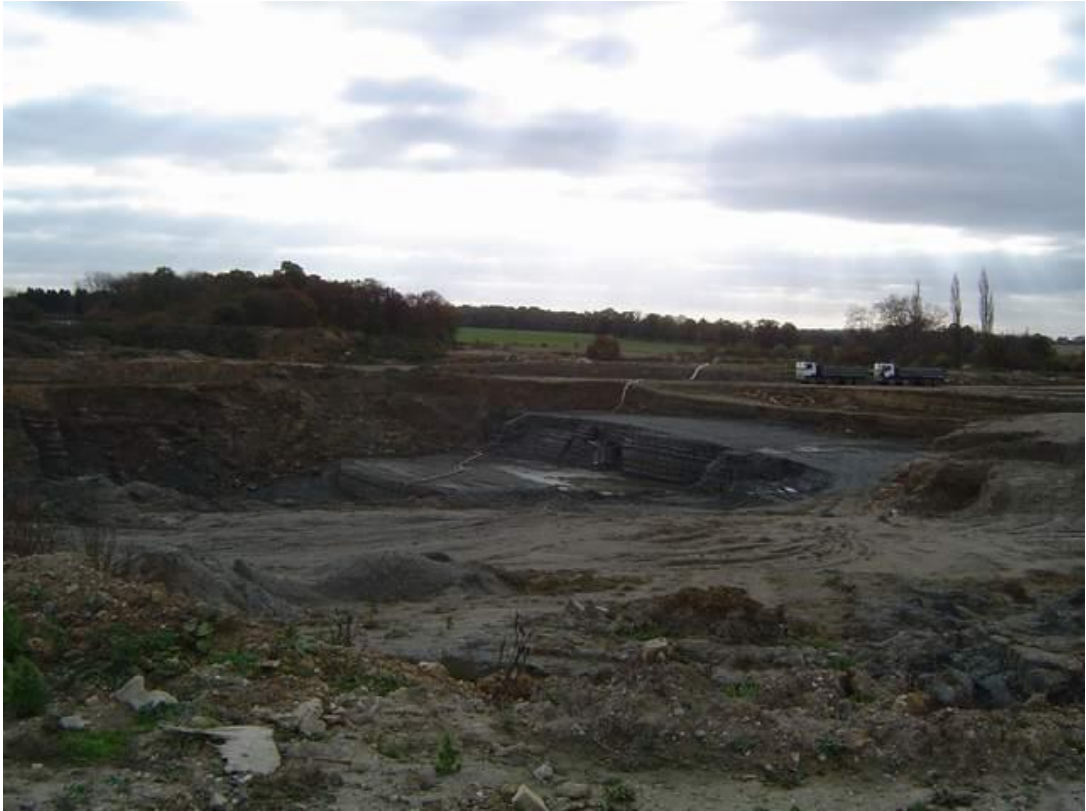
Clay material is currently being excavated from an area to the south-west of the proposed Lake 2, as noted below.

Clay quarry

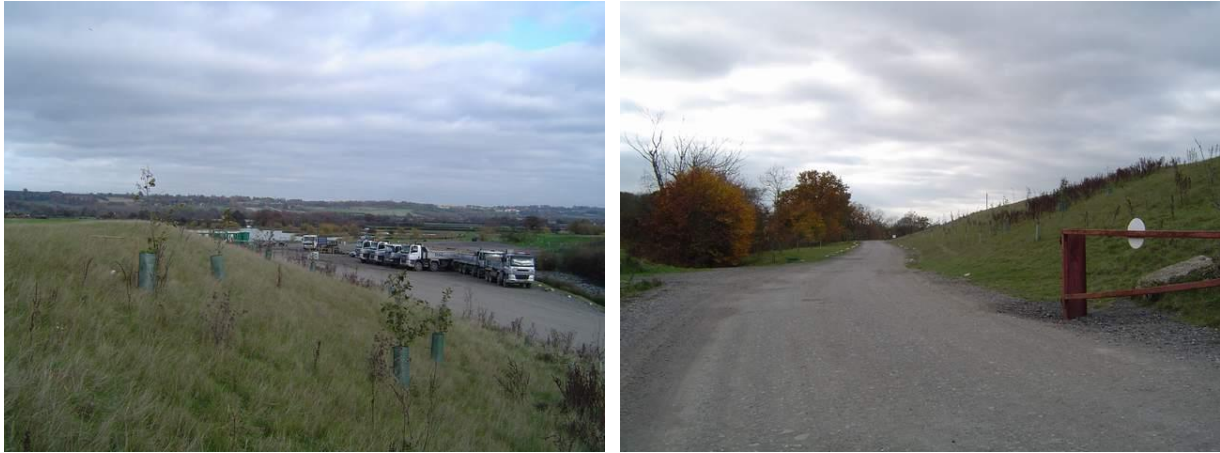
The south-eastern embankment is in good condition and has been planted to soften its visual appearance from the A229 and access track. The tree planting is approved due to the size of the embankment at this point.

South-east embankment alongside access track
