Review of Monk Lakes Environmental Statement Groundwater Impact Assessment

Hydrogeological advice to MBC in relation to
planning application ref. 11/1948

July 2019

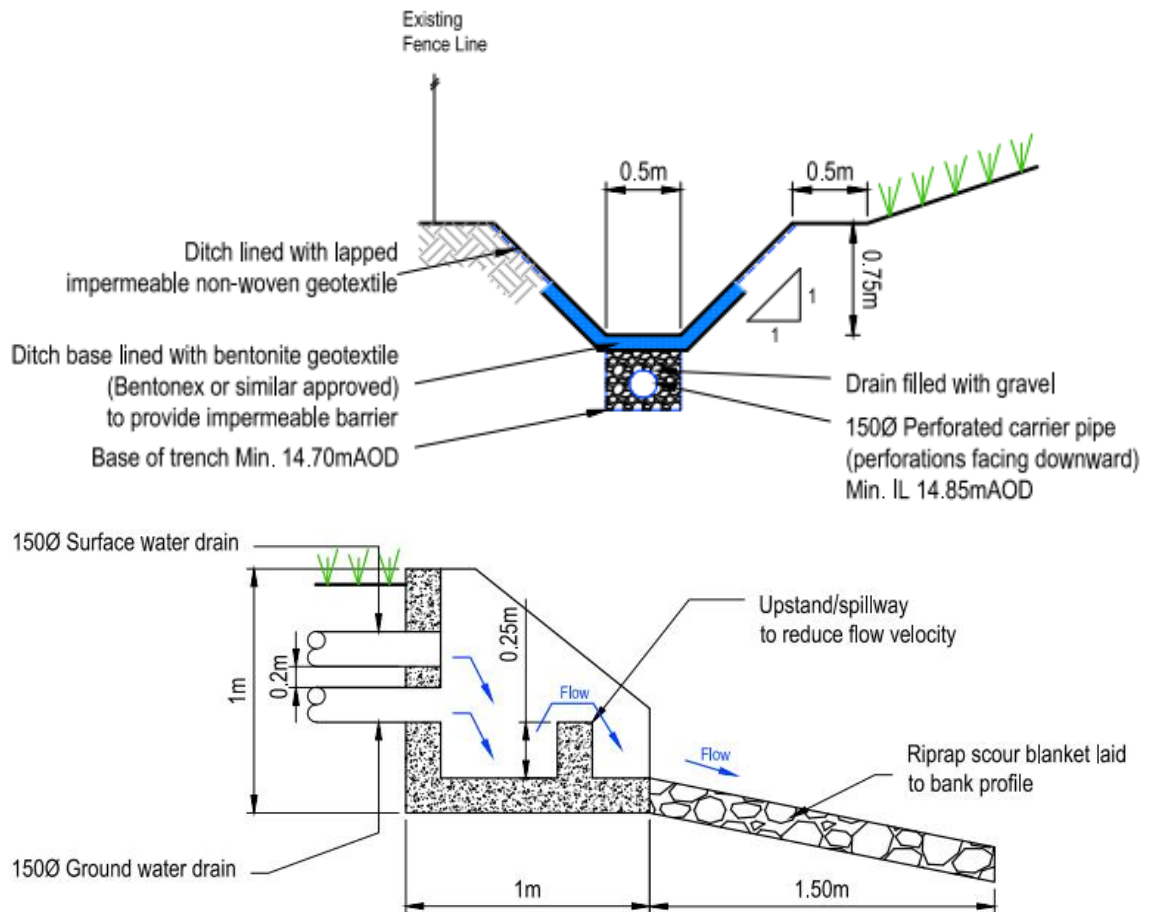
2.3.1 The mitigation proposed by the Applicant involves re-working the existing western boundary ditch to prevent infiltration of surface water through the ditch base and, the installation of a groundwater infiltration pipe below the ditch, to limit the potential for elevated groundwater levels. A cross sectional drawing of the proposed design is shown below.

Figure 1: Typical sections of proposed surface water ditch and groundwater interceptor drain

- 2.3.2 The base of the proposed trench (in which the perforated section of pipe would be set) slopes downward from 14.95 to 14.7mAOD, at which point solid pipe would be used to convey flow through the River Terrace deposits to the outfall (to avoid re-infiltration of the water).

- 2.3.13 It is noted that the side slopes of the drainage ditch are relatively steep, which may result in some settlement that could (in addition to reducing its capacity to carry surface water) adversely impact on the integrity of the impermeable liner.

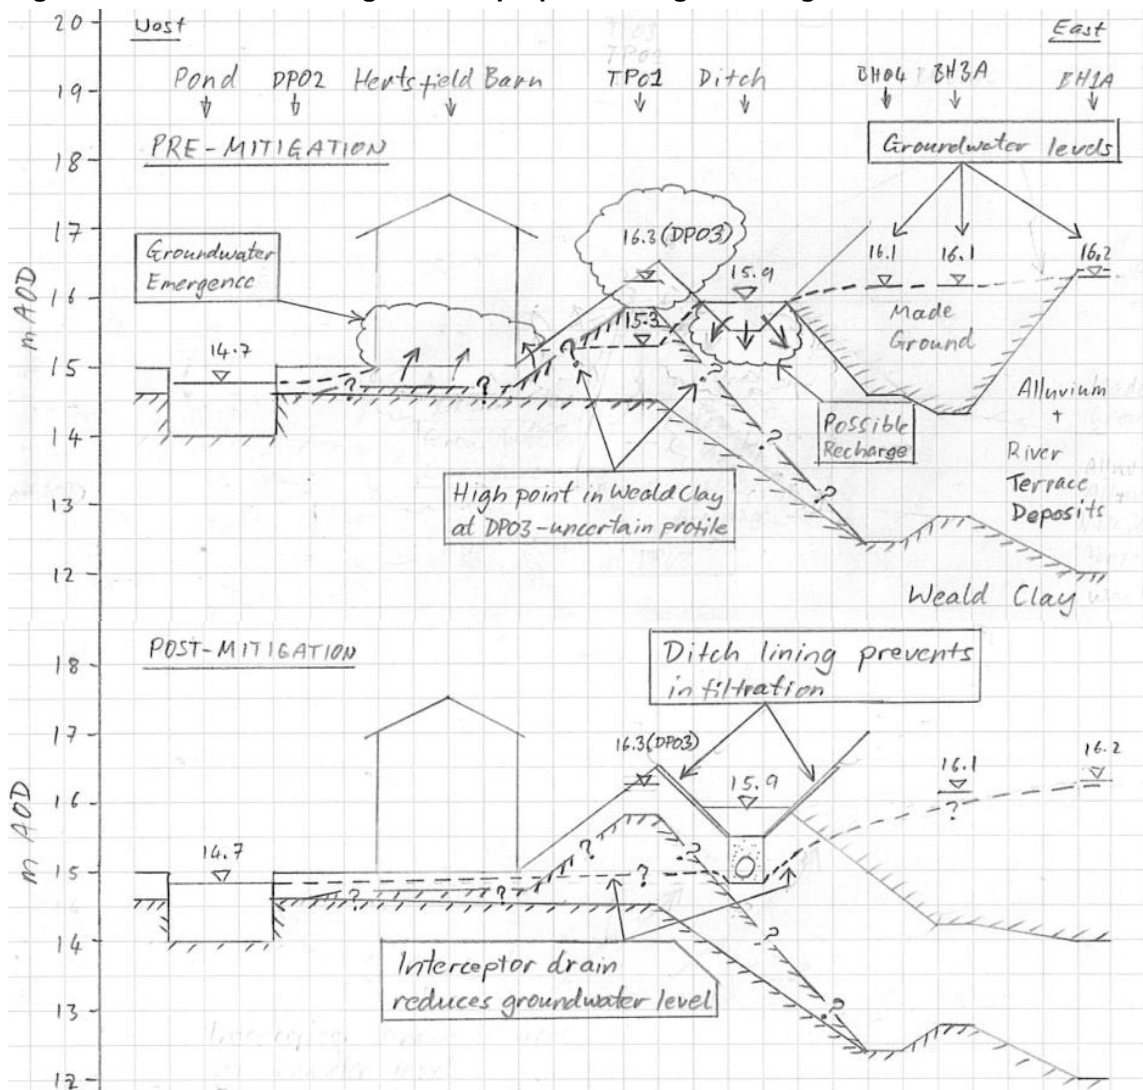
Figure 2: Schematic showing effect of proposed mitigation on groundwater level

- 2.3.9 We have conservatively estimated a maximum groundwater inflow of 15l/s, using data presented by the Applicant (see Appendix B). These estimates do not allow for uncertainties such as increased groundwater level due to climate change, inaccurate permeability estimates, or variations in aquifer thickness, which could all increase the rate of inflow.
